Eagle Parade Conduit  
Eagle Parade  
Buxton  
Derbyshire  
SK17 6EQ

EXISTING  
NORTH ELEVATION - CENOTAPH  
CONDITION SURVEY (1 OF 2)

24233-E-032A

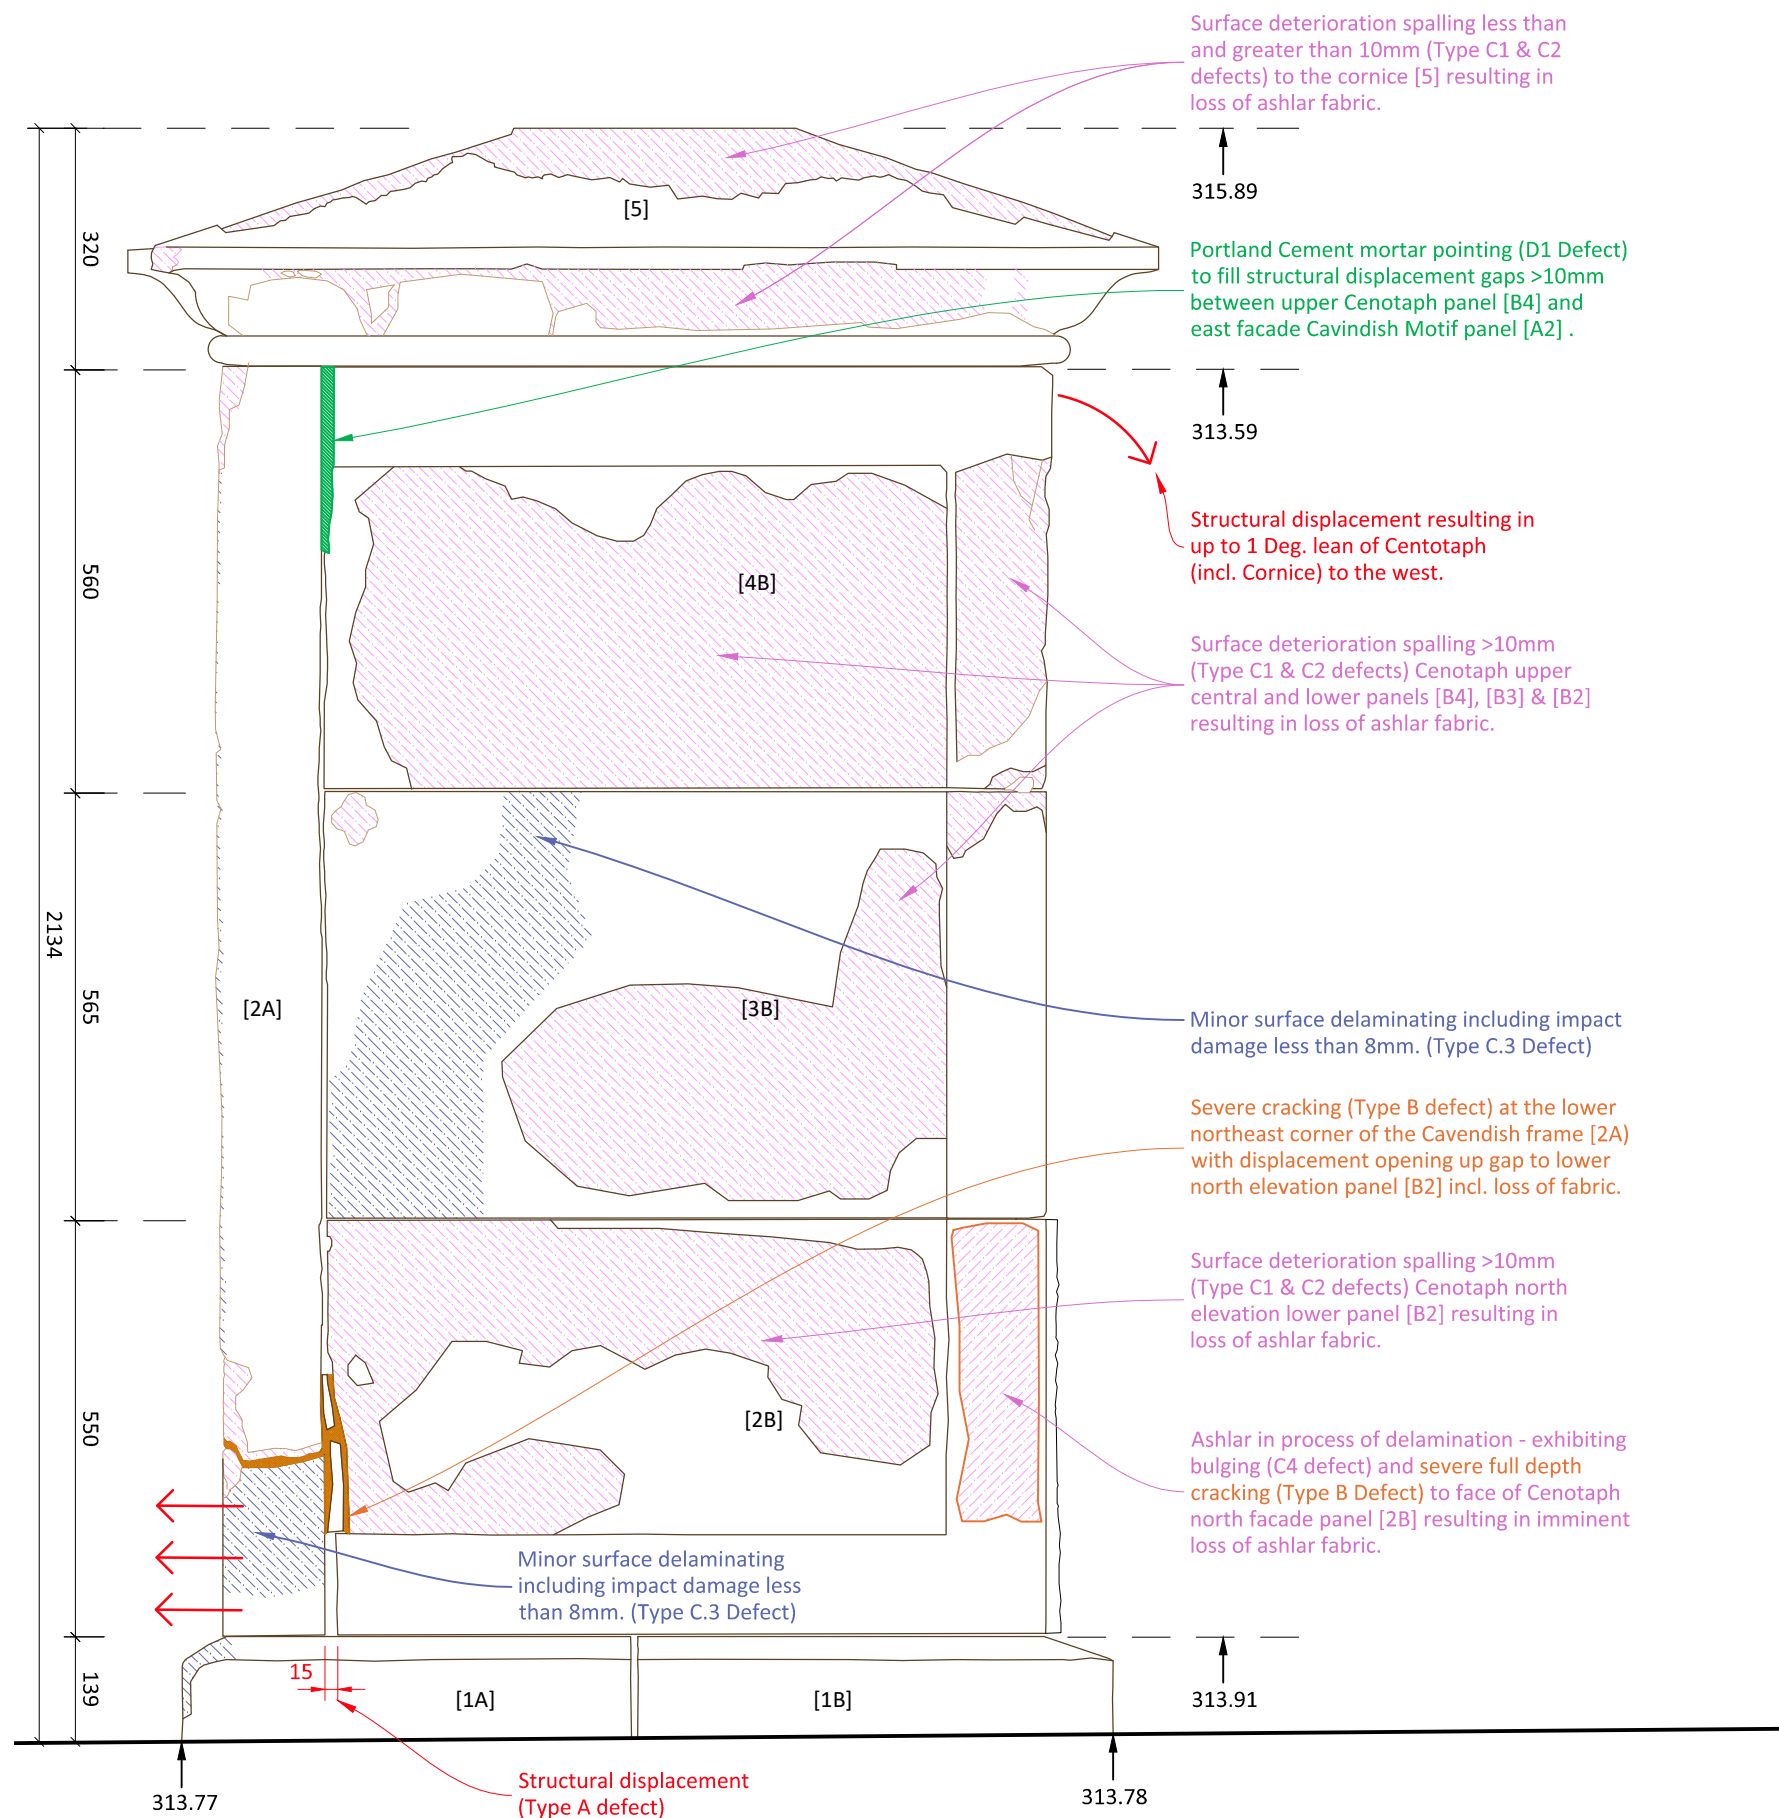
North Elevation  
Existing Survey  
(1:10)

- Type A - DISPLACEMENTS - indicating continued and worsening structural movement.
- Type B - CRACKS/FRACTURES - caused by structural movement or freeze-thaw salt crystallization.

- Type C - SURFACE LOSS - greater than 8mm and up to 15mm with delamination and 'contour-scaling', which has been followed by further crumbling and flaking of the ashlar.
- TYPE C.3. Minor surface delaminating including impact damage less than 8mm.
- Type D - CEMENTITIOUS MORTAR
