Eagle Parade Conduit  
Eagle Parade  
Buxton  
Derbyshire  
SK17 6EQ

EXISTING  
SOUTH ELEVATION - CENOTAPH  
CONDITION SURVEY (2 OF 2)

24233-E-035C

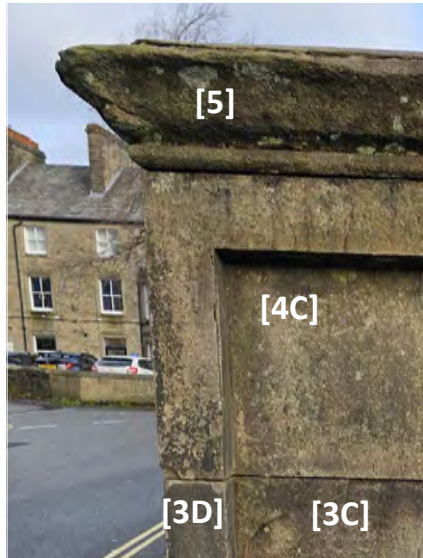
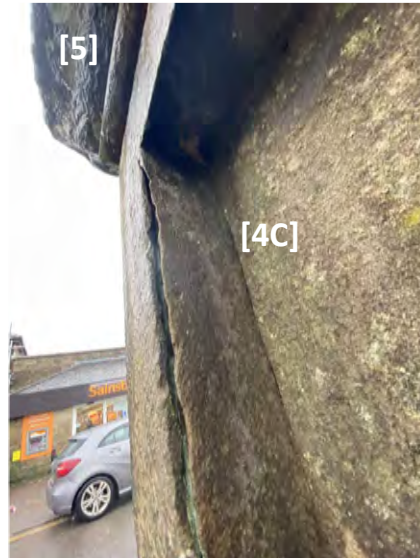
(above & above right) Severe surface deterioration >10mm spalling (Type C1 defect) to panel [4C] and Cornice [5].

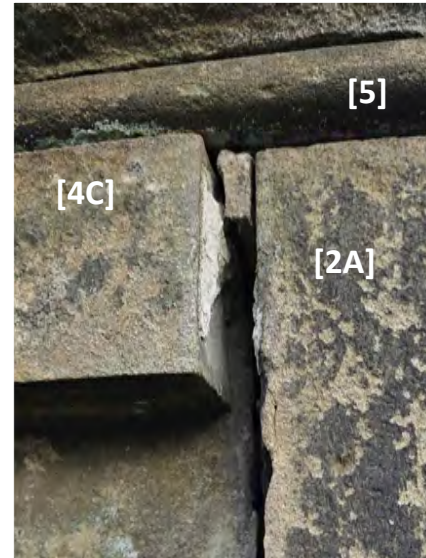
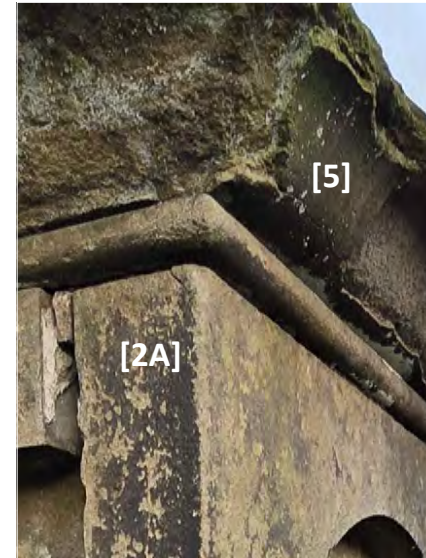
(above & above right) Portland Cement pointing (D1 Defect) to fill structural displacement gaps >10mm between east facade Cavendish panel [2A] and panel [4C]. Severe surface deterioration >10mm spalling (Type C1 defect) to southeast corner of Cornice [5].

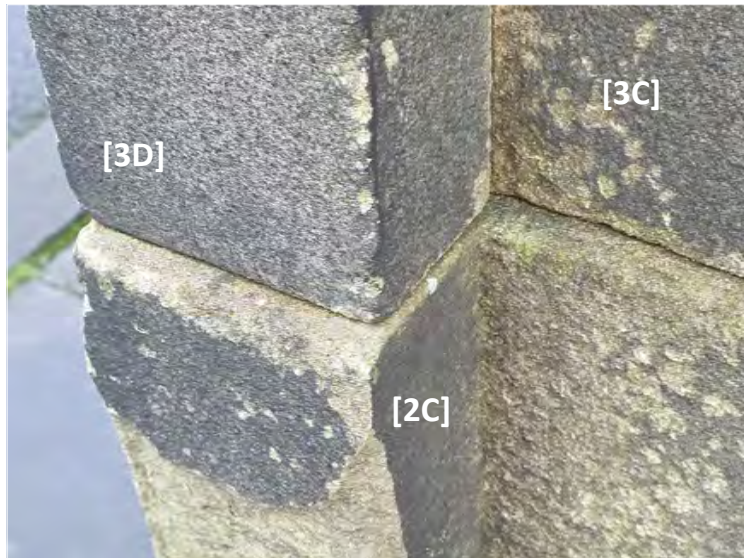
Example of structural displacement (Type A defect) with lower panel 2C pushing southwards below panel [3D]

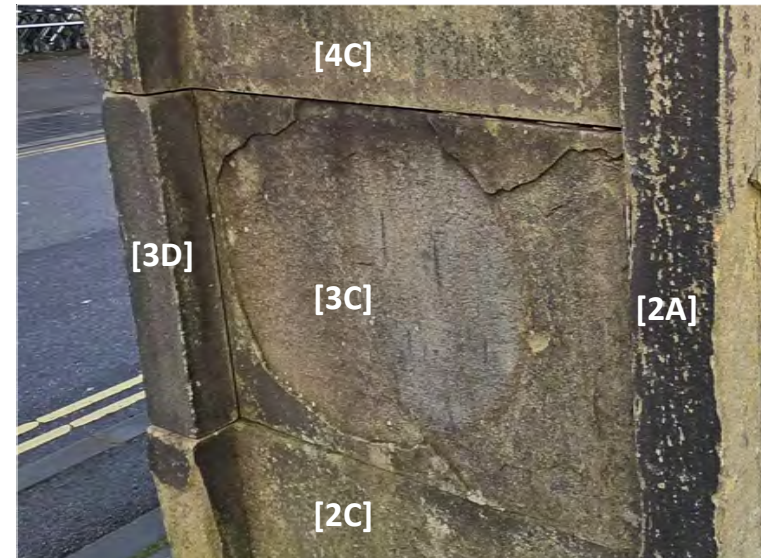
Surface deterioration spalling less than and greater than 10mm (Type C1 & C2 defects) to the cornice [5] and Cenotaph south facade central panel [3C] resulting in loss of ashlar fabric.

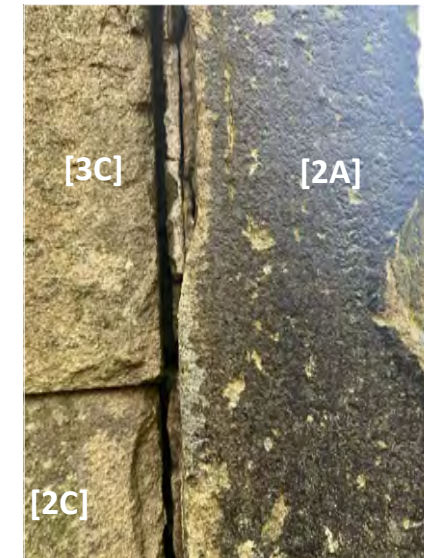
Portland Cement (D1 Defect) to fill structural displacement gaps >10mm between panels [2C], [3C] and [2A].

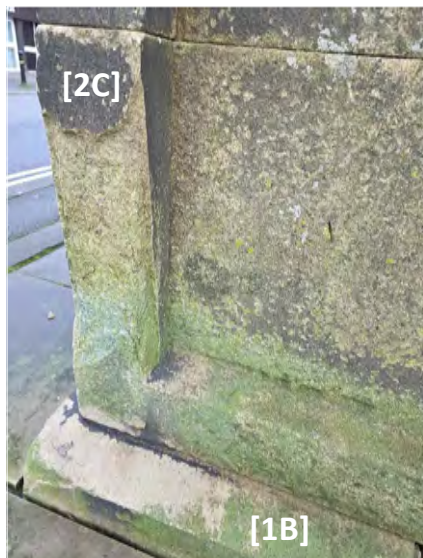
Southwest Corner severe surface deterioration >10mm spalling (Type C1 defect) to southwest lower corner of Cenotaph panel [2C]

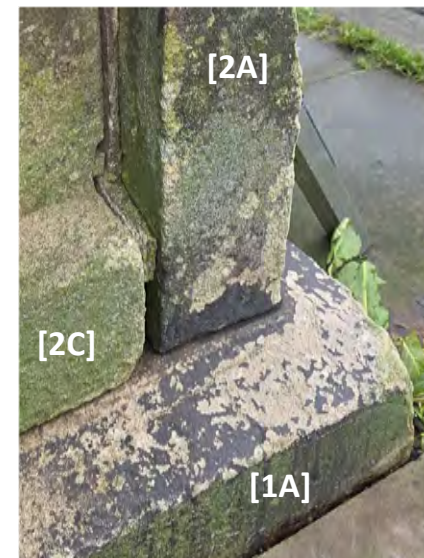
Portland Cement (D1 Defect) to fill structural displacement gaps >10mm at southeast corner [2C] [2A] & Plinth [1A]
