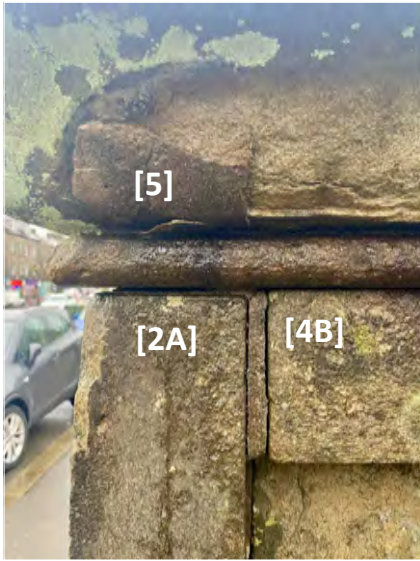
Portland cement pointing between [4B] and Cavindish Motif frame [2A] incl. loss of corner surface to latter.

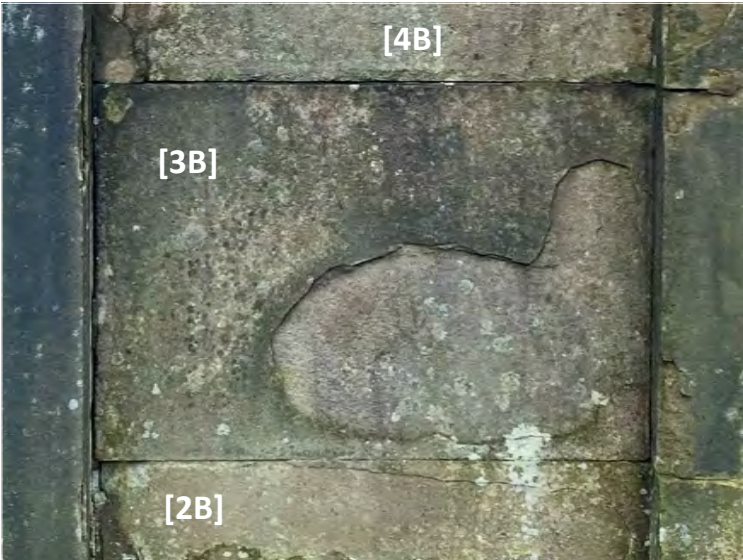
Surface deterioration spalling >10mm (Type C1 defects) Cenotaph north elevation lower panel [B3] resulting in loss of ashlar fabric.

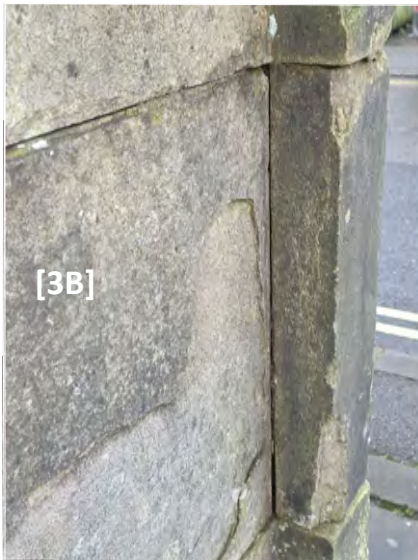
Extent of surface loss to central panel [3B]

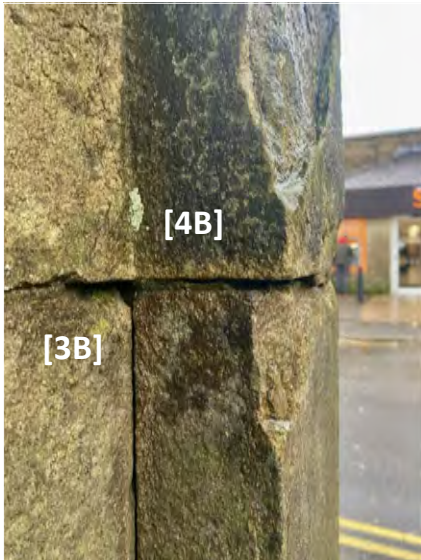
Extent of surface loss to central panel [3B]

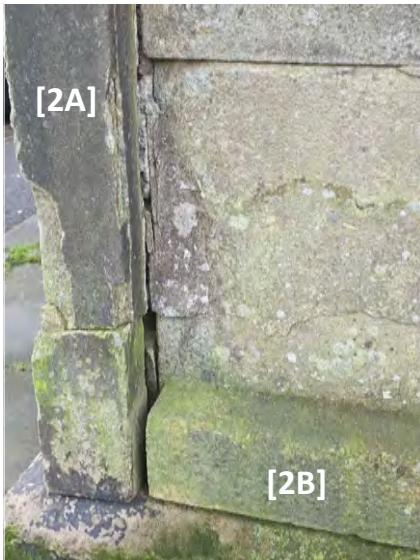
Severe cracking (Type B defect) at the lower northeast corner of the Cavendish frame [2A] with displacement opening up gap to lower north elevation panel [2B] incl. loss of fabric.

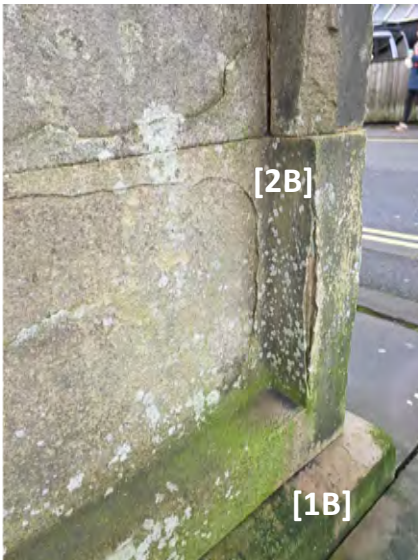
Surface loss to lower panel [2B] and blown surface to NW corner above Plinth [1B]

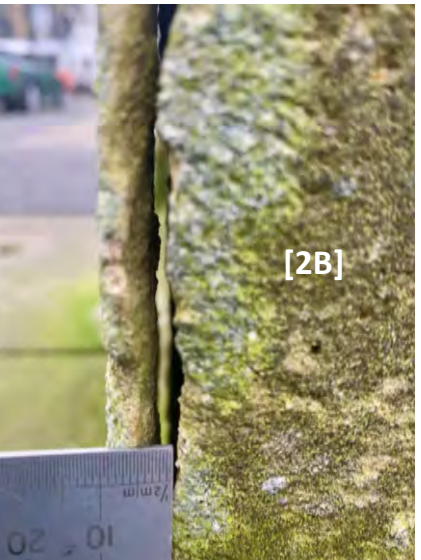
Ashlar in process of delamination - exhibiting bulging (C4 defect) and severe full depth cracking (Type B Defect) [2B] resulting in imminent loss of ashlar fabric.
