Eagle Parade Conduit  
Eagle Parade  
Buxton  
Derbyshire  
SK17 6EQ

EXISTING  
WEST ELEVATION - CENOTAPH  
CONDITION SURVEY (2 OF 2)

24233-E-039B

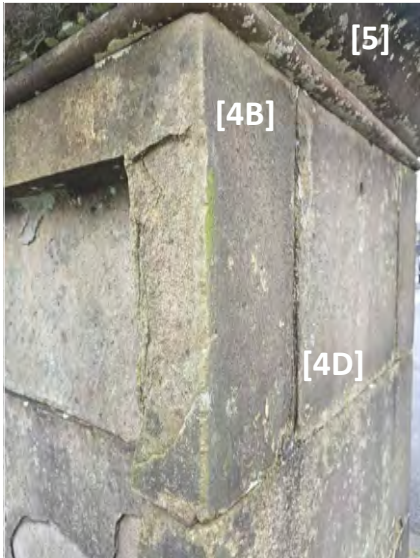
Extent of severe surface loss to panel [4B] viewed from north west.

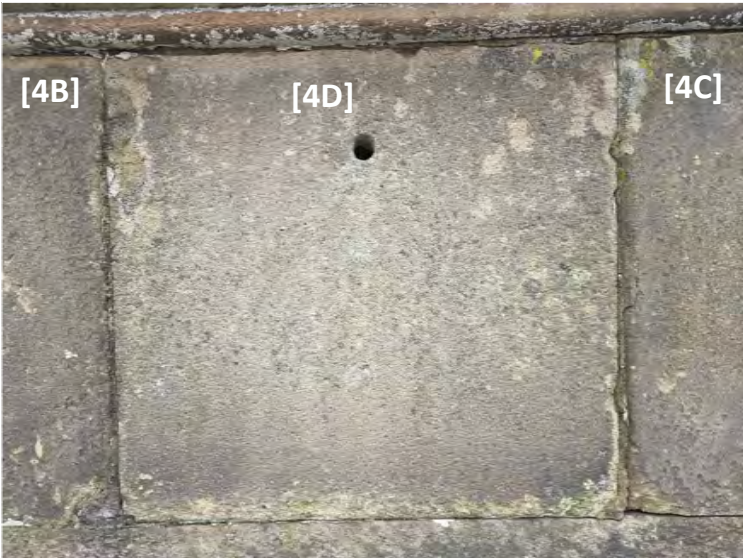
Portland Cement perp end mortar pointing (D1 Defect) to fill structural displacement gaps <10mm and loss of surface to upper panels [D4], [C4] and [B4] of Cenotaph west elevation.

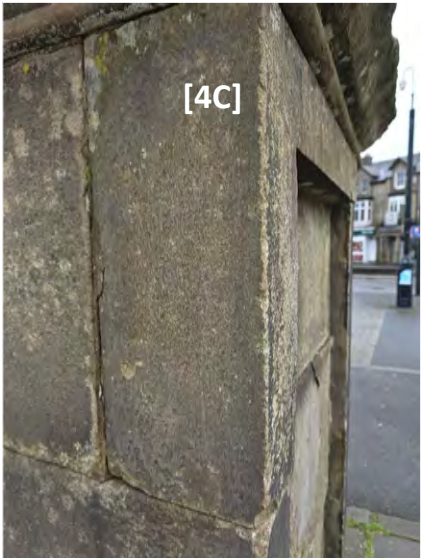
Severe surface deterioration >10mm spalling (Type C1 defect) to both bottom corners of panels [4C].

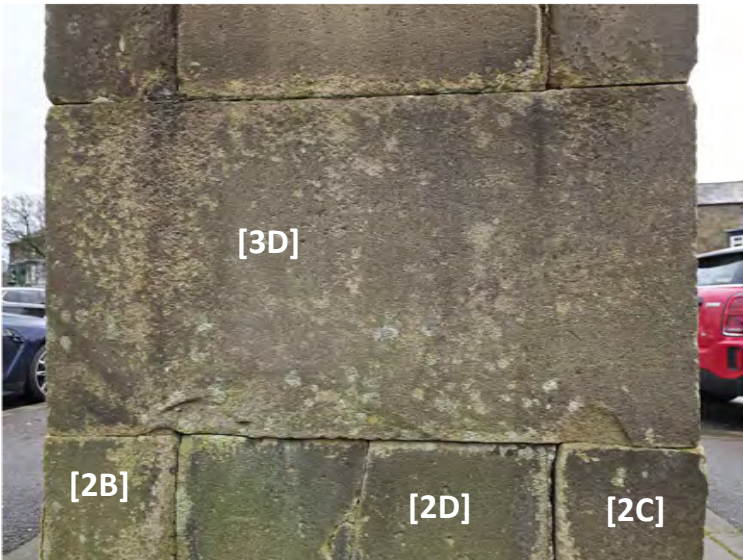
Surface deterioration spalling >10mm (Type C1 defects) to lower section of Cenotaph west elevation mid panel [3D] resulting in loss of ashlar fabric.

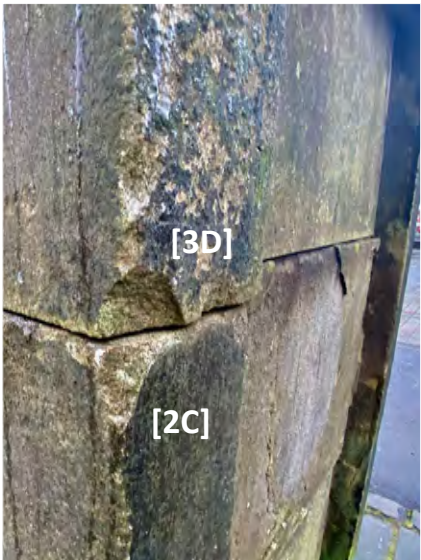
Severe surface deterioration >10mm spalling (Type C1 defect) between panels [2C] and [3D] on southwest corner.

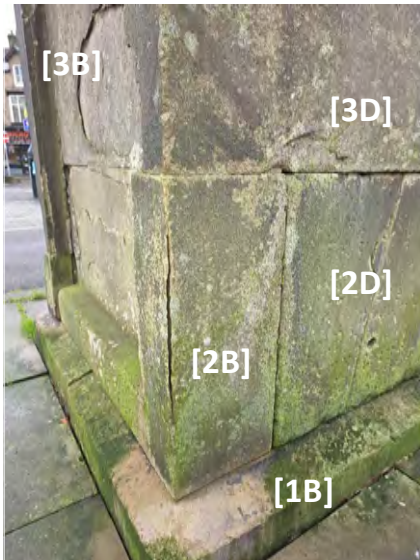
Ashlar in process of delamination - exhibiting bulging (C4 defect) and severe full depth cracking (Type B Defect) [2B] resulting in imminent loss of ashlar fabric.

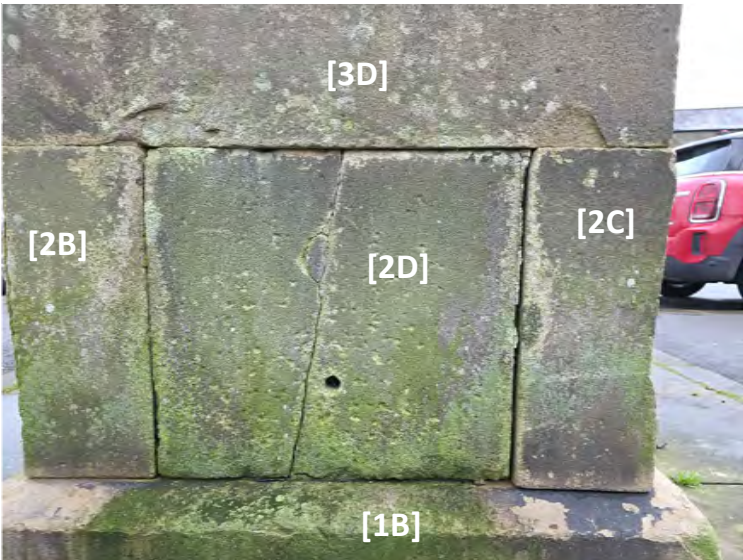
Severe cracking >10mm (Type B defect) through full depth of lower Cenotaph west facade central panel [2D] with minor surface delaminating including impact damage less than 8mm. (Type C.3 Defect) across lower section of panel.

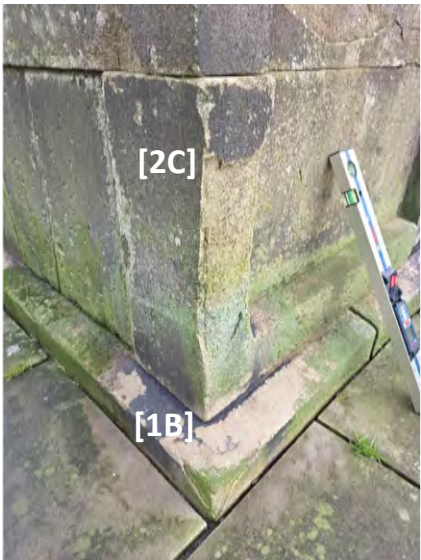
Severe surface deterioration >10mm spalling (Type C1 defect) to southwest lower corner of Cenotaph panel [2C].
