**DLR Engineering**  
**Structural Engineering Report**

**3-4 Bath Road**

**DLR REF: 260023**

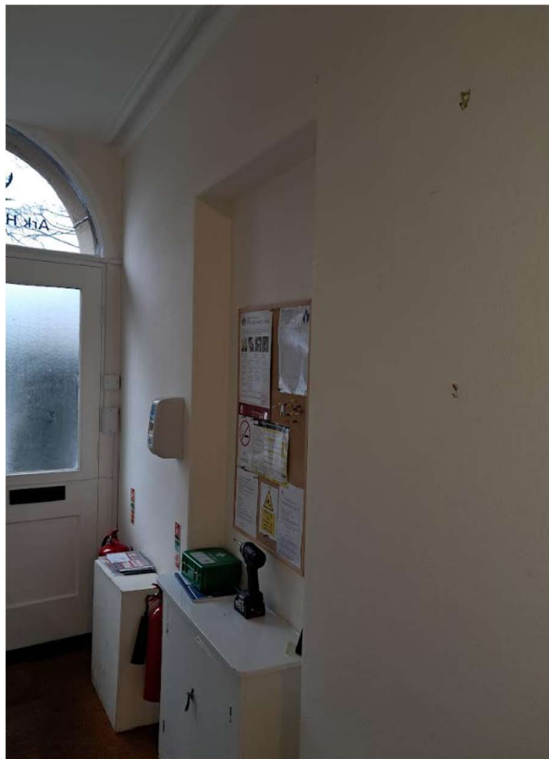
I was able to view the proposed locations for wall removals (see attached photos). These areas appeared to be in good condition and providing an adequate and safe design proposal is supplied, it is not thought these proposed wall openings will have a detrimental impact on the building structure.

*Figure 1 - Wall to be removed entrance area*

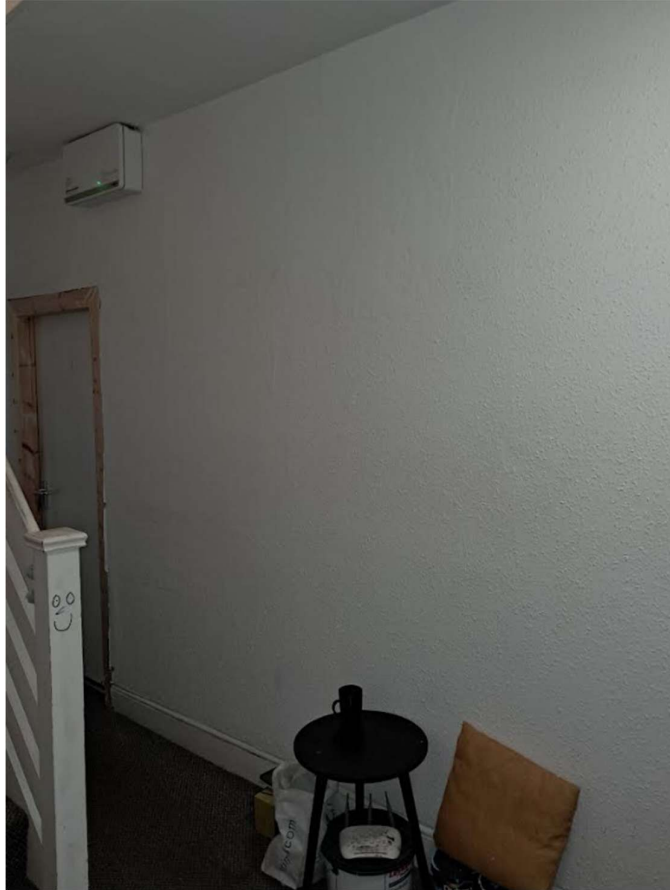
*Figure 2 - Wall to be removed bedroom area*
