## Inspection Report 7990-06-0101

Barn near to:  
Staden Lane,  
Buxton

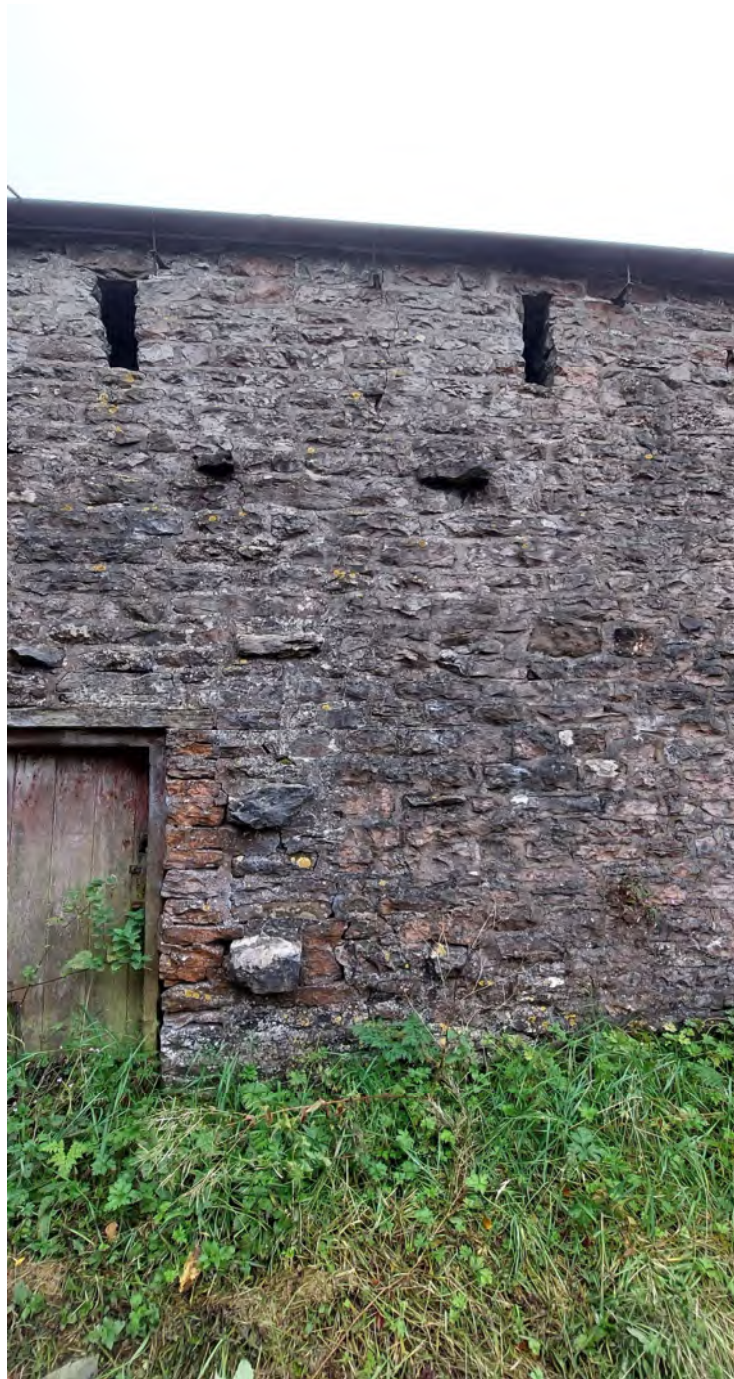
- 3.11. The mortar joints were in poor condition on the right elevation.
- 3.12. The front portion of the building towards the east side were observed to have vertical cracks 3mm wide.

Picture1 - The front portion of the building is referred to as the north elevation with visible vertical cracks 3mm wide.

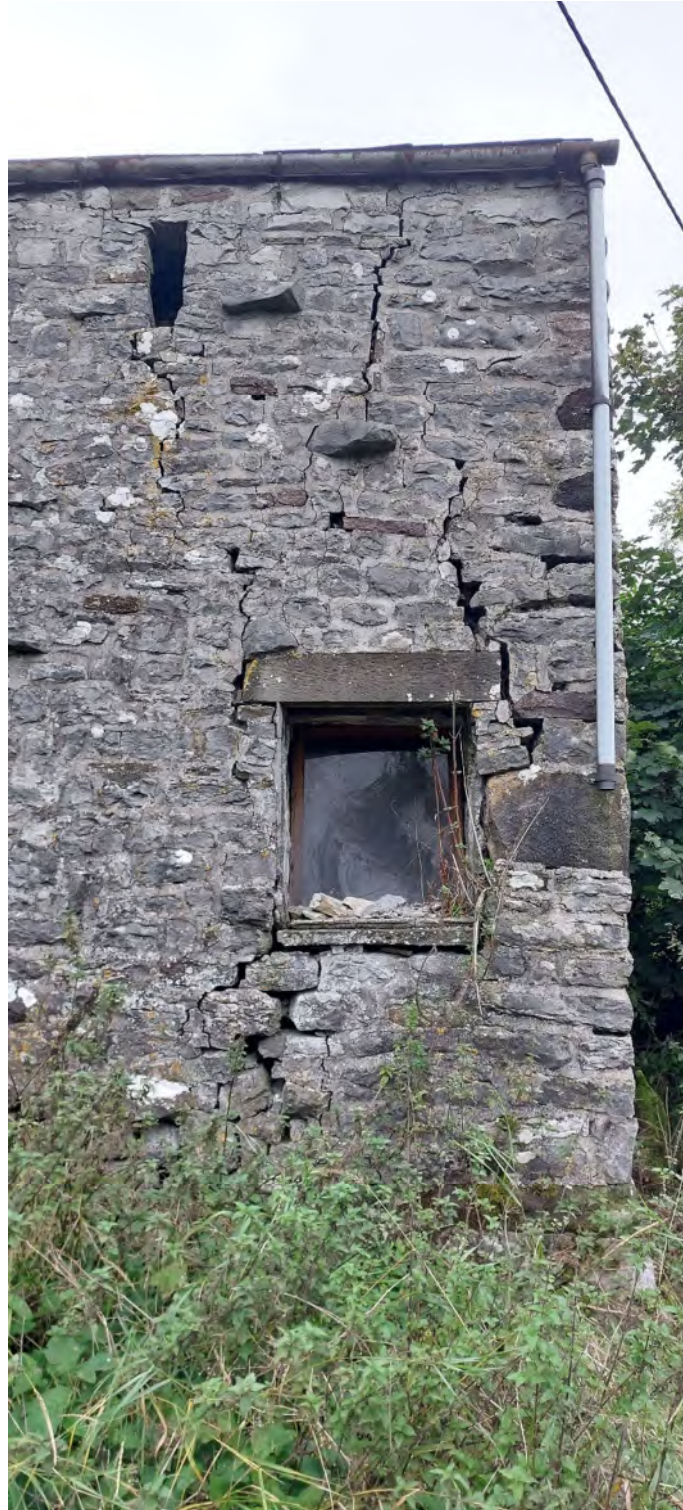
- 3.9. The gutter on the rear elevation was in poor condition. It was corroded and was not connected to the downpipe.
- 3.10. A number of stepped cracks were observed above and below the window on the rear left corner. The cracks varied in width and measured between 12-15mm.

- 5.2. Whilst some repair works are needed, they would not be considered significant as to warrant the demolition of the existing structure.
- 5.3. The cracks observed to the rear elevation towards the east were consistent with signs of settlement. Monitoring could determine whether the settlement is on-going or historic.

Picture2- Visible vertical cracks and loose stone work in south elevation in the building.

- 5.4. Given the age of the structure, it is likely that the structure has no foundation/ has stepped footings.
- 5.5. The cracks on stonework joints should be repaired with a suitable lime mortar mix. The mortar joints were generally in a poor condition, and as such, should be repointed with an appropriate lime mix. The use of Hellifix ties should also be employed where cracks have formed, as to form a mechanical tie between the stonework.

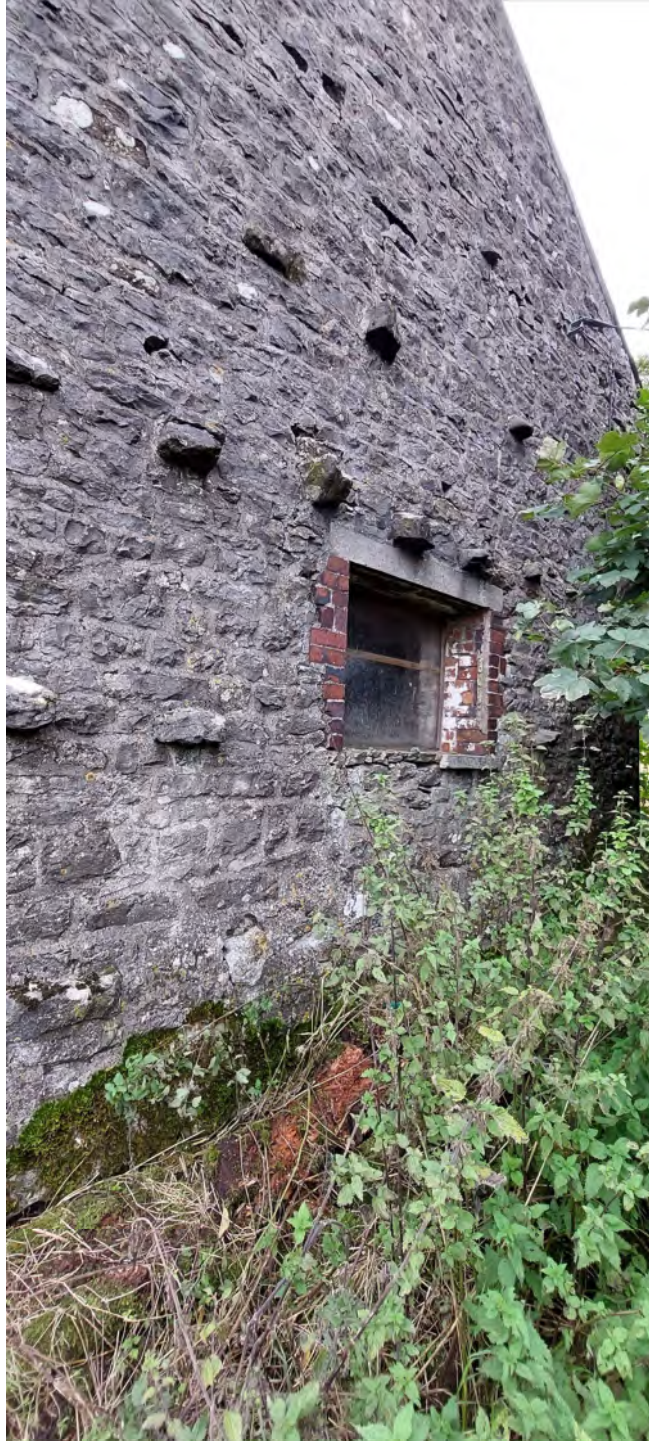
- 3.6. Two barn doors were located centrally, with another door at the left-hand side.
- 3.7. The lintels and frames appeared to be timber.
- 3.8. The left gable was observed, and brickwork was noted around the window.

Picture3- Replacement of stonework with brick work on either side of window at the east elevation (Gable wall).

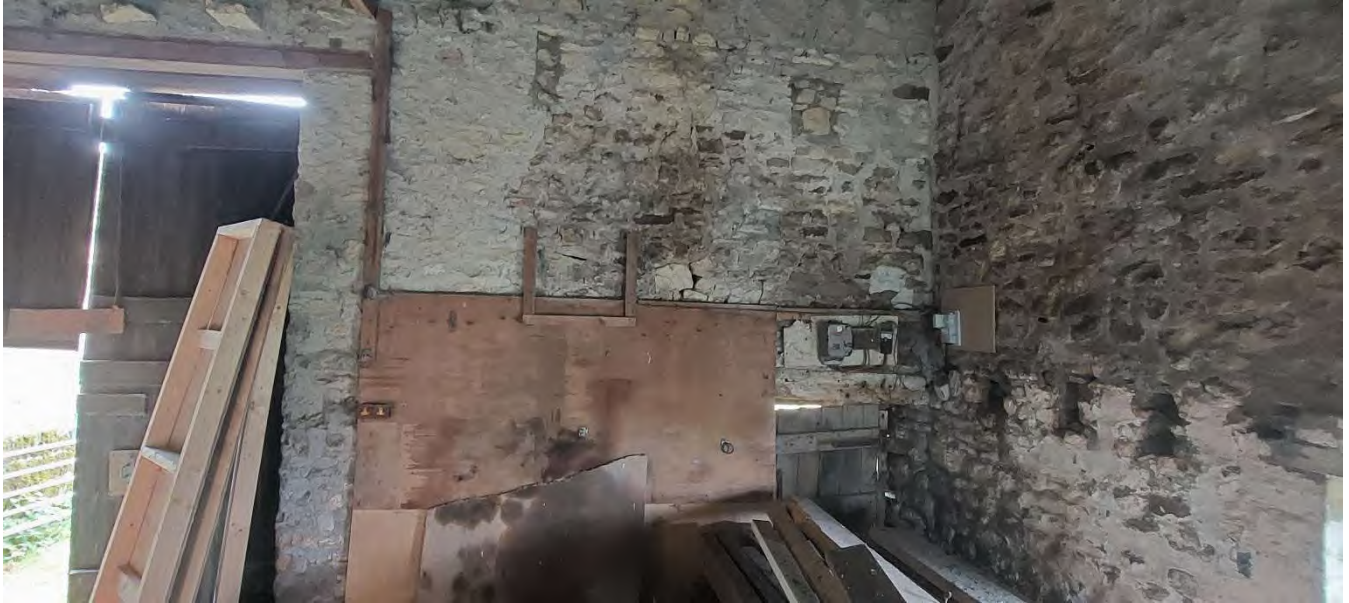
Picture4- The electrical meter is positioned on the east side and is visible from the inside on the north wall.

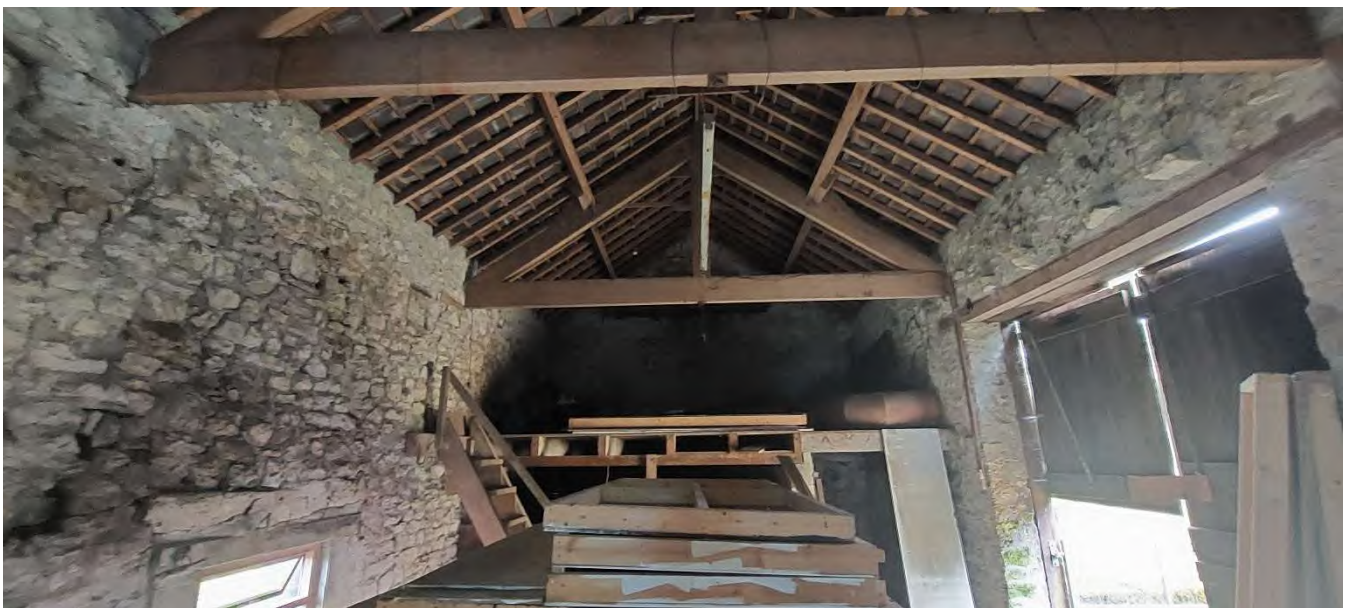
- 4.3. A first floor had been installed within a small portion of the building.
- 4.4. A concrete floor was noted to the ground floor.
- 4.5. A blockwork wall was noted from ground level to the soffit of the floor joists.

- 4.6. The joists to the left of the blockwork wall spanned from front to back and was supported by a timber beam with a timber prop at mid-span.
- 4.7. The joists located to the right of the blockwork wall spanned from right to left, supported by the blockwork on the left and the stone wall on the right.

Picture5- A first floor had been installed within a small portion of the building at the west side.

- 5.6. The gutter and gully need to be replaced on rear of the barn, and adequate drainage needs to be provided away from the site.
- 5.7. Calculations are required to prove the adequacy of the existing timber floor structure if it is to be utilised.

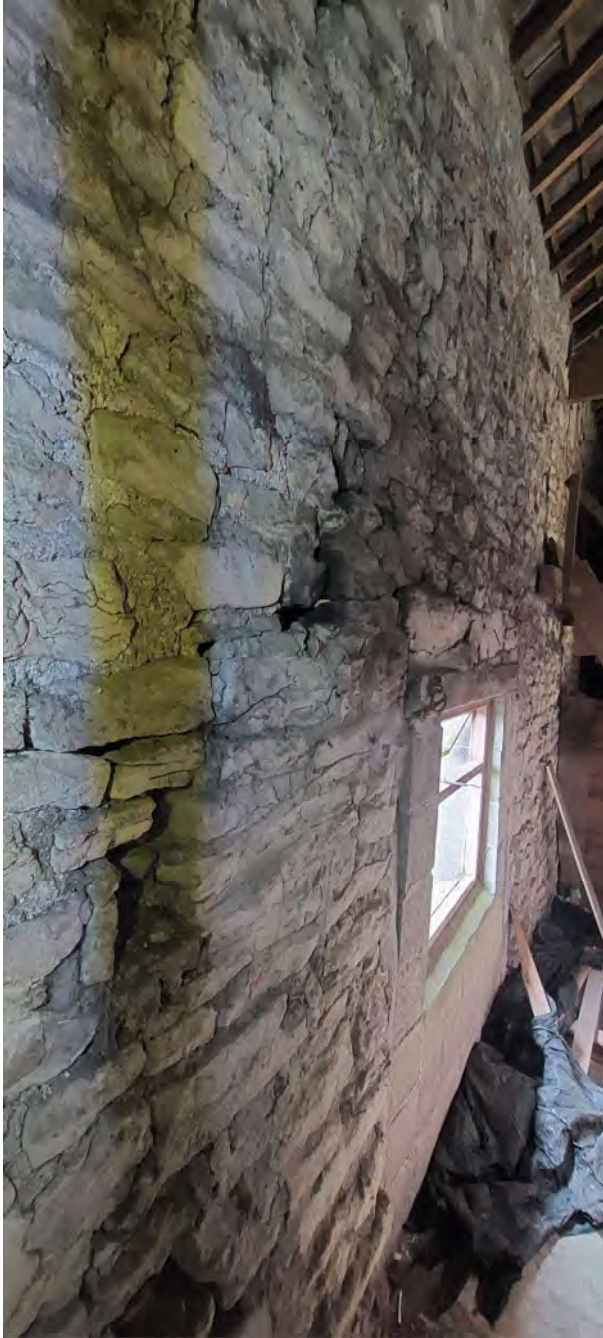
- 4.8. A stepped crack was observed below the purlin to the left wall.
- 4.9. The rear wall did not show any significant defects in the stonework; however, it was noted to be misaligned with the perimeter footprint at the central section.

Picture6- The wall misaligned with the perimeter footprint at the central section above lintel.
