# Preliminary Roost Assessment

Buxton Museum and Hardwick Hall,  
Terrace Road, Buxton, SK17 6DY

*March 2026*

| Report Ref. | 26-010-PRA |

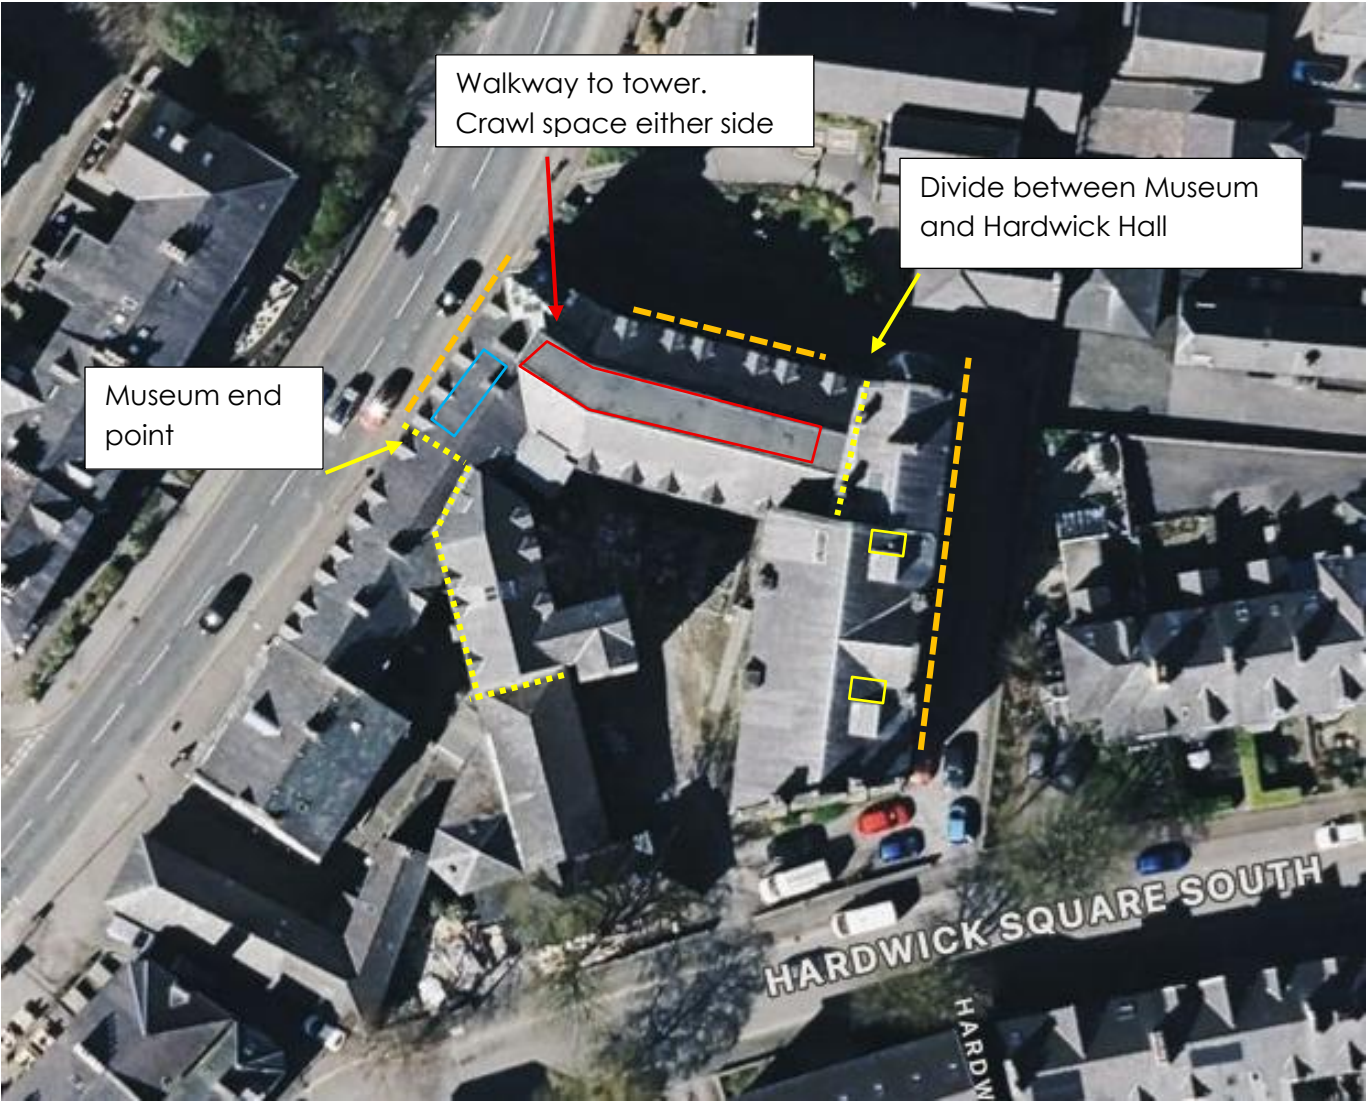
Figure 2: Building layout and survey constraints.

3.5.1 It should be noted that the buildings are very tall, some five storeys to the roofline. Due to this height it has not been possible to survey and visually inspect the entirety of the roofline to the, north, east and west. The inner courtyard facings have been assessed, from within the upper levels of the building which gave very good access and visibility. None of the small, crawl space, attic voids have been entered or inspected due to extensive water damage and visibly lost floors/boards/rafters. This was considered a health and safety risk.

- 5.1.1 Based on the constraints posed by the height of the building and visual inaccessibility of the roofline to surveyors from the ground, it is proposed that the building is surveyed from the upper floors, from within the building. This approach is only feasible if the windows can be opened/closed, to allow use of the infra red light panels and associated cameras. This approach will only allow for the internal courtyard rooflines to be assessed.

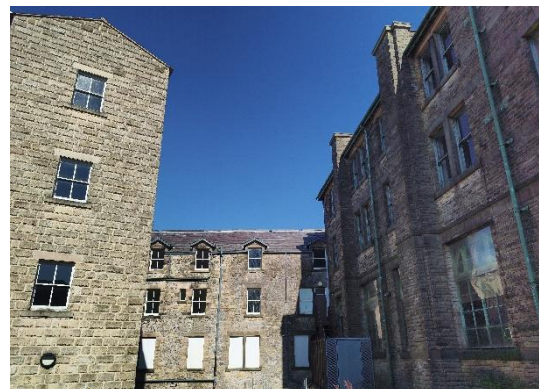
Image 6: Southern roofline. Missing tile at the far eastern edge of the roofline, just above the eastern gable end.

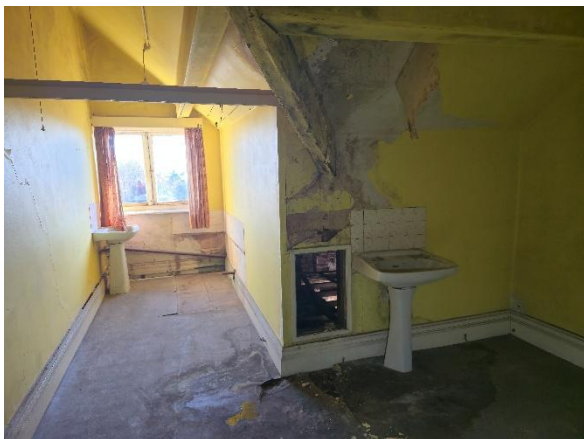
Image 7: Indication of one of three small crawl spaces on the western aspect of Hardwick Hall

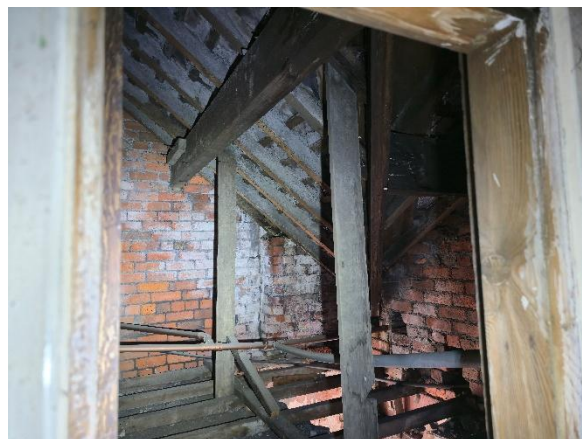
Image 8: Internal view of crawl space and significant deterioration.

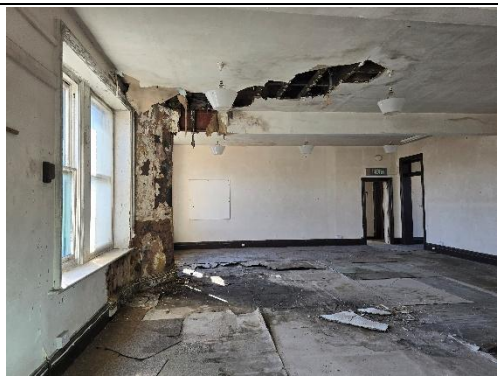
Image 9: An indication of the deterioration within Hardwick Hall.

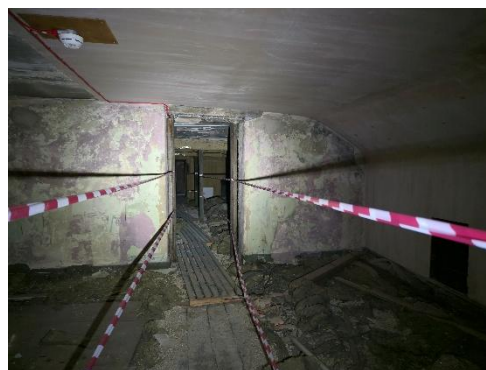
Image 10: Walkway view within the museum to the tower. Crawl spaces either side.

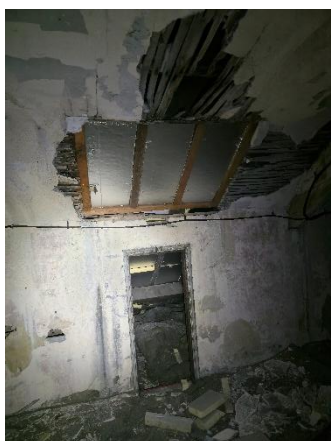
Image 11: Crawl space view with Kingspan present
