SIDE ELEVATION (EAST) OF THE OLD HALL HOTEL, WHITEHOUGH

PROPOSED REMEDIAL WORKS TO GABLE WALL

DRAWING NO. 04

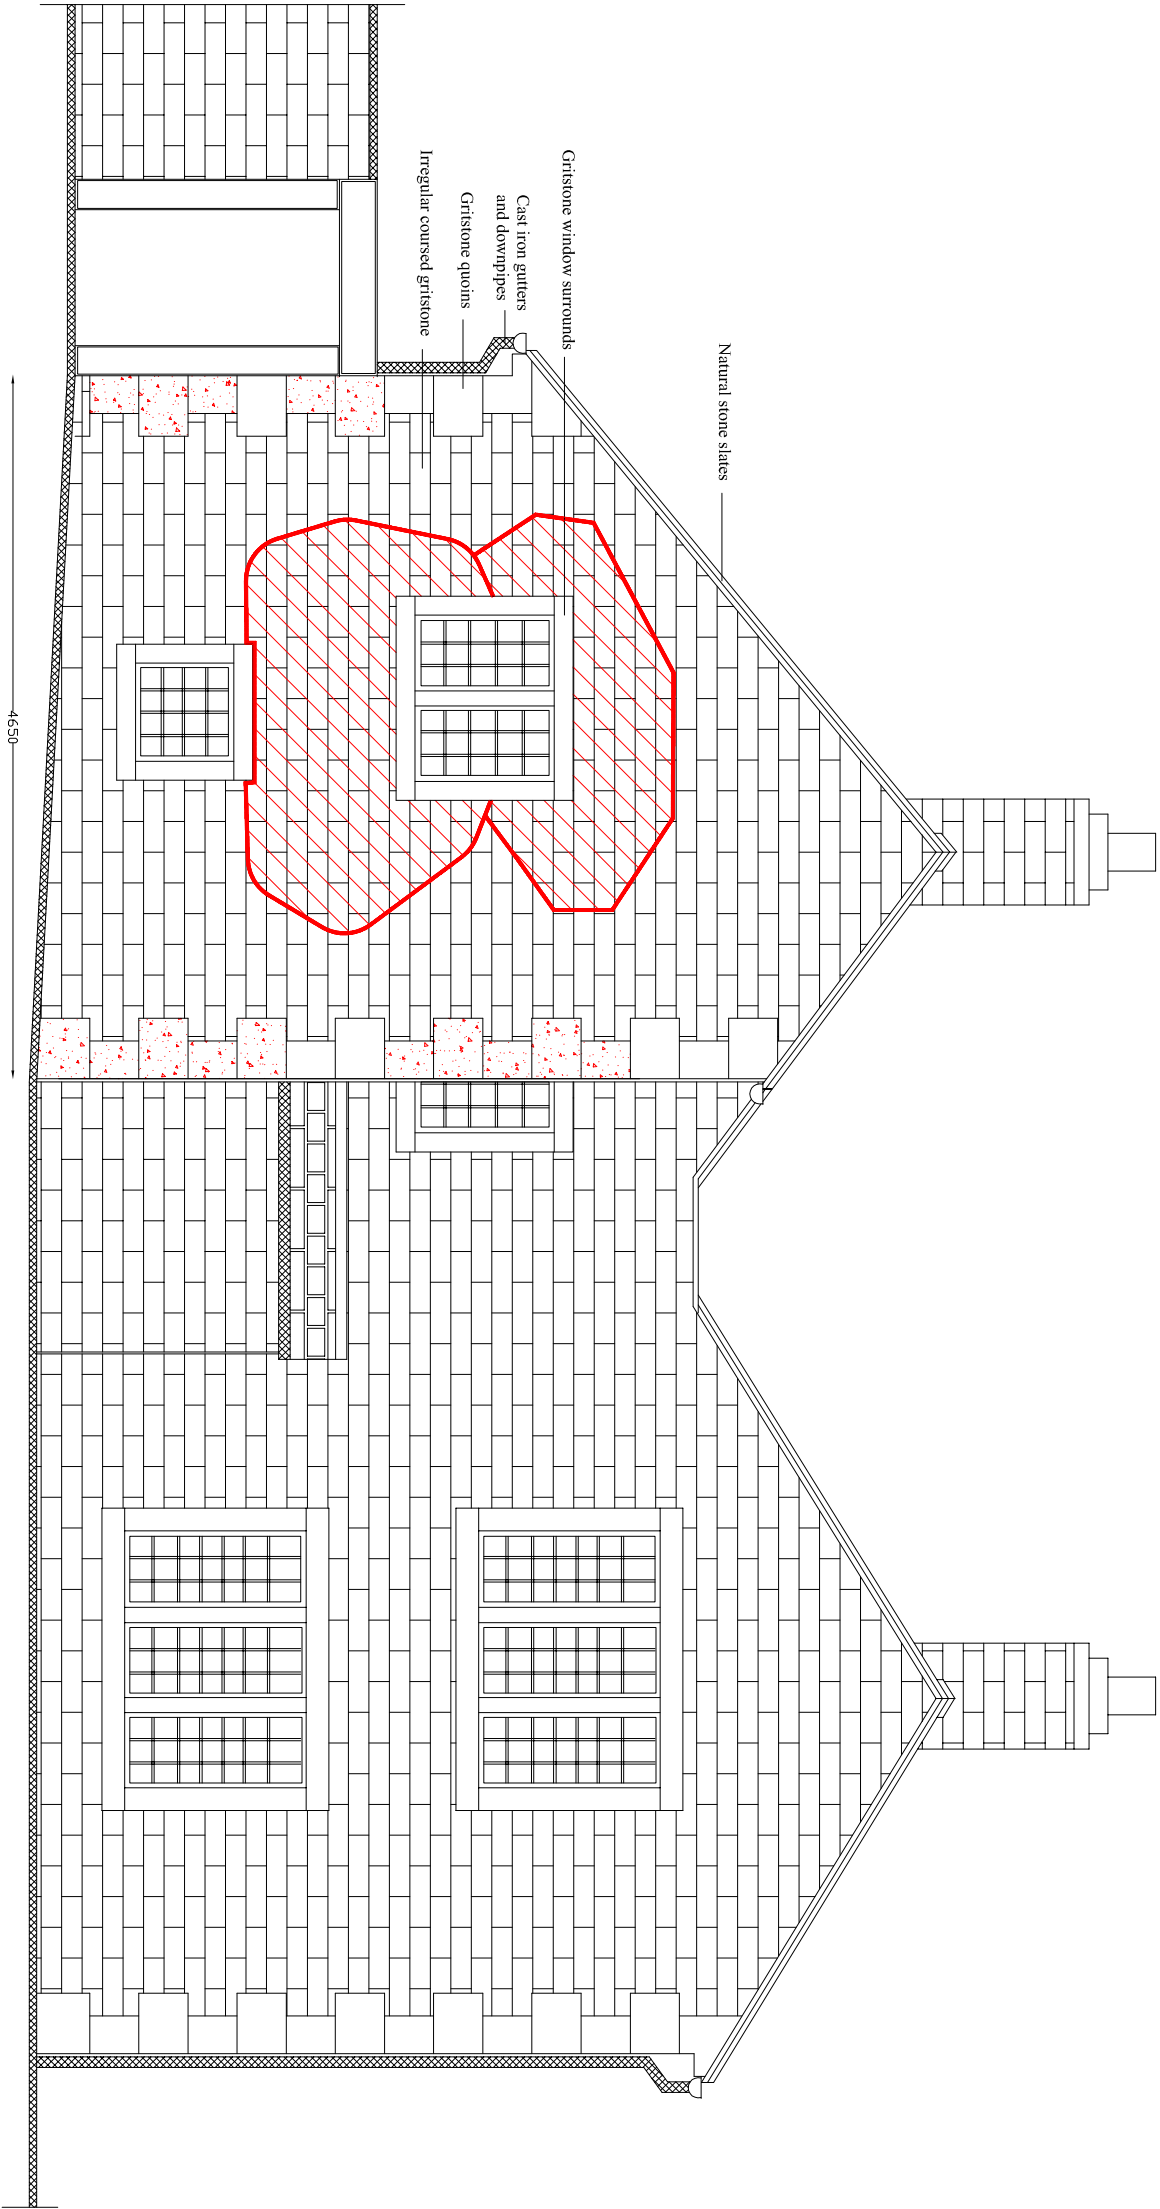
WALL AREA AFFECTED BY
DEFORMATION AND BULGING

STONE QUOINS AFFECTED BY
SPLAYING OF THE OUTER FACES

The external leaf of the gable wall is to be taken down to the cill height of the ground floor window and is to include any parts of the wall that appear defective, or will adversely affect the stability and appearance of the gable wall. The existing stone is to be saved, numbered and relayed in the same irregular coursing as existing. If on inspection the stone has perished, split or splayed then it is to be replaced with material of the same type, size and texture as the original stone.

The new rubble fill between the leafs of masonry is to be replaced with a modern solid construction with ties or masonry throughs connecting the internal and external leafs of the wall. The pointing is to be a weak mix of sand/lime mortar with slightly recessed finish.

The defective quoins are to be carefully taken down and rotated to allow the splayed side to be on the internal side of the wall allowing the unaffected side to become the external side. If on inspection the quoins are perished beyond their effective use then they are to be replaced by new quoins of the same size appearance and texture as the original quoins. The mortar is to be sand/lime with a weak consistency and a flush or slightly recessed finish.
