# *Martin Prescott Environmental Services*

## **Bat and Barn Owl Survey of Industrial Buildings at Salem Mill, New Mills. Surveyor- Martin Prescott**

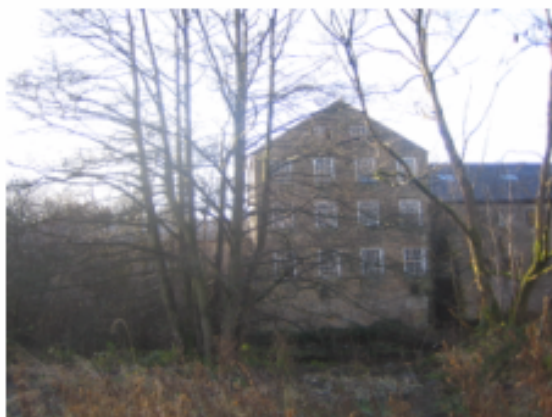
P1 Building 3, N gable

Old stone mill building with pitched, unlined slate roof.  
It had three storeys, the top being a high open space into the roof area. There were several windows including one with no glass, allowing pigeons, and potentially, bats and Barn Owls in. There was a platform suitable for nesting Barn Owls.  
Considered unlikely to be used as a major roost, but crevices in the masonry and under roof slates etc. were suitable for the occasional bat.  
No signs of bat occupation were found.

**4.2** The bat roosting potential of building 3, although significant, was not considered to be more than low for a major roost, although occasional bats are more likely. Factors likely to discourage bats are: the roofing slates were unlined, the top floor was lit by several windows and the building infested with pigeons. It was considered suitable for nesting Barn Owls.

**5.1** Activity surveys, (either dawn or dusk) must be carried out on building 3 at the appropriate season (April to September, but very weather dependant) to determine whether occasional bats are roosting and to determine exactly where they are roosting, before any structural demolition takes place.

**5.3** The open window should be partially blocked to prevent Barn Owls moving in. A 10cm gap should be left at the top to allow access to any bats present.

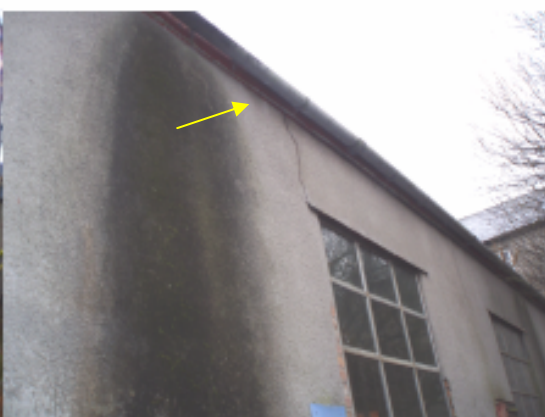
Corrugated sheeting roof, unlined with roof lights. Rendered brick walls. Gaps under barge boards (photo).  
Considered to have very low bat roosting potential.  
No signs of bat occupation were found.

P2 Gaps under barge boards, building 2

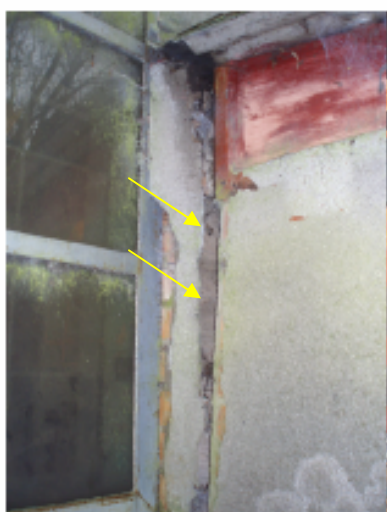
Corrugated sheeting roof, unlined. Rendered brick walls. Gaps between this building and building 2 (photo).  
Considered to have low bat roosting potential.  
No signs of bat occupation were found.

P3 Gap buildings 2 and 4

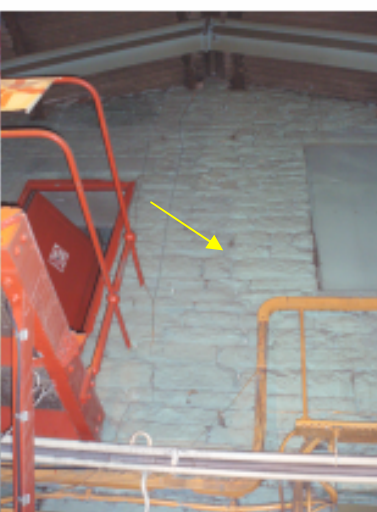
P4 Gaps in masonry, building 3

**5.2** Whether bats are found or not, and before structural work starts, the roof slates and any other features where there are gaps suitable for bat access must be removed carefully, by hand, under the supervision of a suitably qualified bat worker.
