# Arboricultural Advice in accordance with BS 5837:2012 Trees in relation to design, demolition & construction – Recommendations Tree Pruning and protection specification 21st June 2012

Subject Property: 2 Gorse Way

Glossop SK13 8SX

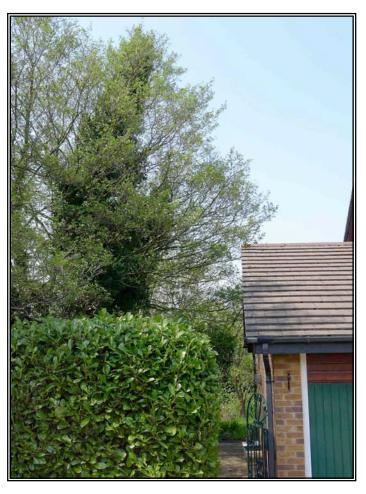
- 2.1.1 The area of the consented works is slightly over hung by the branch tips of a single mature Alder (Alnus glutinosa). The tree is also congested with ivy effectively suppressing any inner crown growth.
- 2.1.2 The consented works entail the construction of a second storey above the existing garage with windows to the front and rear elevations. There will be some internal works to the garage walls though this will have no impact on the adjacent trees.
- 2.1.3 Pruning works to the tree will need to reduce the branch spread back from the construction area and also to provide sufficient space for the necessary high access scaffold.

- 2.2.1The tree works must be completed by professional and qualified arborists covered by a minimum of £5 million insurance.
- 2.2.2 The lateral branches are to be pruned back to 1.75m back from the existing garage wall to enable the installation of a 1.5m wide high access scaffold. Pruning cuts should be positioned carefully to keep the size to the minimum at made at suitable healthy side branches. The side branches should have a diameter of at least one third of the branch removed. As far as is reasonably possible the pruning should result in a flowing natural crown outline.

- 2.2.3 In response to the loss of foliage the tree will respond with new growth. In time this may lead to a future requirement for further pruning. To encourage the formation of inner crown growth to compensate for lost foliage, rather than growth focussed at the branch tips I advise the ivy is removed. There are sound ecological reasons for retaining ivy and in general it does little harm to trees. However the obstruction of light will prevent any inner crown growth which would reduce the trees need to put on rapid growth at the branch tips leading to future pruning. The ivy should be removed in a two-stage operation; initially

severed at the base and allowed to die off over a period of 6 months. This allows any resident wildlife time to relocate and also weakens the ivy's attachment to the tree. After 6 months the ivy can be removed.
