DAYTIME BAT SURVEY AT ASHMOUNT, CHAPEL ROAD, WHALEY BRIDGE, DERBYSHIRE

2015

RACHEL HACKING ECOLOGY

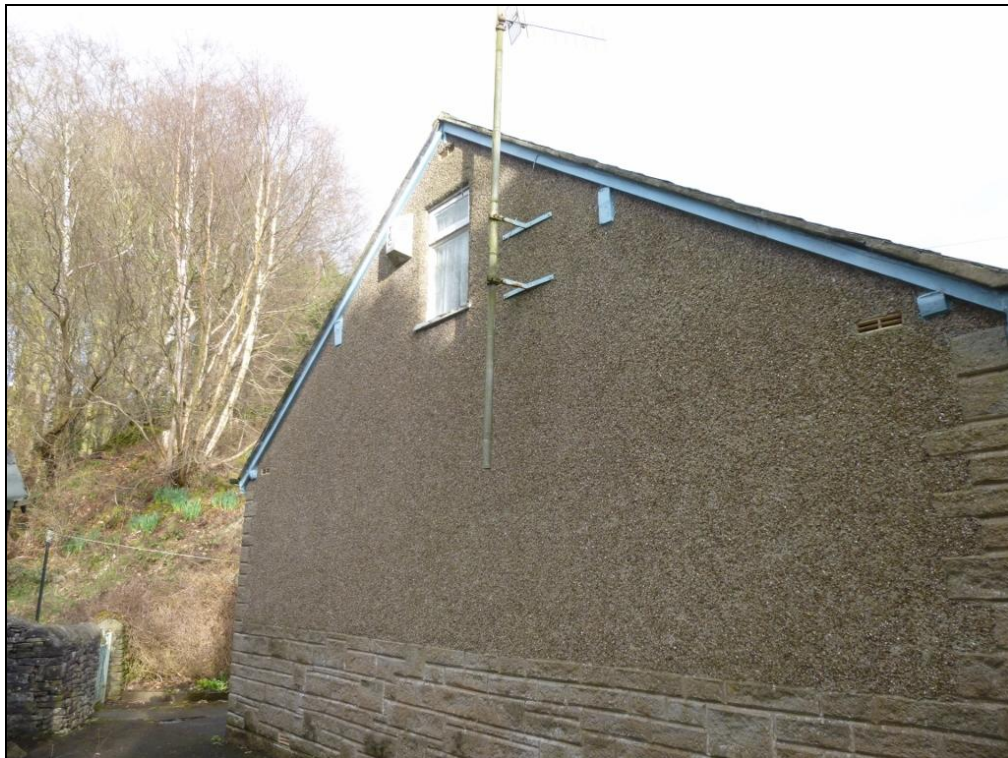
- 3.3 The brickwork and the pebbledash are in excellent condition and complete. The property has gable ends with equal pitch. At each gable, the roof and external walls are sealed with cement, which is intact, and none of the gable ends provide access opportunities for bats (see Photograph 1).

Photograph 1 showing north-western gable end of the property

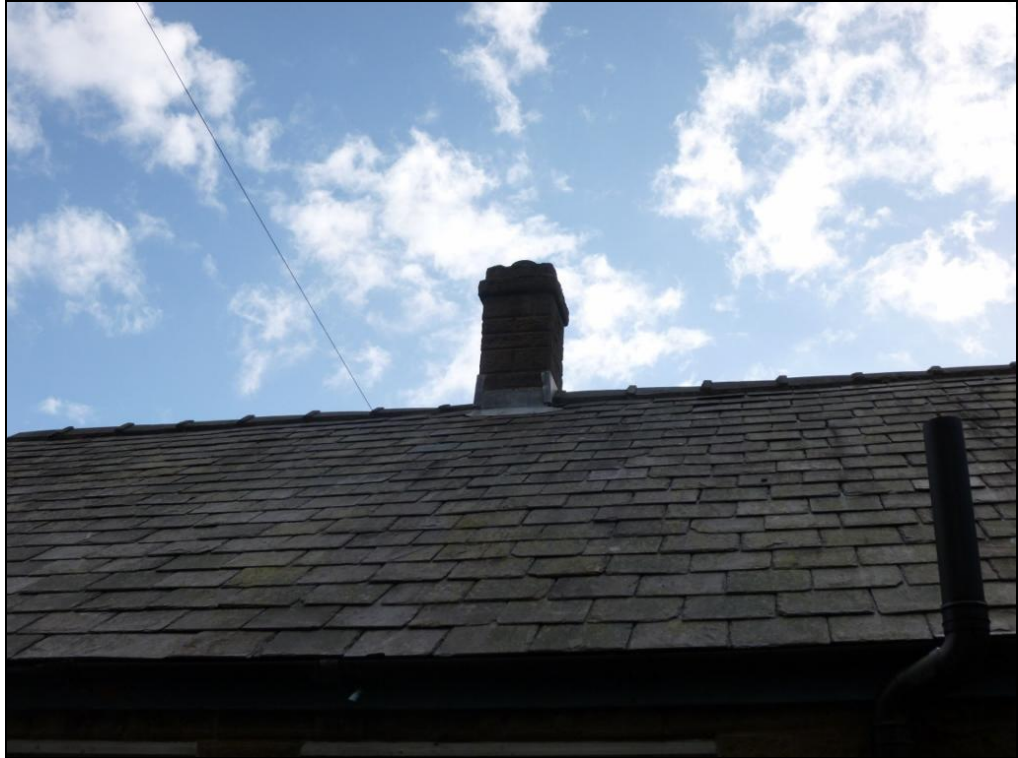
- 3.4 The roof is pitched throughout and the square roof tiles and slate ridge tiles (see Photographs 2 and 3) are in very good condition. No disrepair or gaps within the roof tiles are visible. The ridge tiles were complete, therefore no opportunities exist which would provide entry points for bats into features which are commonly used for roosting i.e. into the roof space and/or behind roof tiles/clay ridge tiles.

Photograph 2 showing northern-facing rear of the property

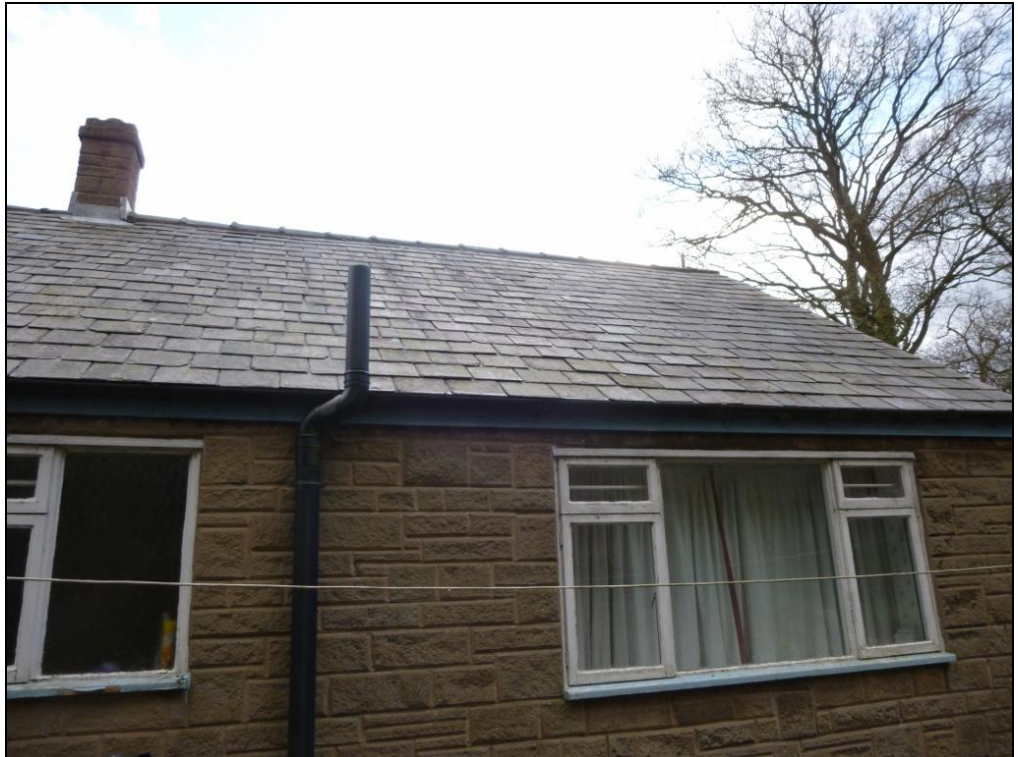
Photograph 3 showing the rear of the property, including the roof

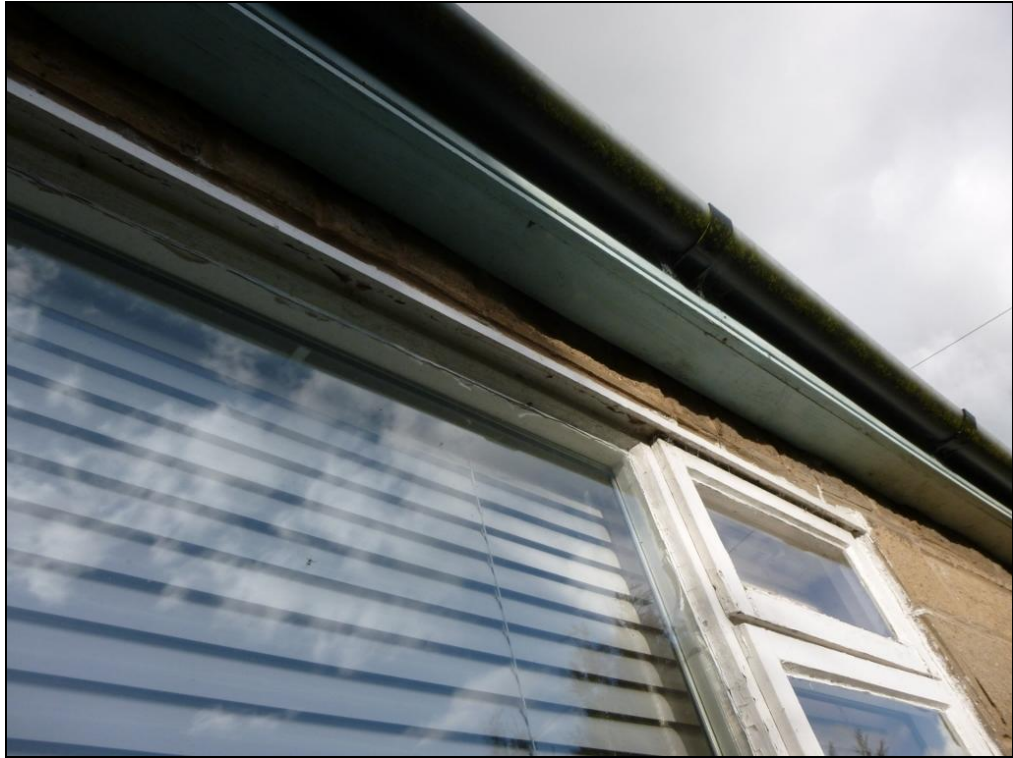
- 3.5 Wooden soffit boards and bargeboards are present throughout the exterior of the property. These are all in good condition, with no visible gaps providing access to the roof space (see Photograph 4). They are not completely flush to the external walls due to the curvature of the

brickwork, but were sealed and any minor gaps were covered in cobwebs, suggesting no bat access.

Photograph 4 showing the wooden soffit boxes and barge boards in good condition

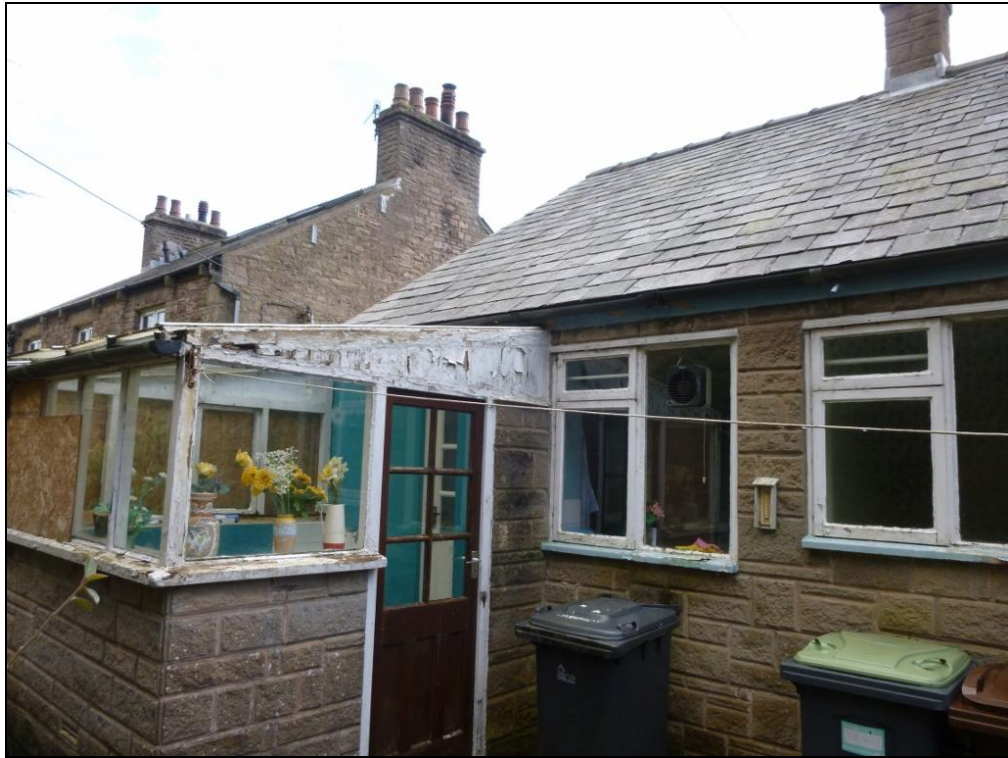
- 3.6 A timber frame lean-to exists to the rear of the property. This was in poor overall condition with a sheet plastic roof, providing no roosting opportunities for bats (see Photograph 5). To the rear of the property there exists a wooden storage shed, but this provides no roosting opportunity for bats (see photograph 6). No evidence of bat activity was found on the property exterior.

Photograph 5 showing wooden frame lean-to at the rear of the property

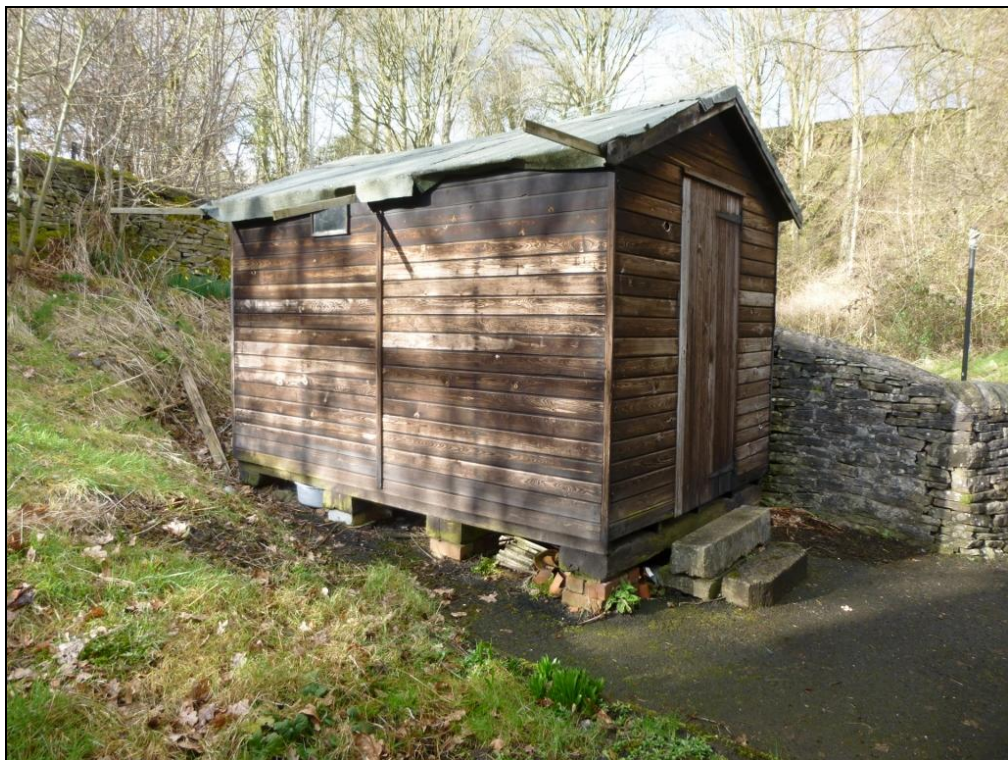
Photograph 6 showing wooden shed at the rear of the property.

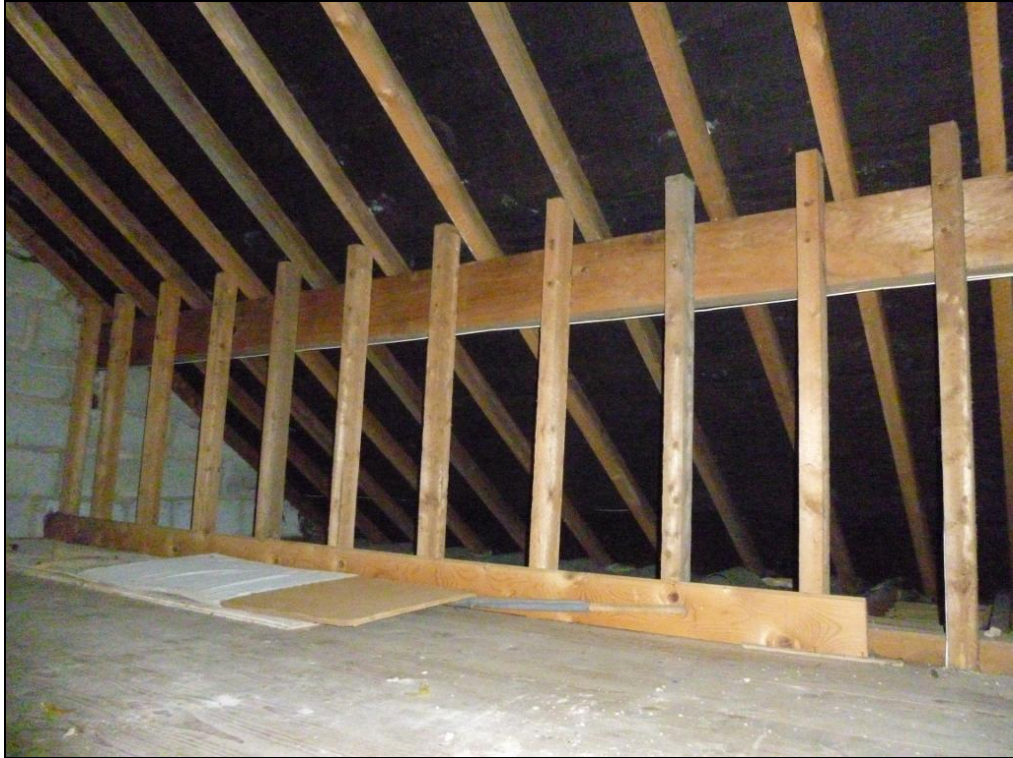
- 3.8 The loft space is open, completely accessible and was inspected thoroughly. The loft space spans the width of the entire property and is approximately 7m long by 3m wide and 2m high, with exposed wooden beams and traditional bitumen underfelt (see Photograph 7). The loft space has been well maintained and fully insulated.

Photograph 7 showing internal view of loft space

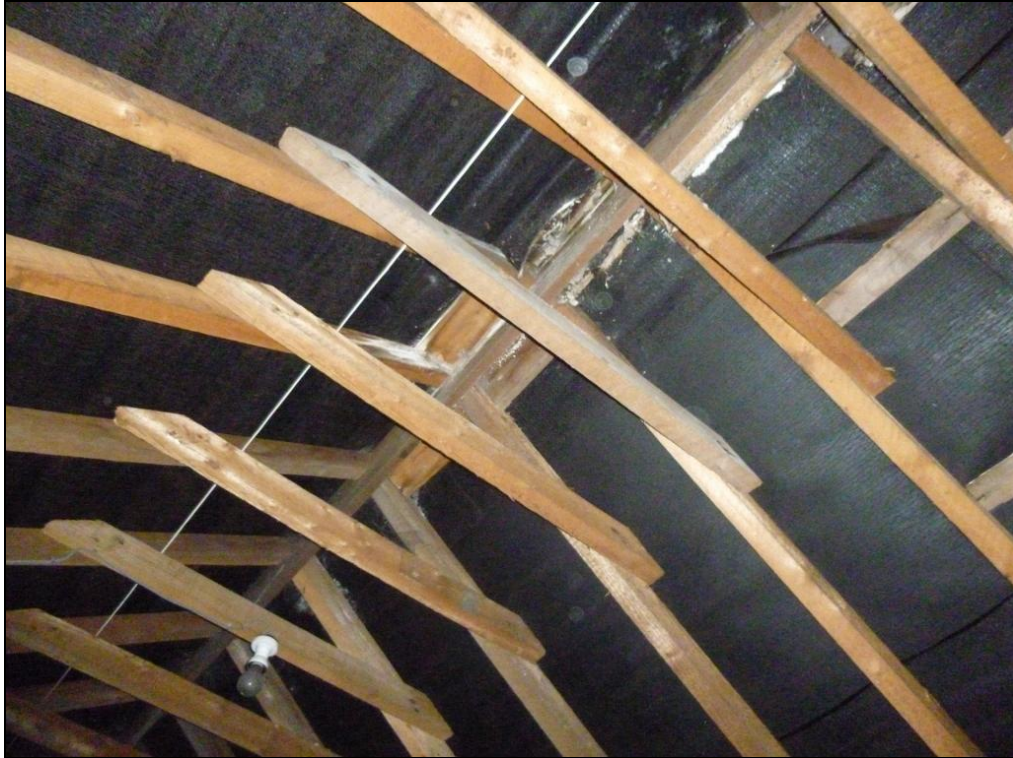
- 3.9 The roofing felt is flush to the roof tiles and to the joists, with some tearing in the felt at the apex, but with no visible gaps or daylight (see Photograph 8). There were odd tears in the roof lining but otherwise no access for bats through the roof tiles. No cracks could be found within the woodwork. The roof space is well sealed, with minor daylight visible where the roof joists meet the external bargeboards. The roof space had considerable cobwebbing throughout, suggesting no recent bat activity.

Photograph 8 showing the good condition of the roof felt and joists

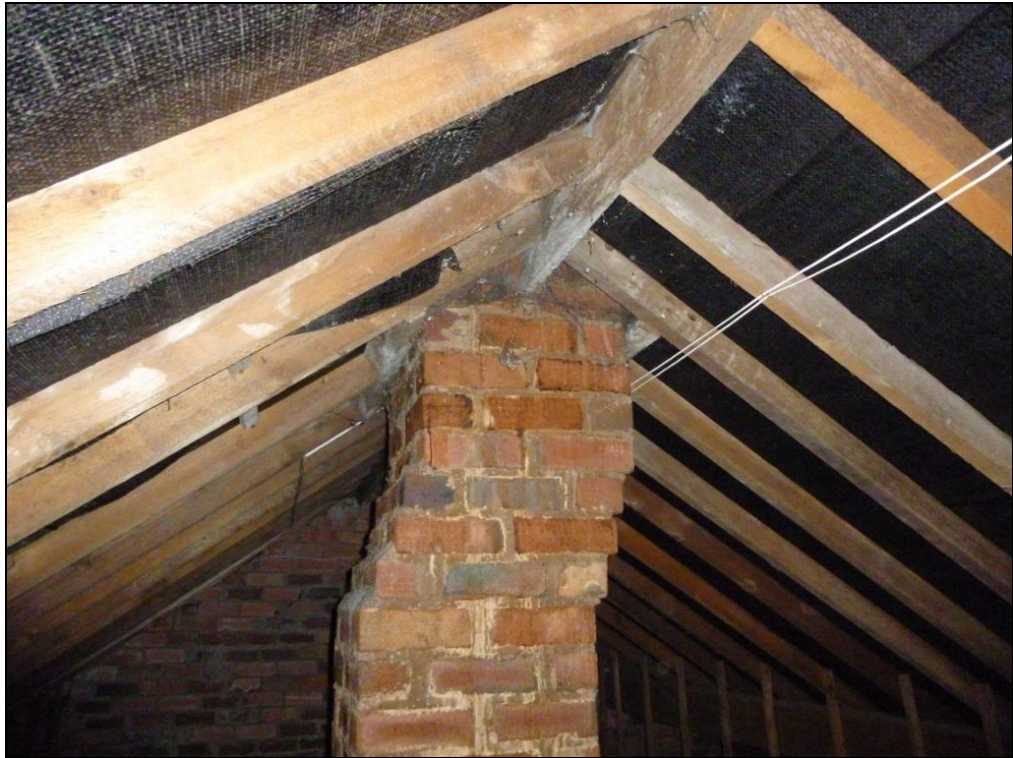
- 3.10 The central chimney stack was in good condition, with no visible gaps for bat access. The loft also had one timber frame window, to the north west of the property. This gable end had a more recent breeze block construction, with the opposite gable being older brickwork (see Photograph 9). There was no mortar missing from either gable end, and there was wooden flooring throughout with the appropriate insulation. The walls are double skin (two layers of brick) with no cavity.

Photograph 9 showing the chimney stack and brickwork gable end

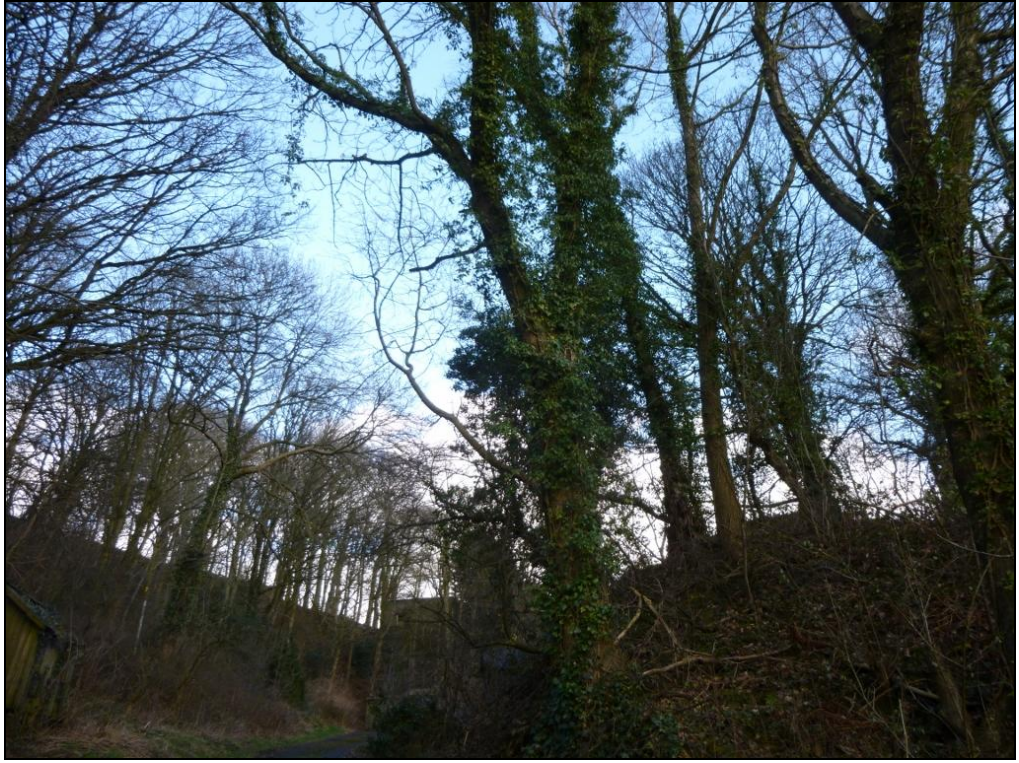
Photograph 10 showing an ivy-clad tree to the rear of the property
