Martin Prescott Environmental Services

12.6.2015

Bat and Nesting Bird Survey of Riverside Mill, Glossop **30th April, 8th and 12th June 2015 – Interim Report** **Surveyor- Martin Prescott (lic. no CLS001281)**

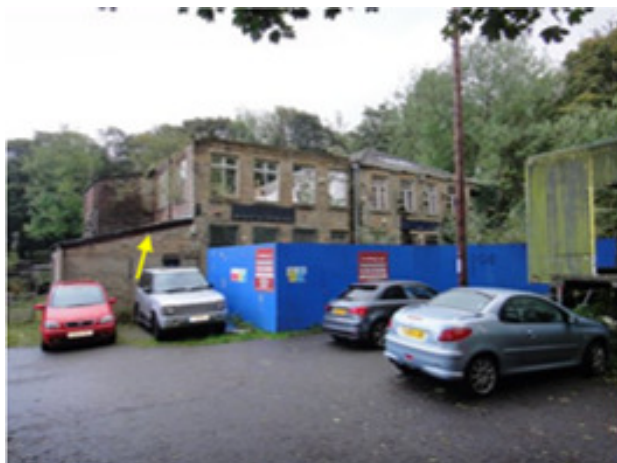
Many gaps suitable for roosting bats such as under barge boards (photos 1 and 3).

P1 NW aspect, gaps under barge boards

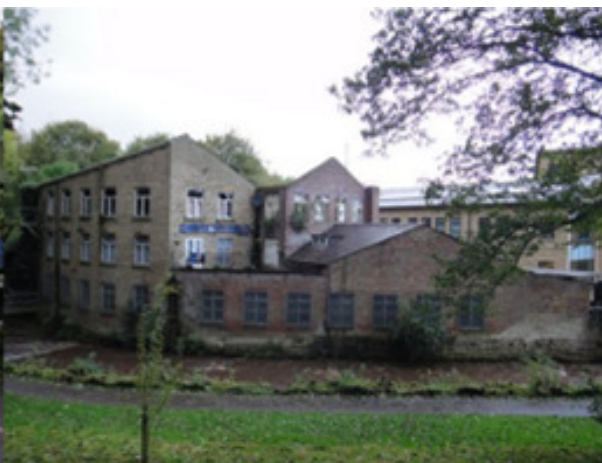
P2 SE aspect, many broken windows

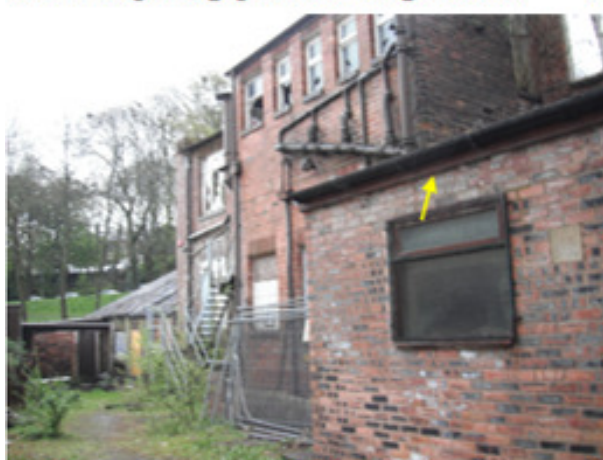
P3 N. aspect, gaps under barge boards

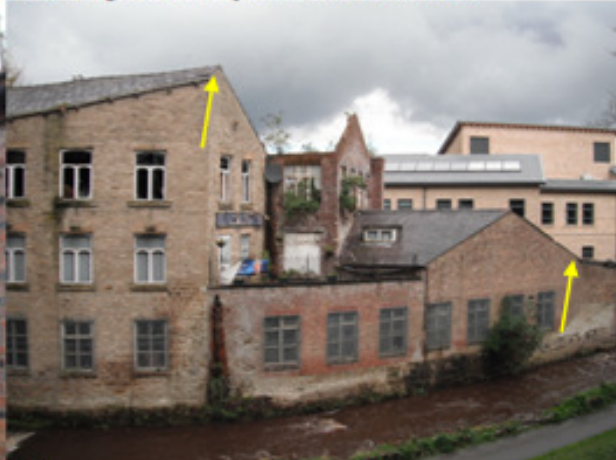
P4 S. aspect, gaps under roofing slates

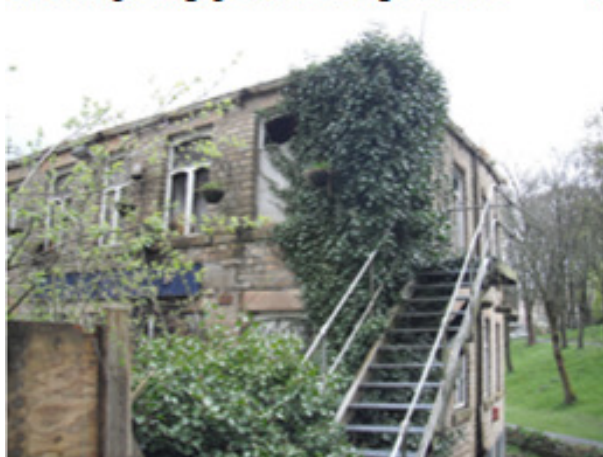
The first floor was open to the roof and infested with pigeons. The roof was of slate partially lined with boarding (photo 8). There were several skylights and many broken windows. There were gaps under roofing slates suitable for roosting bats. (photo 2)
There was a thick covering of Ivy at the SW corner (photo 5), of high potential for nesting birds, but of low suitability for roosting bats. The Ivy could hide suitable crevices in the masonry.

4.3 Most of these buildings were likely to be used by nesting birds. The Ivy on building 2 was considered particularly likely to be used.

P5 Ivy at SW corner, building 2

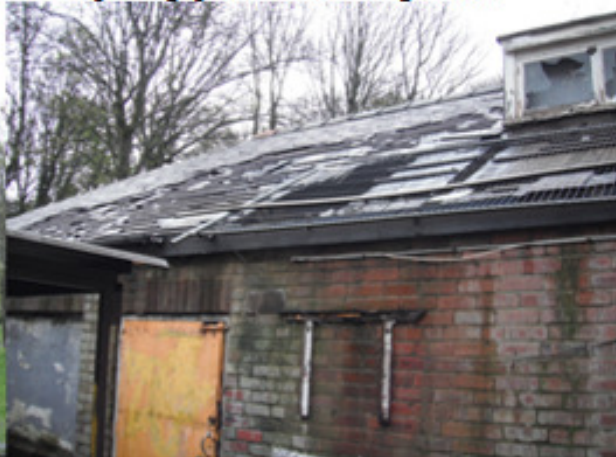
Building 7 Single storey lean-to, incomplete slate roof (photo 6)

Many gaps under partial slate roof and easy bat access into the interior.

P6 Missing slates, building 7

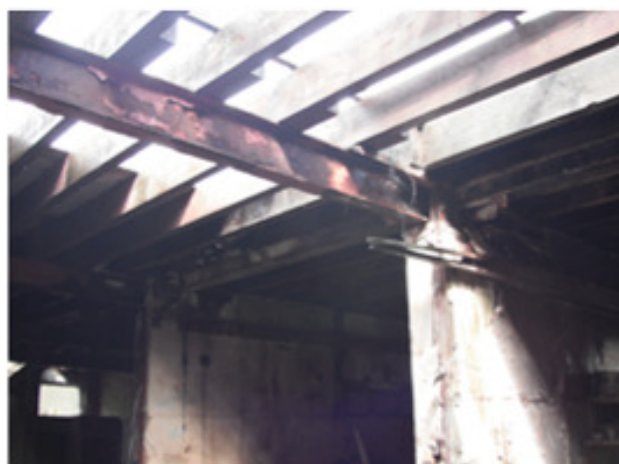
Easy bat access through missing roof area. (photo 7)

There were holes in the masonry suitable for roosting bats.

P7 Building 1, missing roof

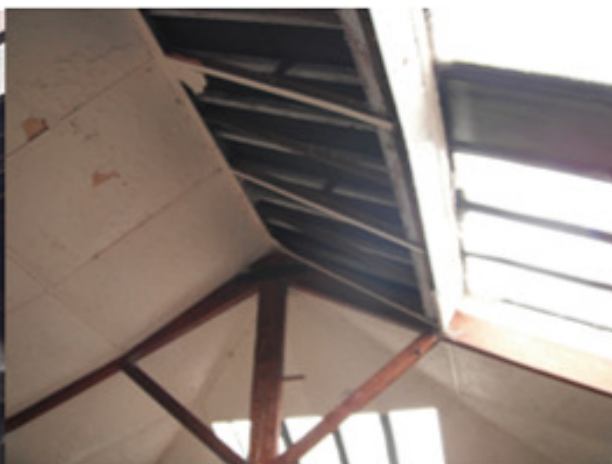
P8 Building 2, board-lined slate and skylights

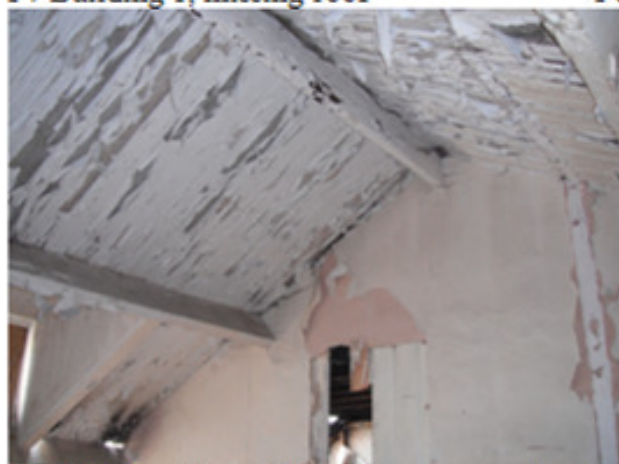
Roof board-lined (photo 9) and relatively complete, with gaps suitable for bat access at missing slates.

P9 Building 4, board-lined slates, some slates missing.

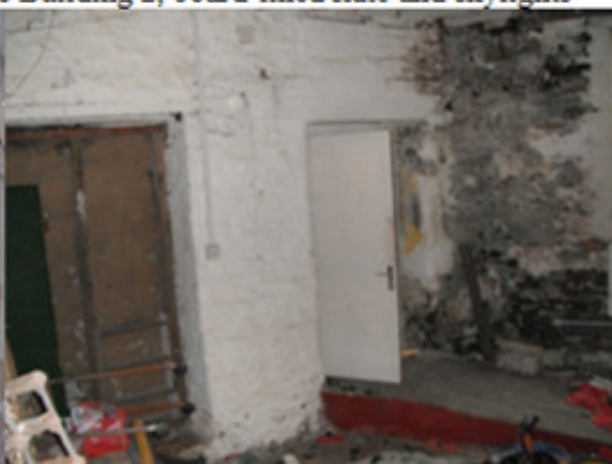
There was a basement running under buildings 1, 2, 3 and 4 (photo 10). Although there were crevices in the masonry it was considered too dry to be of more than very low suitability for hibernating bats.

P10 Basement

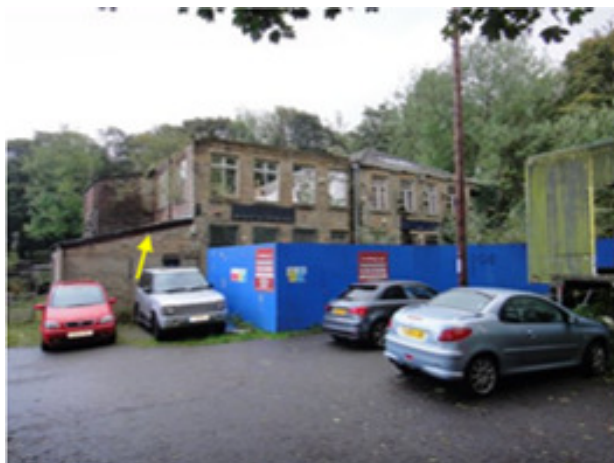
Many gaps suitable for roosting bats such as under barge boards (photos 1 and 3).

P1 NW aspect, gaps under barge boards

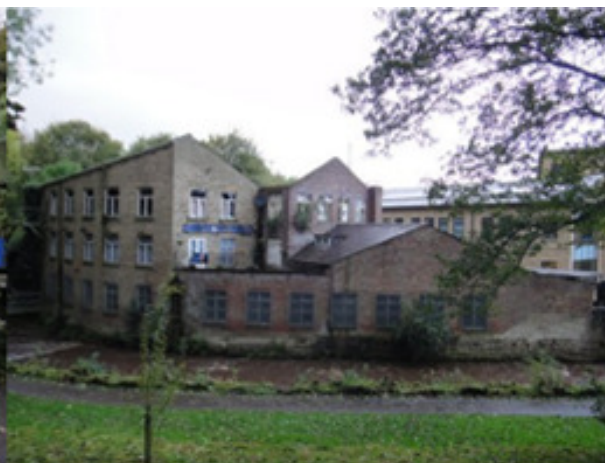
P2 SE aspect, many broken windows

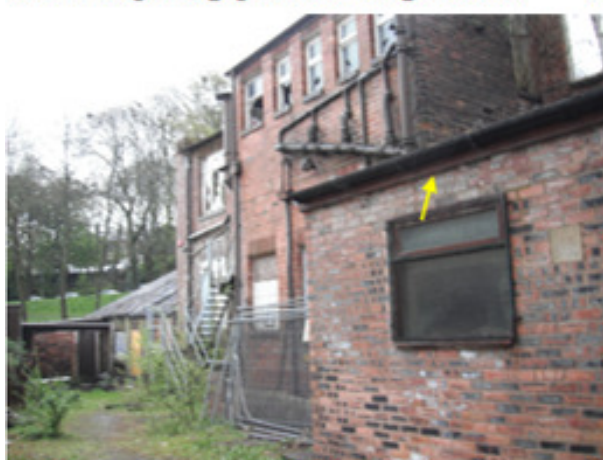
P3 N. aspect, gaps under barge boards

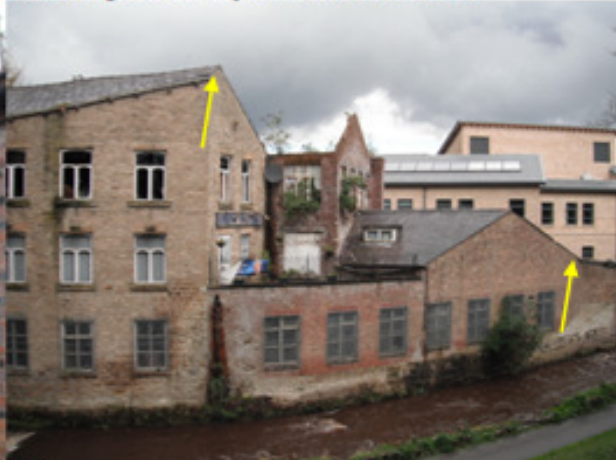
P4 S. aspect, gaps under roofing slates

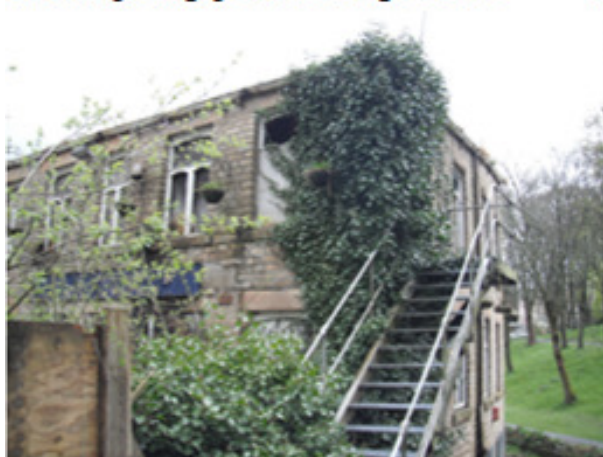
The first floor was open to the roof and infested with pigeons. The roof was of slate partially lined with boarding (photo 8). There were several skylights and many broken windows. There were gaps under roofing slates suitable for roosting bats. (photo 2)
There was a thick covering of Ivy at the SW corner (photo 5), of high potential for nesting birds, but of low suitability for roosting bats. The Ivy could hide suitable crevices in the masonry.

P5 Ivy at SW corner, building 2

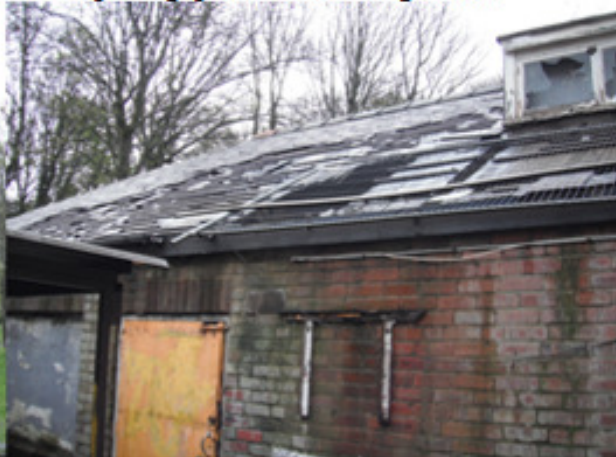
Building 7 Single storey lean-to, incomplete slate roof (photo 6)

Many gaps under partial slate roof and easy bat access into the interior.

P6 Missing slates, building 7

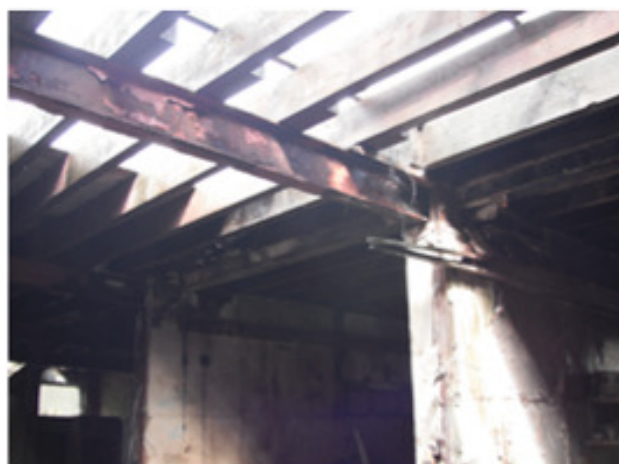
Easy bat access through missing roof area. (photo 7)

P7 Building 1, missing roof

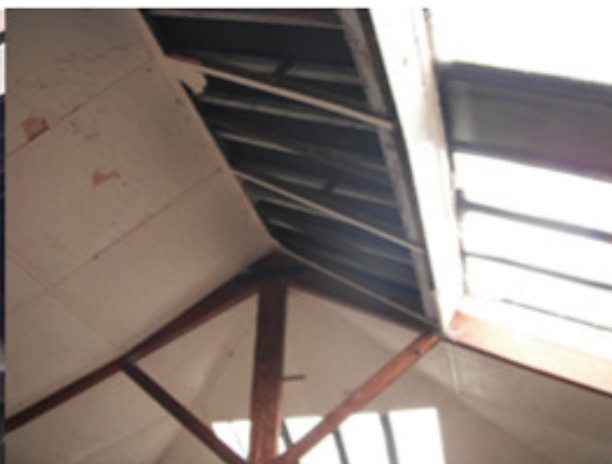
P8 Building 2, board-lined slate and skylights

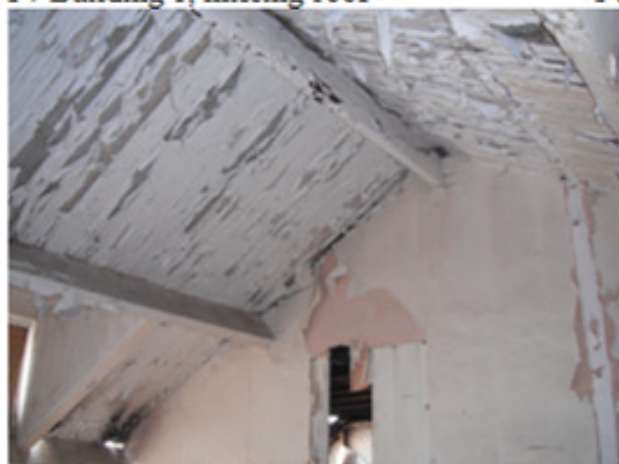
Roof board-lined (photo 9) and relatively complete, with gaps suitable for bat access at missing slates.

P9 Building 4, board-lined slates, some slates missing.

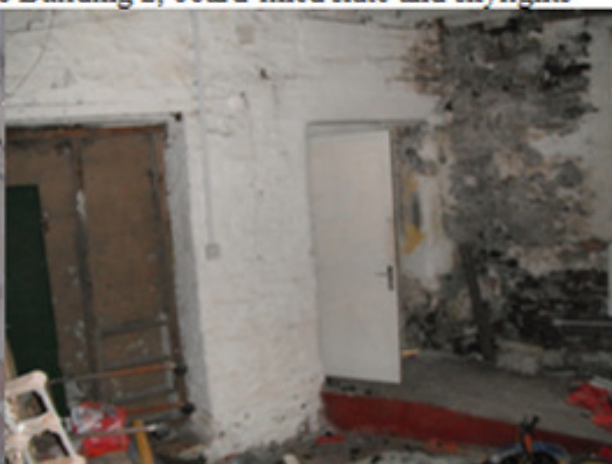
There was a basement running under buildings 1, 2, 3 and 4 (photo 10). Although there were crevices in the masonry it was considered too dry to be of more than very low suitability for hibernating bats.

P10 Basement

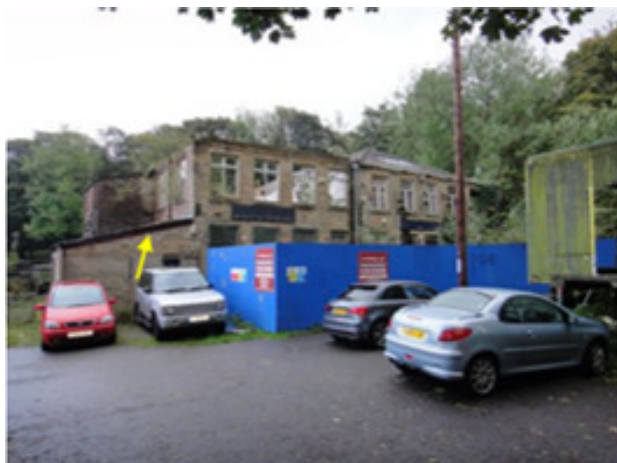
P1 NW aspect, gaps under barge boards

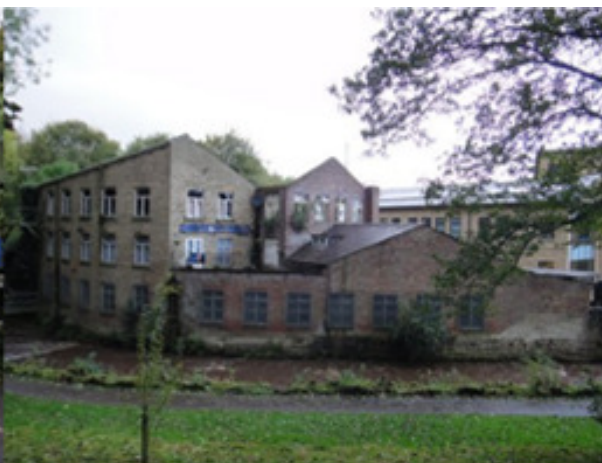
P2 SE aspect, many broken windows

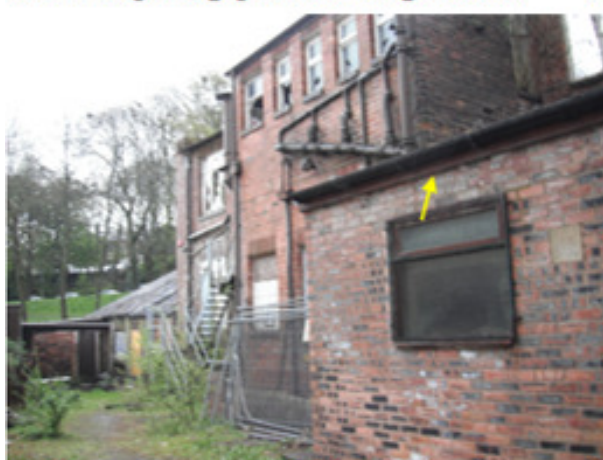
P3 N. aspect, gaps under barge boards

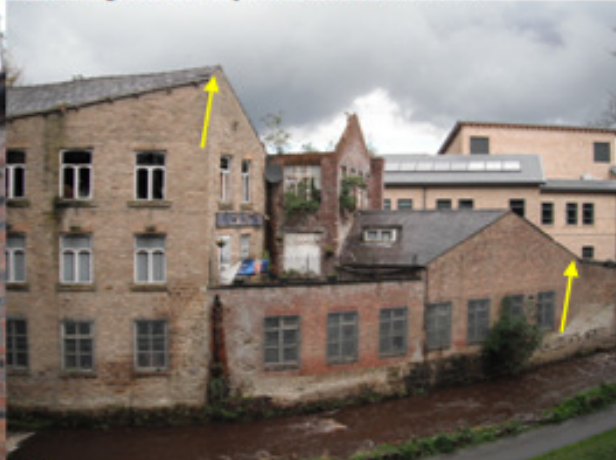
P4 S. aspect, gaps under roofing slates

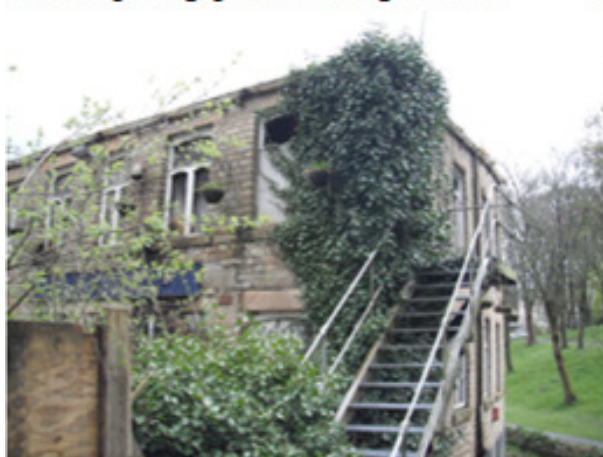
The first floor was open to the roof and infested with pigeons. The roof was of slate partially lined with boarding (photo 8). There were several skylights and many broken windows. There were gaps under roofing slates suitable for roosting bats. (photo 2)
There was a thick covering of Ivy at the SW corner (photo 5), of high potential for nesting birds, but of low suitability for roosting bats. The Ivy could hide suitable crevices in the masonry.

P5 Ivy at SW corner, building 2

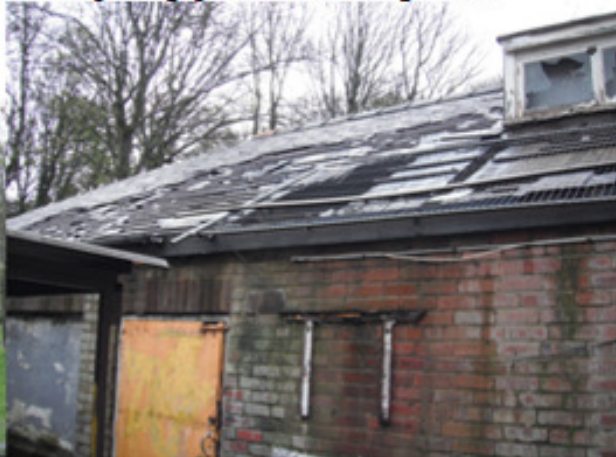
P6 Missing slates, building 7

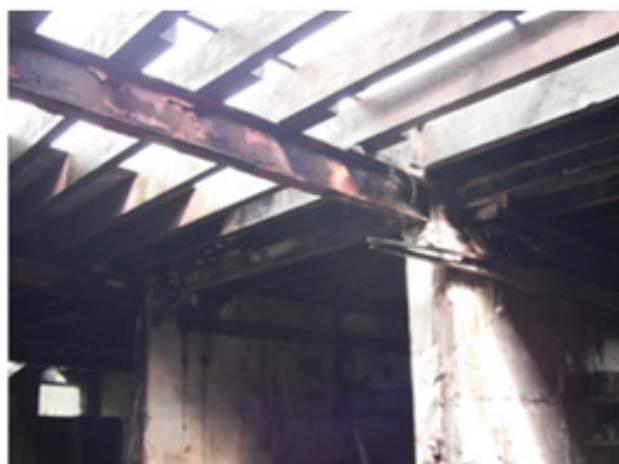
Easy bat access through missing roof area. (photo 7)

P7 Building 1, missing roof

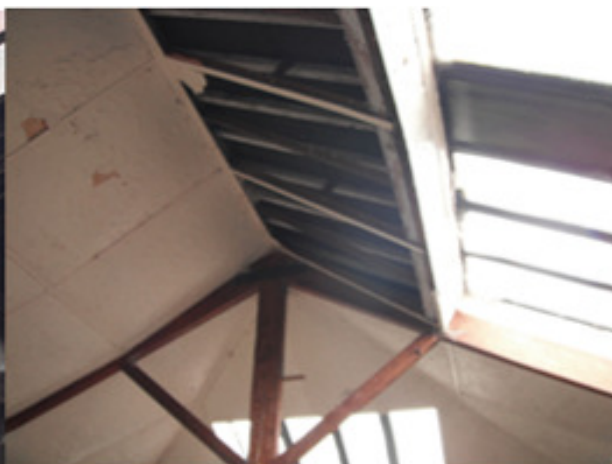
P8 Building 2, board-lined slate and skylights

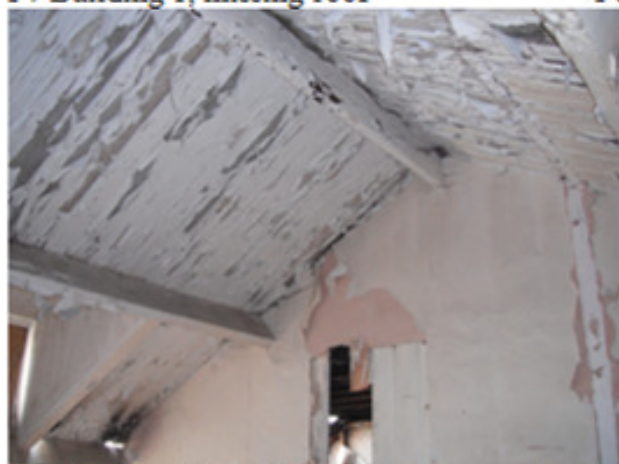
Roof board-lined (photo 9) and relatively complete, with gaps suitable for bat access at missing slates.

P9 Building 4, board-lined slates, some slates missing.

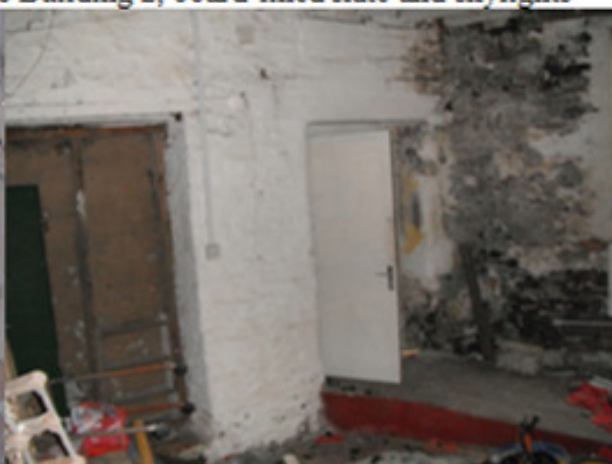
P10 Basement
