**Bat and Barn Owl Survey Report,  
For  
The Barn,  
Manor Park Road,  
Old Glossop,  
Derbyshire,  
SK13 7SQ.**

**nlg ecology ltd**

August 2014

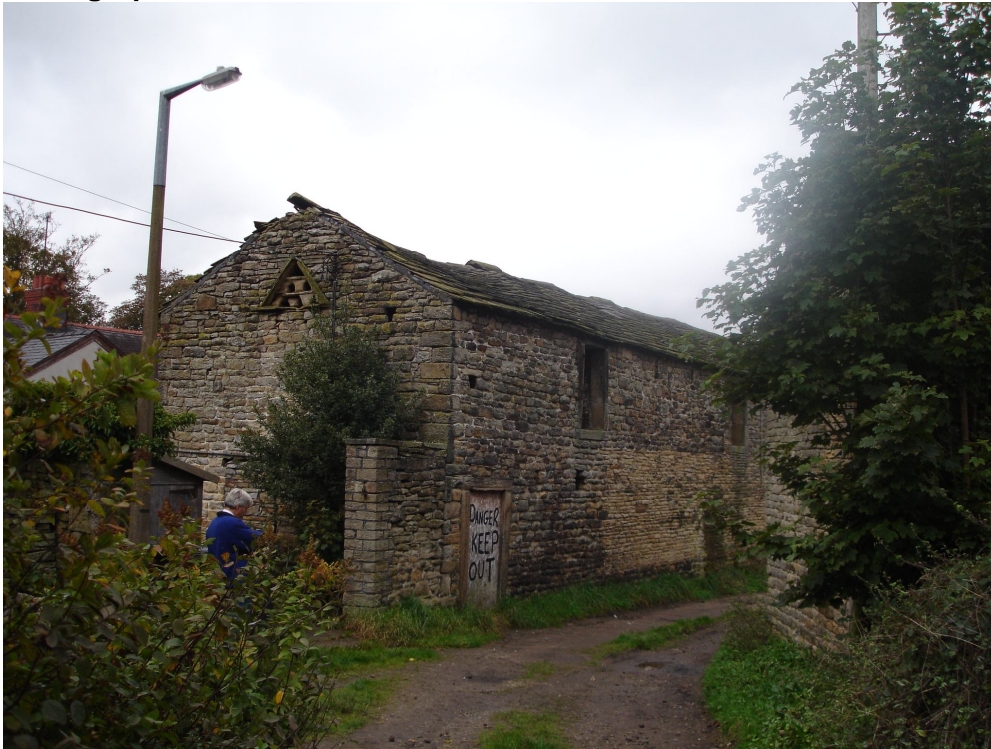
The barn section.

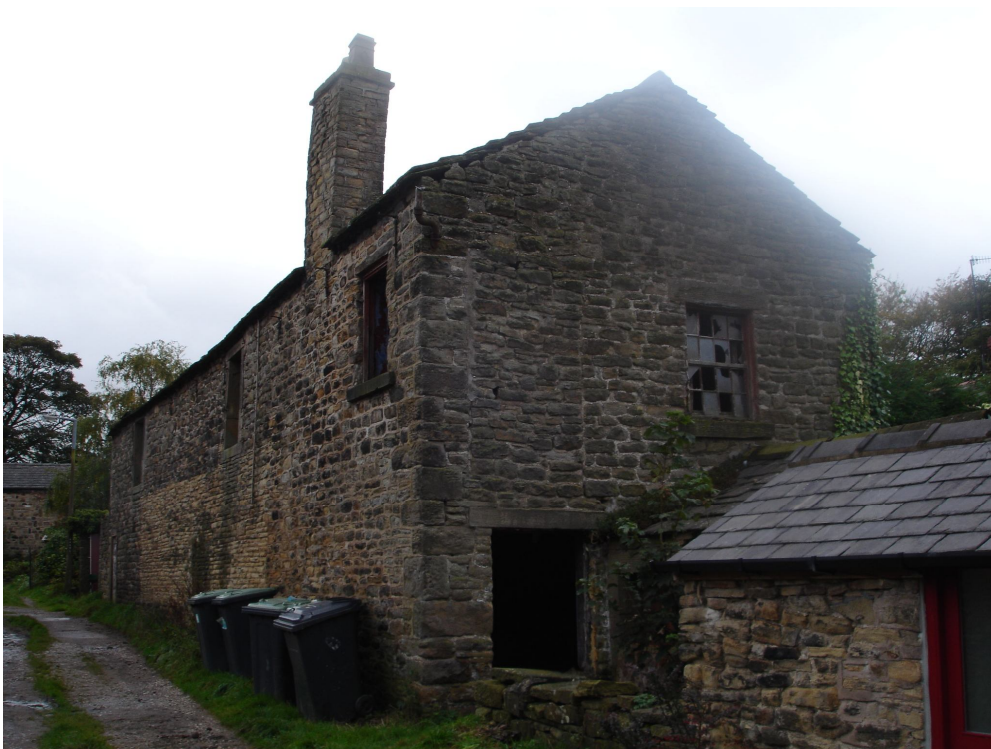
Barn and adjoining dwelling
