DAYTIME BAT SURVEY AT MARSH LANE, NEW MILLS, DERBYSHIRE

JUNE 2016

RACHEL HACKING ECOLOGY

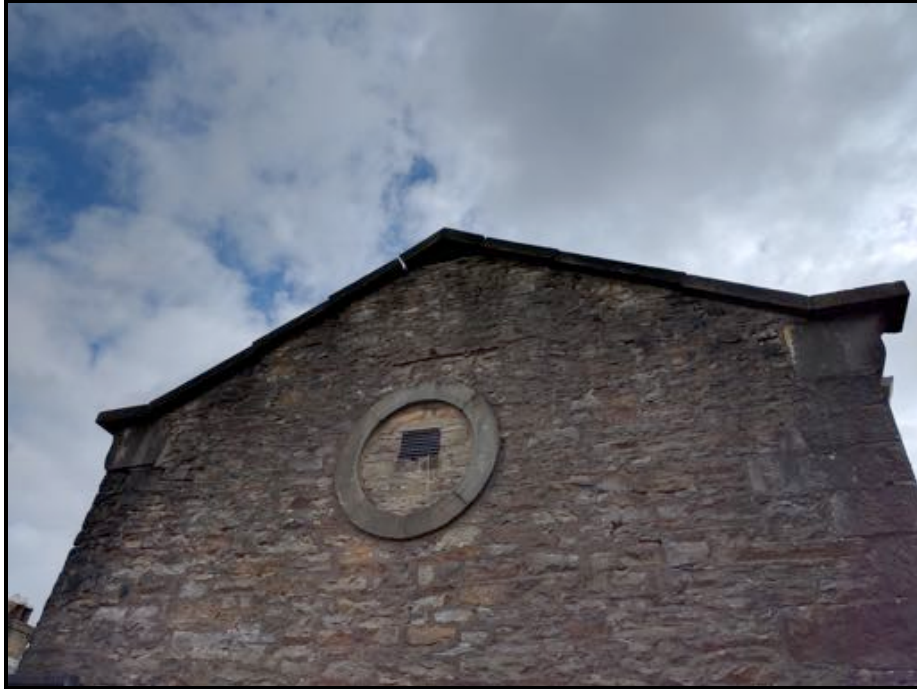
- 3.1 The existing site comprises a stone barn building with an attached garage. The barn stonework is complete, but with some broken mortar and gaps between stones on the eastern elevation. The stone eaves are complete and intact.

Photograph 1 showing one of gable ends

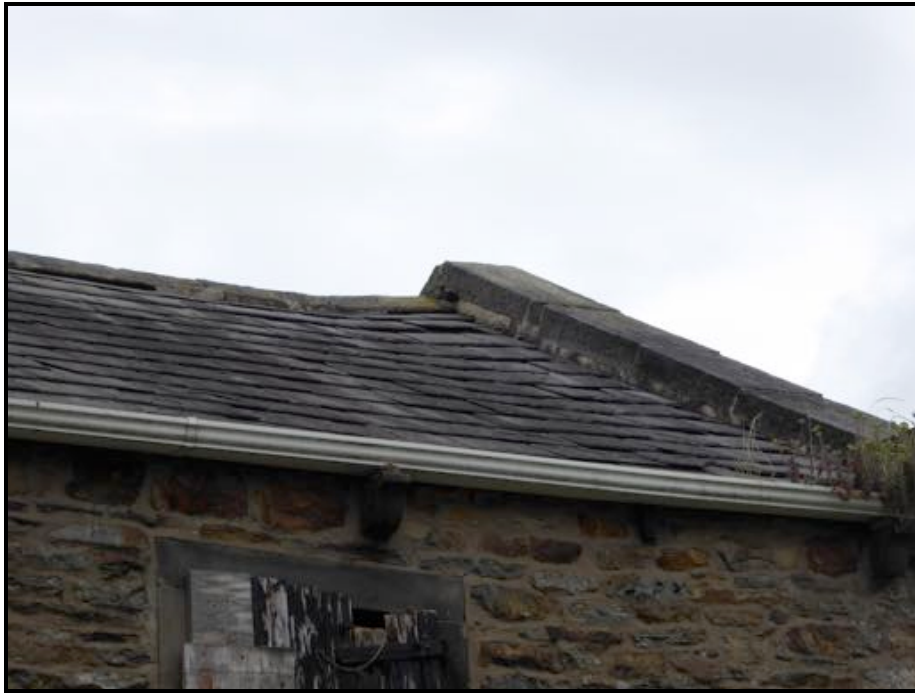
- 3.2 The barn has a single-pitched and tiled roof. The roofline is uneven, but all tiles are present (see Photograph 2), though minor gaps are present underneath some of the tiles. The concrete ridge is complete, but with a small gap underneath the southern edge of the ridge.

Photograph 2 showing the tiled roof

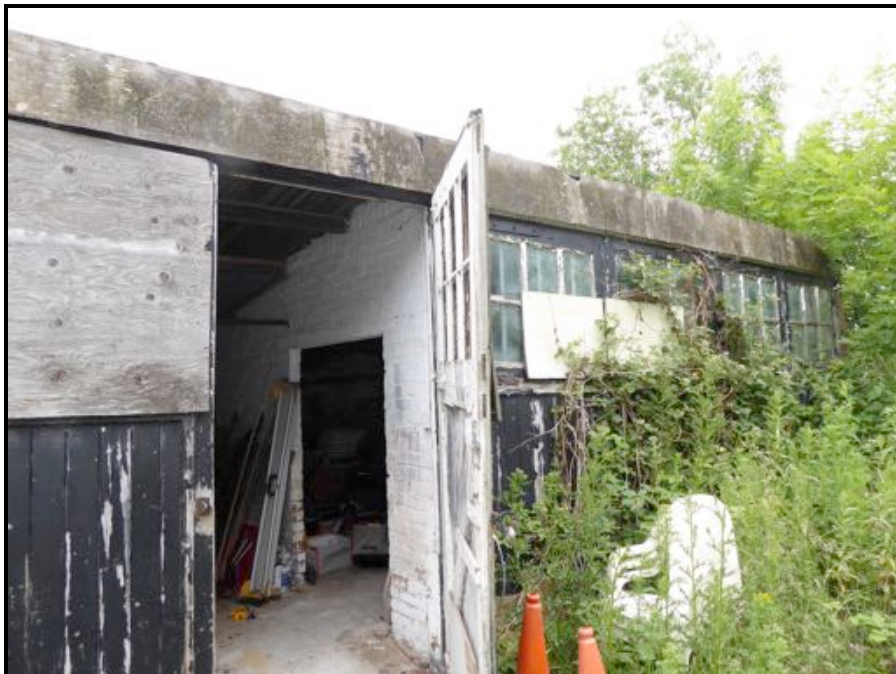
- 3.3 There is a garage attached to the main barn building and this is in a poor state of repair (see Photograph 3). The garage has a flat roof which appeared to be moderately sealed, though the wooden panelling shows signs of rotting. No observable cavities existed on the exterior of the garage.

Photograph 3 showing the attached garage

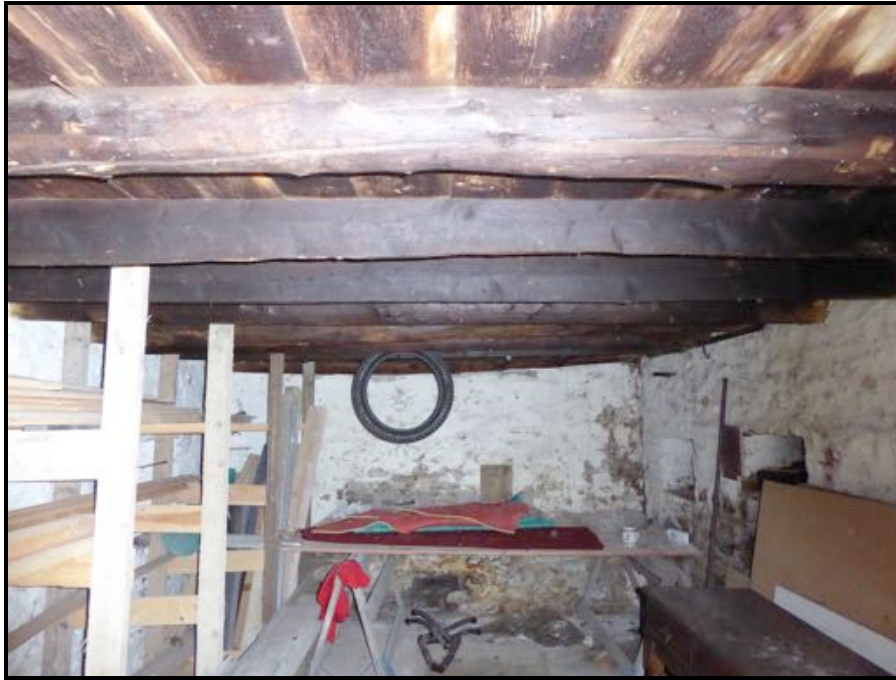
- 3.4 Internally, the barn is split over two levels. The ground floor has several rooms, with exposed floorboards above (see Photograph 4). The ground floor rooms have complete brickwork and are dusty and cobwebbed throughout. No suitable roosting cavities were present in the ground floor rooms.

Photograph 4 showing the ground floor room of barn

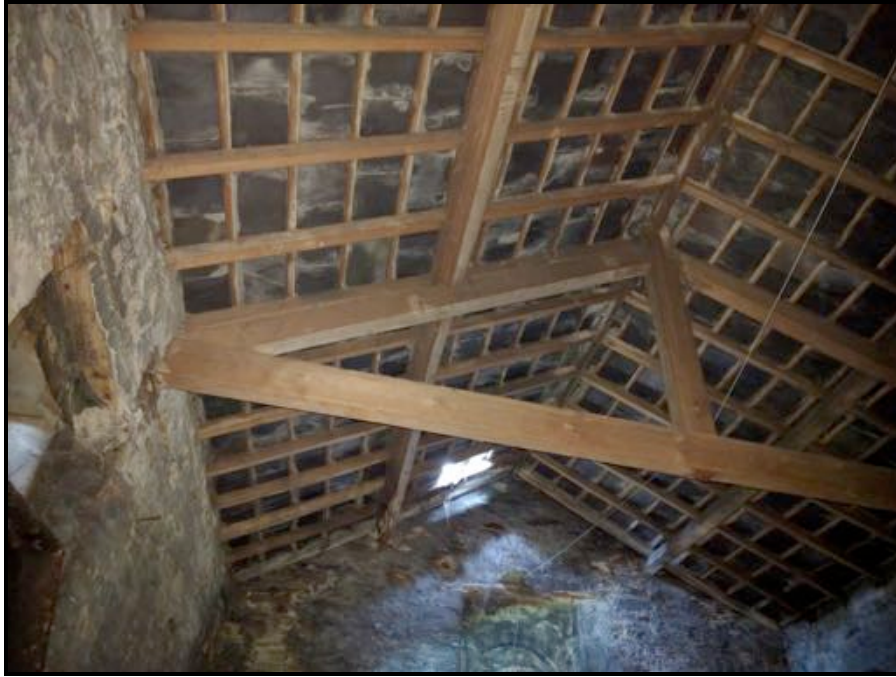
- 3.5 The upper floor has exposed tiles and wooden roof beams. The beams are complete and without gaps or cracks. The stonework, tiles window lintels and central ridge beam are considerably dusty and cobwebbed, suggesting no recent bat usage. No evidence of bat activity, such as droppings, were observed in the interior of the barn.

Photograph 5 showing the upper floor of the barn

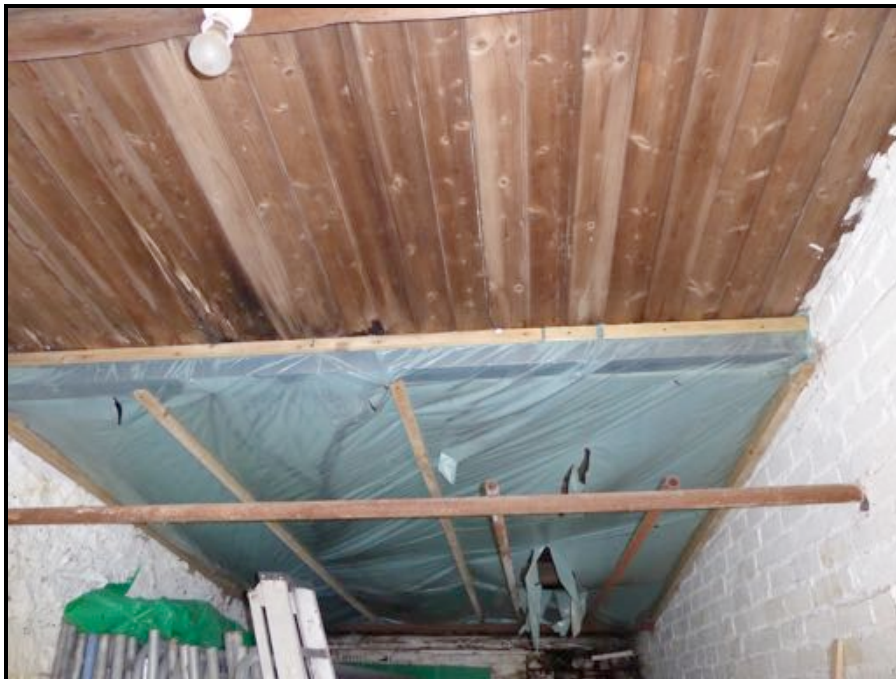
- 3.6 The interior of the garage has a wooden panel ceiling and the internal brickwork is complete. No visible gaps or cavities could be observed internally, and the garage as a whole appeared to be moderately well sealed.

Photograph 6 showing ground floor room of garage
