# PRICE&MYERS

## The Octagon, Pavilion Gardens, Buxton

### Report on Inspection of Exposed Octagon Eaves Structure

Prepared by: Steve Wickham MA MICE MIStructE February 2015 23765

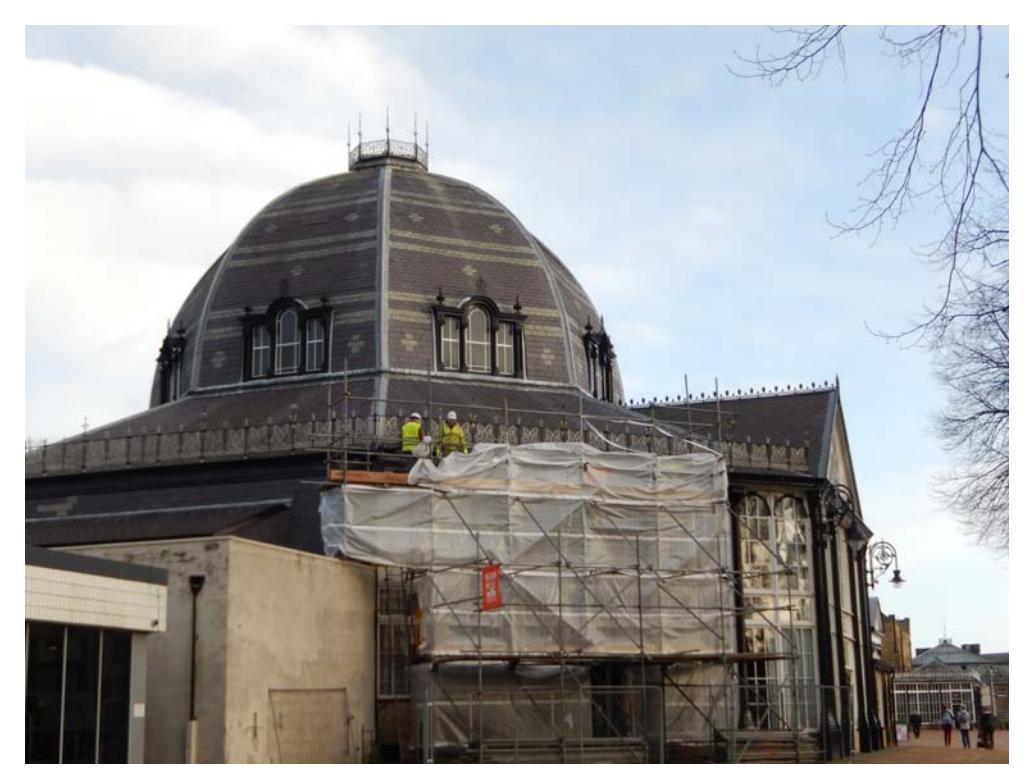
Photo 1: The Octagon Building showing South West elevation with scaffolding for opening up.

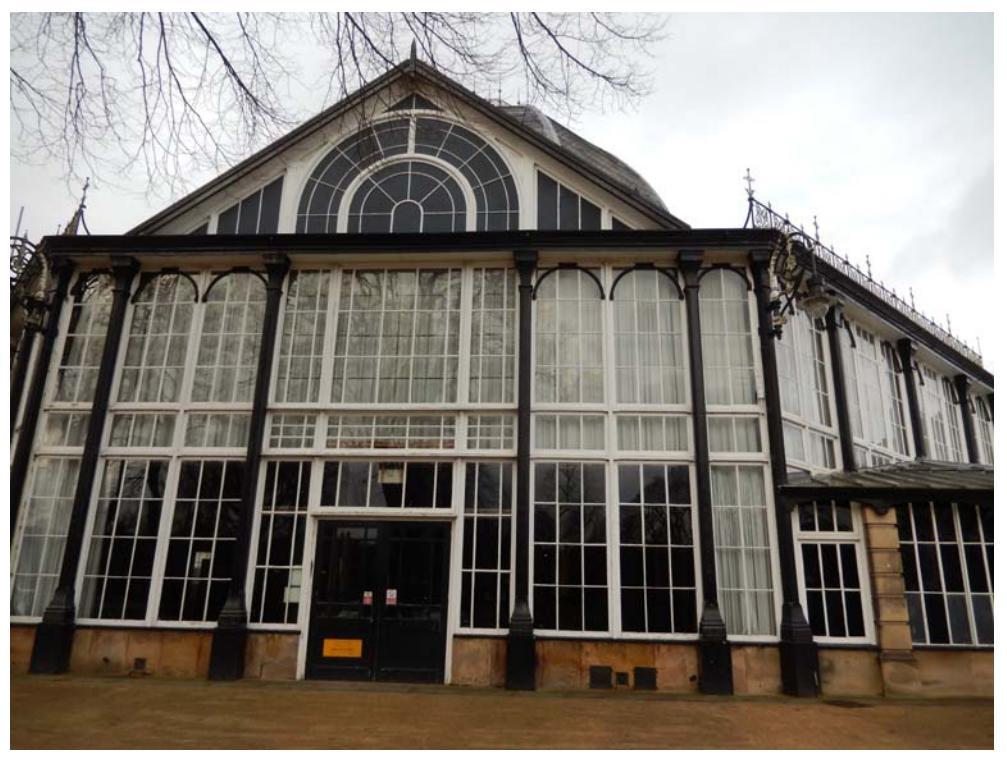
Photo 2: South elevation

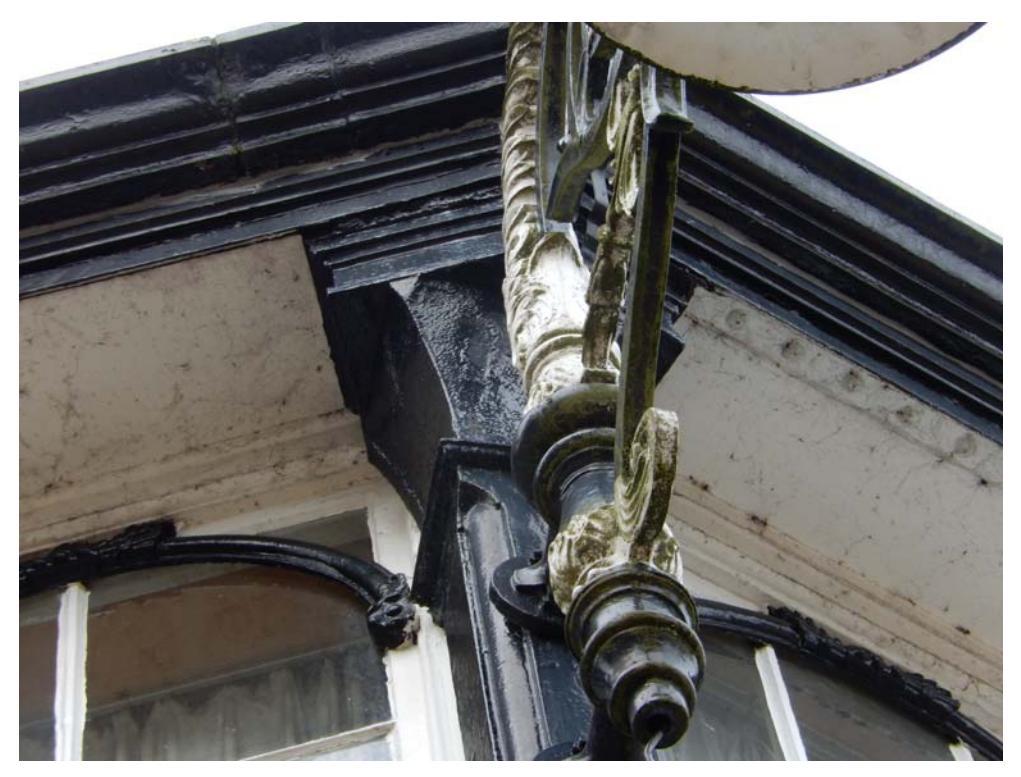
Photo 3: South West corner soffit showing original soffit and adjacent new soffit.

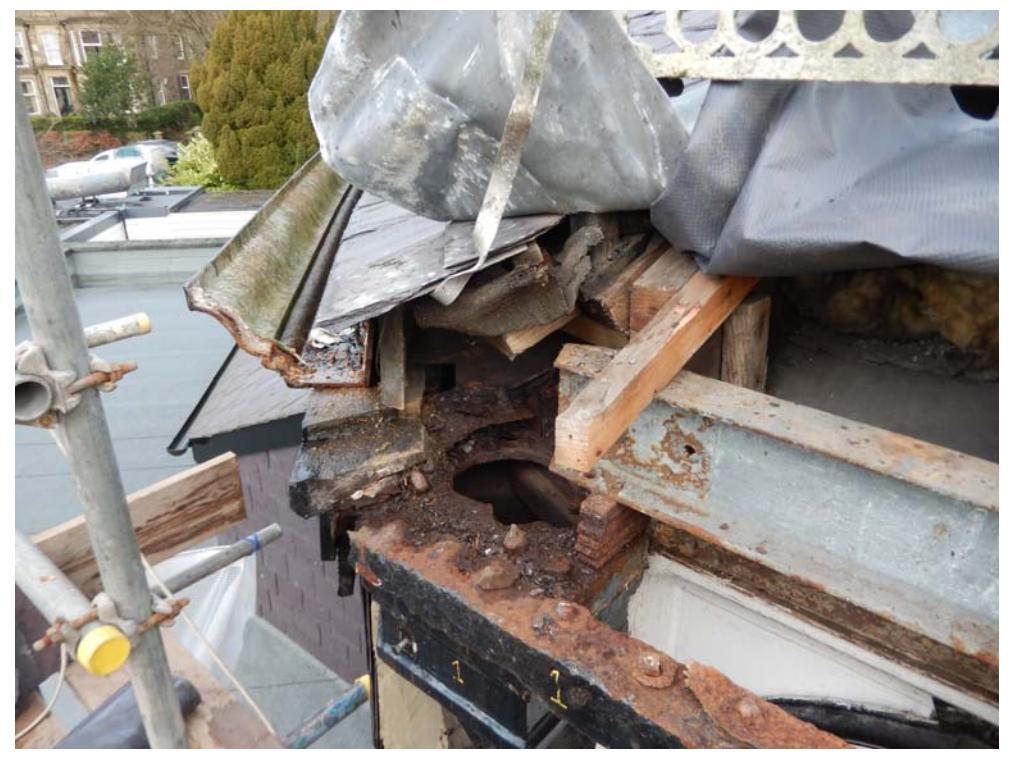
- There were indications that the column at the corner between the southwest and western elevations may have moved out by 10-20mm as evidenced by the lack of fit of the now detached front angle of the horizontal eaves girder and a possible small gap between window frame and back of column.

Photo 4: North West end of opening up showing top of column.

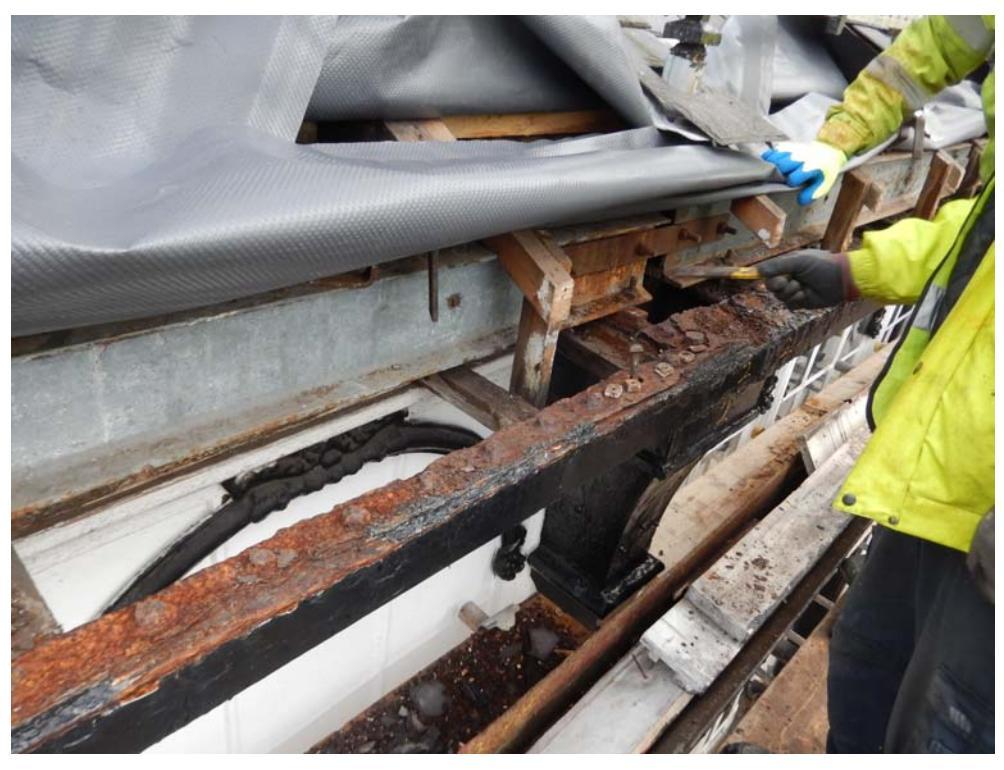
- On the exposed southwest eaves there has been extensive corrosion presumably as a result of the gutter leaking. The wrought iron horizontal girder has severe corrosion throughout its length. This, coupled with past removal of sections of the flat web plate, has resulted in almost total destruction of this member over significant lengths. In the original condition the 220x55 softwood rafters would have been birds-mouthed over a timber plate sitting on the outer section of the eaves girder. However, in order to support the ends of the rafters over the south west elevation eaves where the girder has been severely compromised, short lengths of steel rsj's have been installed between the tops of the columns supporting the cut back rafter ends via a short softwood splice on fixed to the side of the top of the cast iron columns with multiple narrow shims. The outer angle chord of the horizontal eaves truss has come totally detached from the southwest corner column.

Severe corrosion has clearly has totally destroyed the horizontal wrought iron eaves girder. Past remedial works have attempted to address the support of the rafter ends by introducing steel joists in lengths between the columns. The remedial works are not satisfactory as the steel joists are supported on multiple steel shims which are themselves now corroding. The steel joists are not properly attached to the columns so do not provide any effective ties between the columns. The connections between the cut back rafters and the steel joists is not satisfactory. The eaves fabricated girder performs the function of supporting the rafters at the eaves (and the gutter) as well as tying together the tops of the external elevation columns. The girder on the southwest elevation is clearly corroded well beyond repair. Whilst the historic repairs with the steel joists does support the roof they are not well fixed and this is not a satisfactory condition.

Photo 5: Corroded eaves ring beam wrought iron angles and extremely corroded web plate and recent UB's supporting rafter ends.

The eaves girder must be replaced in a form that not only supports the roof but ties the column tops together. It is considered likely that this will be needed on all elevations.

This could be done by replicating the original construction of creating a new horizontal girder from angles and plate with some additional stiffening to support the rafters over the longer spans. The original material was wrought iron but this is not readily available now. Some form of pure iron may be possible but mild steel is likely to be the most available and practical material to use.

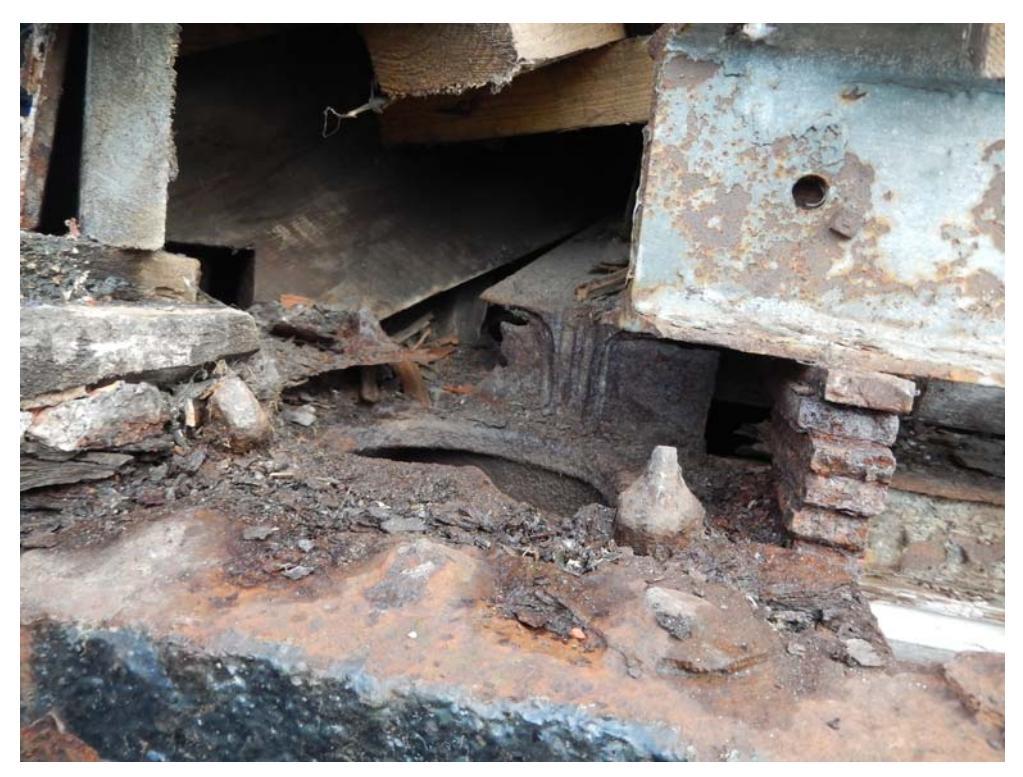
Photo 6: South West corner column showing hip lattice truss end.

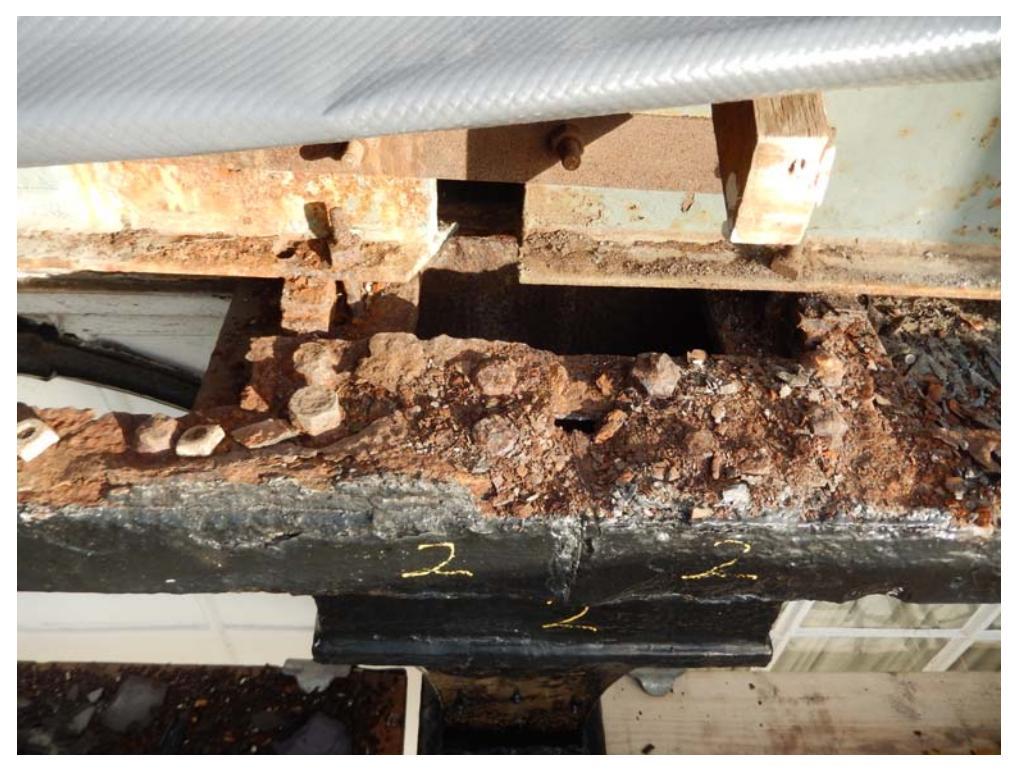
Photo 7: Column 2 to eaves ring beam junction.

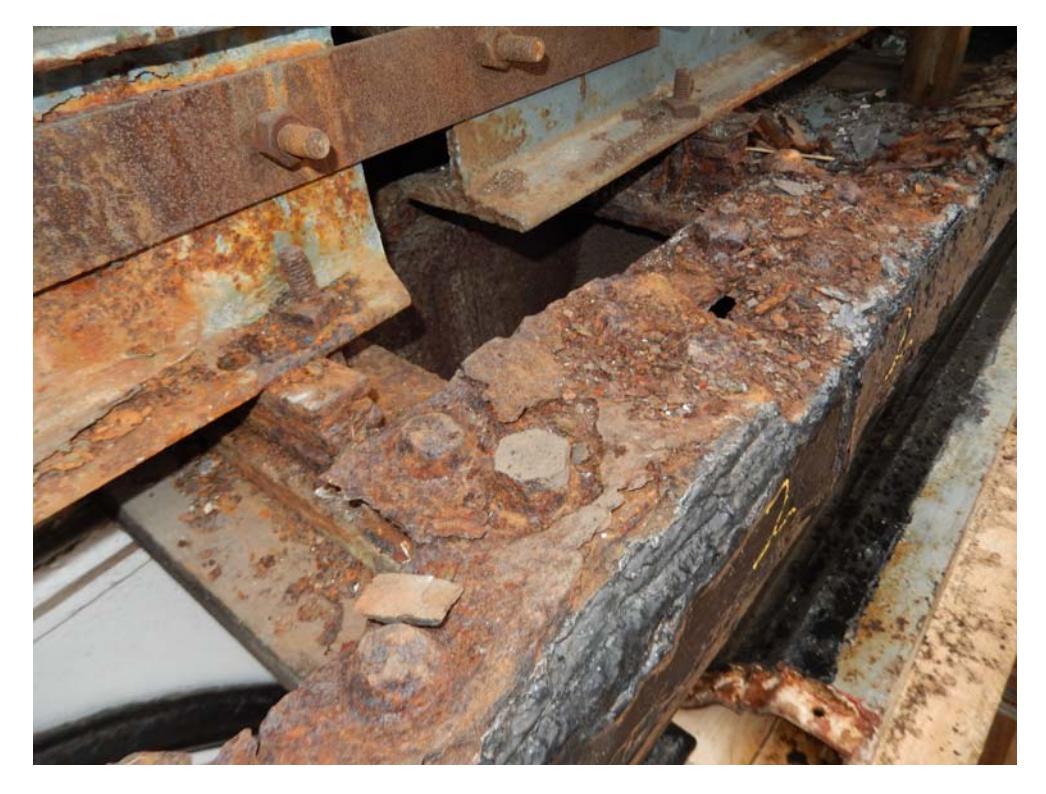
Photo 8: Column 2 to eaves ring beam junction.

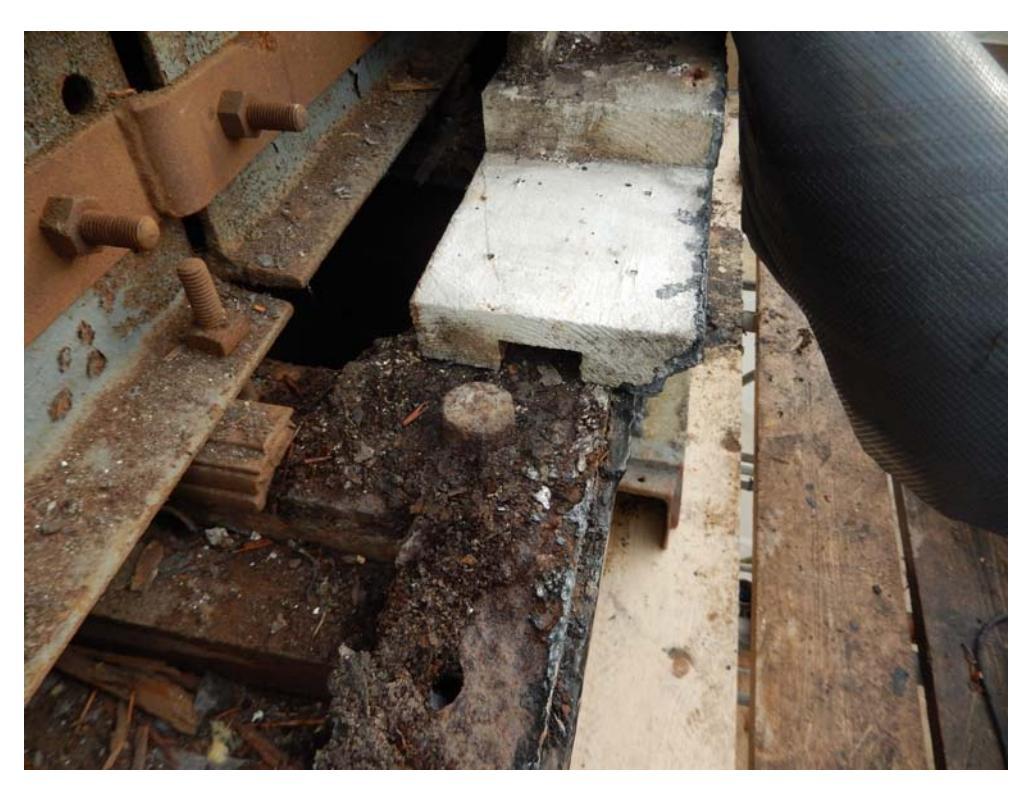
Photo 9: Column 2 showing original gutter support plate.

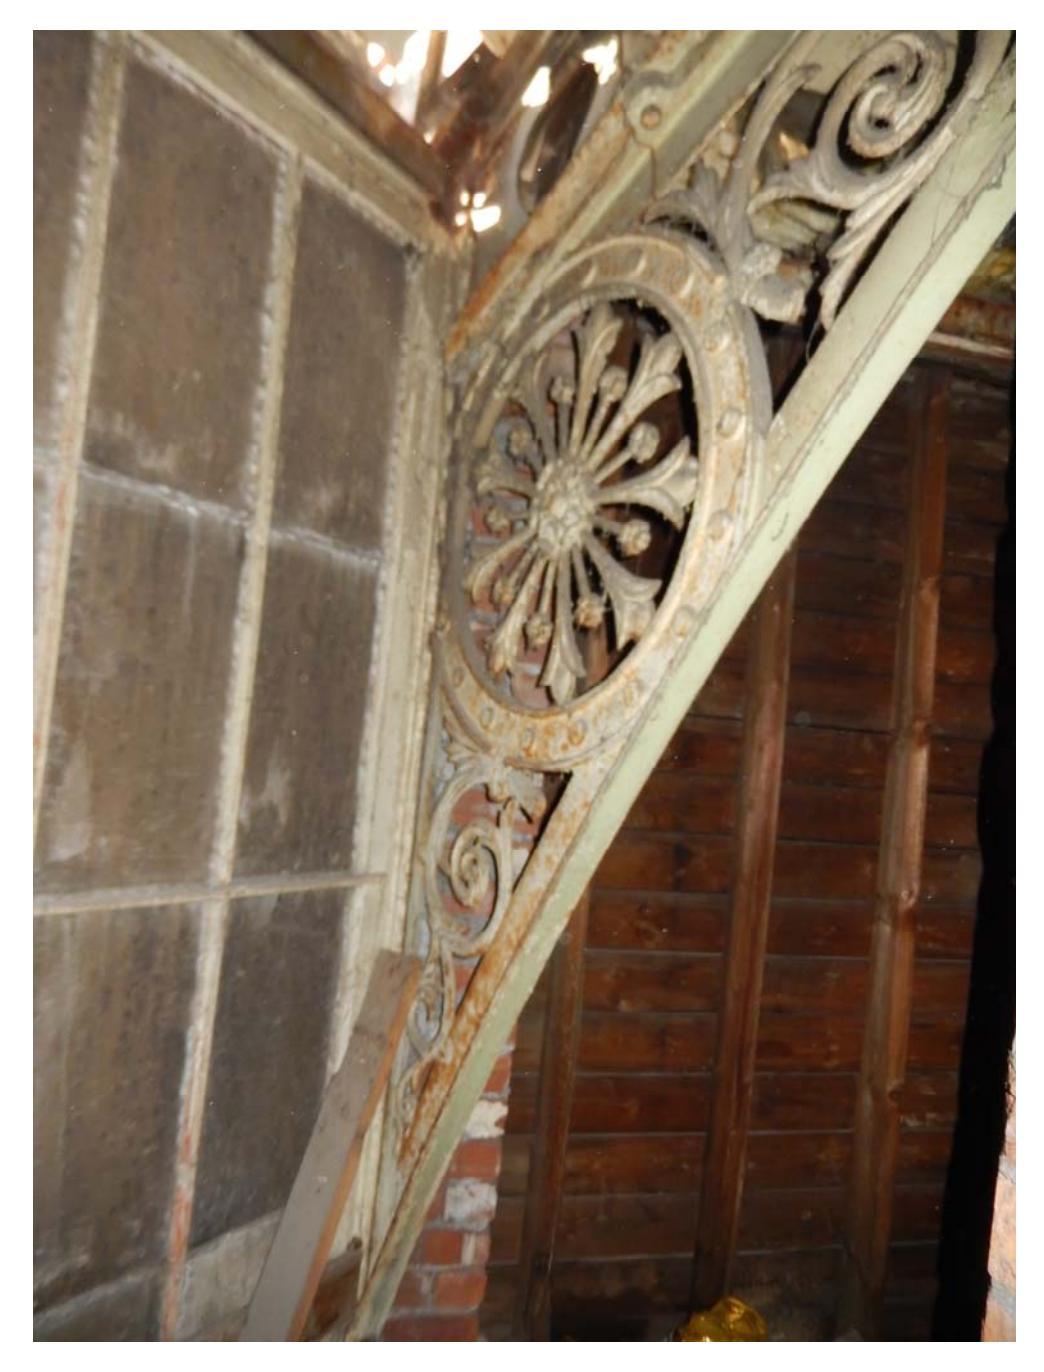
- The principal radial lattice truss rafters are supported on the outside corner cast iron columns via decorative cast iron haunches bolted to the underside of the lattice rafter truss. The haunch sits on a corbel which is part of the cast iron column. The end of the top of the lattice member appears to be bolted through into the face of the columns with two bolts. On the column that could be seen one of the bolts between truss end and column was missing. The cast iron haunch had a fracture through the top of the haunch against the underside of the truss.

The one principle radial lattice truss to column connection that could be seen had three defects: the lattice truss has had some corrosion noted in the end angle which bolts to the back of the column; of the two bolts to the column one was missing; the cast iron haunch had a fracture at its top which is bolted to the bottom chord of the lattice truss. The fracture and the missing bolt may be a result of the possible small outward movement of the column on the corner between the southwest and west elevations.

Photo 11: CI haunch connection of hip lattice beam to Column 1.

The principal radial lattice truss connection to the external column needs attention. On the column which was inspected the haunch is fractured. This could be repaired by splicing a new piece across the fracture. It looks likely that the angles forming the end plate of the lattice truss will need to be strengthened and now bolts inserted through into the back of the column. It isn't known if these defects will be on other radial truss to column connections. The other seven will need to be inspected to check this.

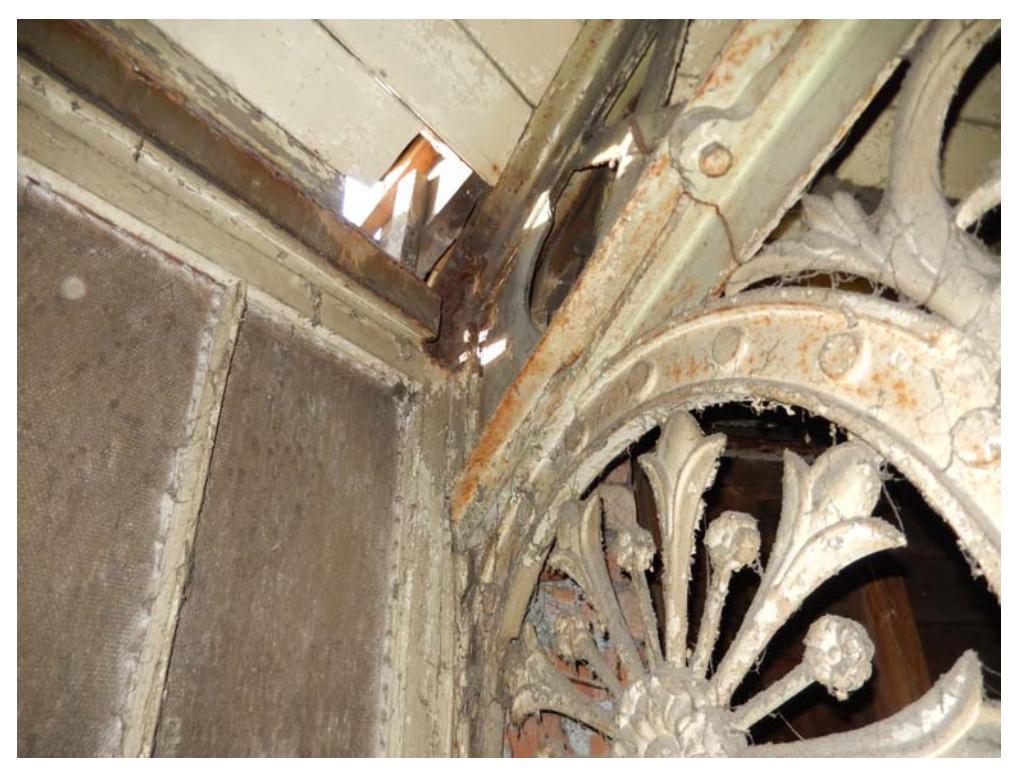
Photo 12: Crack in haunch.

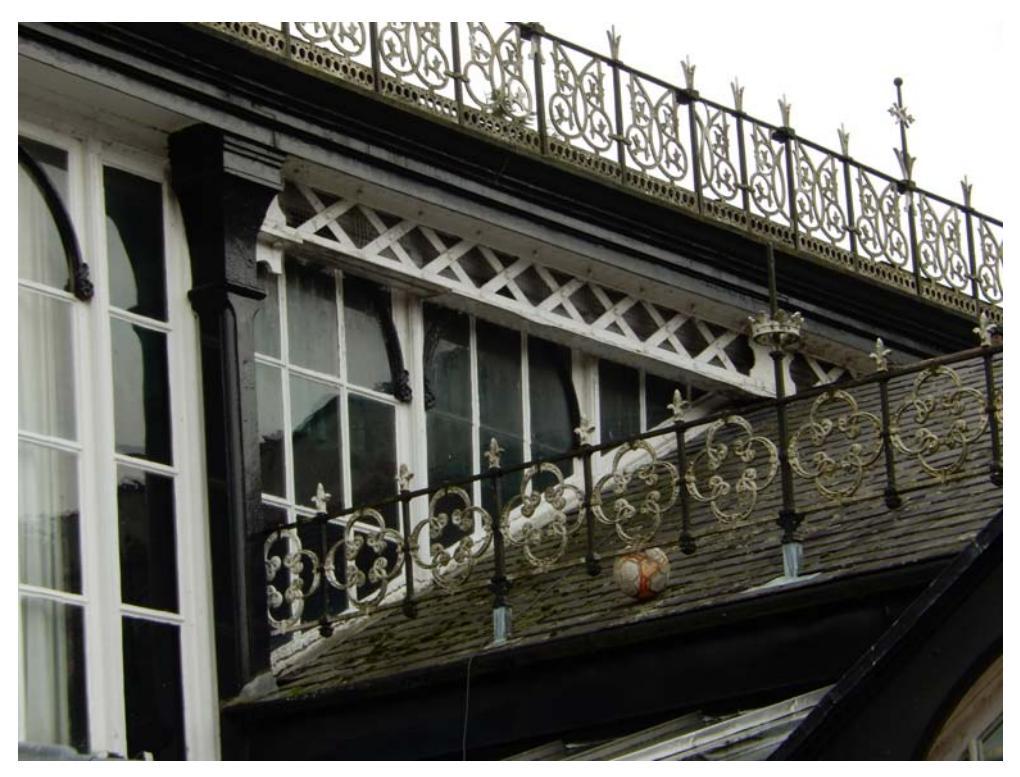
- The lattice truss in the east elevation spanning over the Octagon reception could not be inspected close up but could be seen to be likely to be suffering corrosion with the paired angles forming the bottom chord being forced apart by corrosion of the internal diagonals and the touching faces of the angles. Plates have been added to both top and bottom chords – this looks like a probable later remedial work rather than original construction.

The lattice truss supporting the roof over the Octagon Reception appeared to have suffered corrosion but the extent of this could not be determined. However the presence of full width top and bottom flange plates may indicate that this is a long standing defect that has had past remedial work.

Photo 13: Suspect lattice truss to East elevation over Octagon reception.

It is probable that the lattice truss supporting the eaves over the Octagon Reception is in a poor condition. The most practical repair will probably be to replicate the construction and replace the whole truss.
