Buxton Caravan Club Site,  
Derbyshire

## **Preliminary Roost Assessment for Bats**

Report No: CSA/3151/01

November 2016

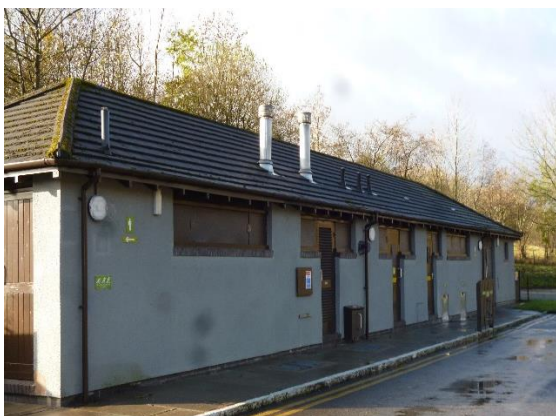
- 4.3 The external inspection of the toilet block found the thick clay roof tiles to be in good condition and well-sealed, with significant moss growth. A horizontal slit was present in the panelling above all timber window frames, corresponding to the potential roof void access points cited above, with the internal metal mesh preventing access in most cases. Gaps were present where pipework emerges from the eaves; some were heavily covered by cobwebbing, and one showed signs of use by nesting birds. No potential roost features were identified in the external structure.

Plate 1. The toilet block with hipped clay tiled roof, grey rendering and chimney flues

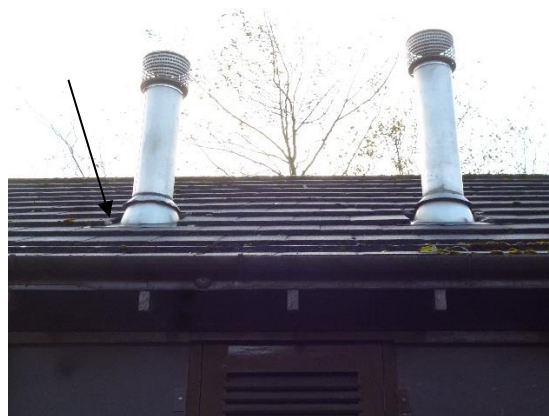
Plate 2. Gaps around base of chimney flues

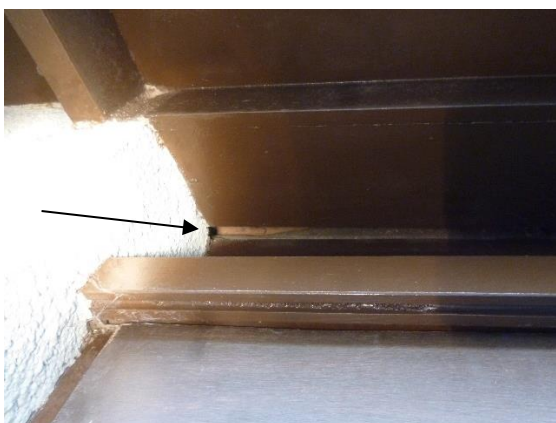
- 5.1 The internal and external inspections revealed limited access opportunities into the roof space overall with minor gaps at the eaves, and this was largely blocked by metal mesh. No evidence of bat activity was identified within the roof void, following a thorough search. The roof structure was otherwise well sealed, and no suitable external roost features were identified.
- 5.2 With reference to Table 4.1 of the BCT Best Practice Guidelines<sup>1</sup>, it is concluded that the toilet block has a negligible potential to support roosting bats

Plate 3. Gaps at eaves above wooden windows into roof space, mostly covered by metal mesh

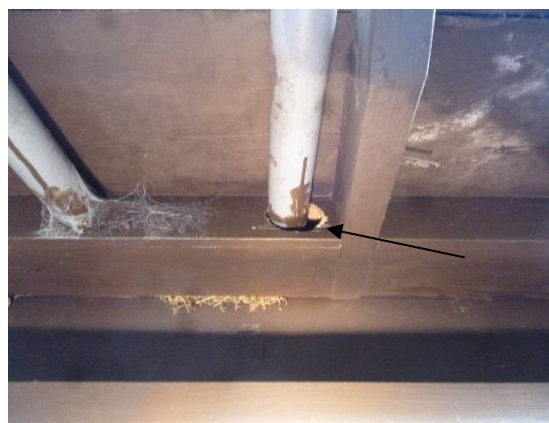
Plate 4. Gaps around pipe work as it leaves the roof at the eaves

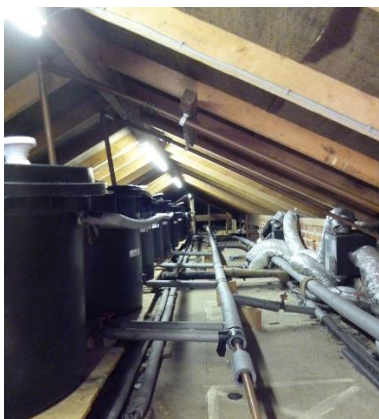
- 4.2 The internal inspections found the roof void to be a simple trussed structure, housing 14 water tanks and associated pipework. The water system had been drained at the time of survey for closure over the winter months, however based on experience the system would have likely kept the roof void very warm during the spring and summer months. The majority of the floor was boarded, except for the far western end, with fibreglass insulation underneath, and thus much of the roof space could be searched thoroughly for evidence of bats. The floor was found to be generally very clean with no sign of bat or rodent droppings, and no sign of droppings was found on top of water tanks. The bitumen felt lining was generally in good condition. Points of light were seen at the eaves around much of the roof - these were in most cases blocked by a metal mesh to prevent bird nesting, however the gaps did in places afford potential access points for bats. However, following a thorough search no evidence of roosting bats was found within the roof void. The roof contained strip lighting along the ridge and is likely subject to some disturbance during the Site's active season.

Plate 5. Internal inspection, water tanks, pipework and clean floor boarding

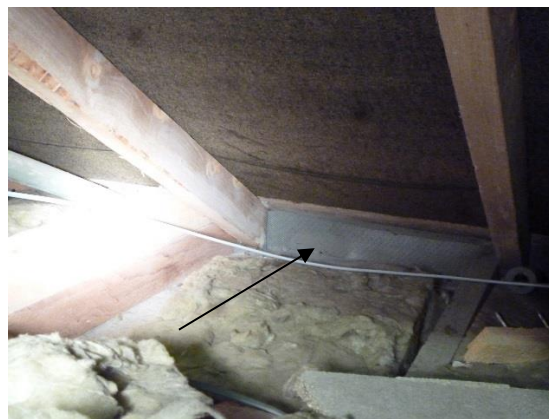
Plate 6. Bitumen felt lining with wire mesh at eaves.
