ARBORICULTURAL DEVELOPMENT REPORT

ON TREES LOCATED WITHIN POTENTIAL DEVELOPMENT SITE OFF WOOLLEY BRIDGE ROAD, GLOSSOP, DERBYSHIRE

RICHARD LLOYD CONSTRUCTION LTD Mr Mark Jones, Managing Director

Based on initial survey inspection in August 2012, Reviewed and amended in March 2017

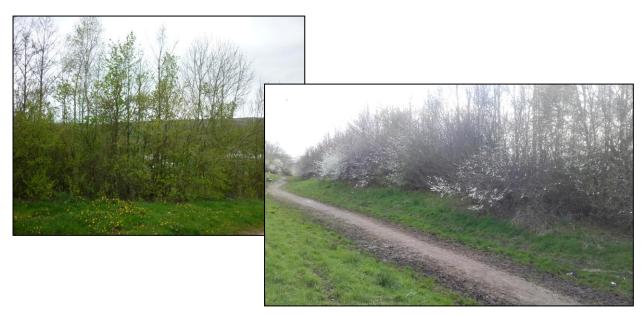
- 5. The formal planted screen (TG1) bordering the footpath and screening the site requires thinning to 2m centres and the removal of some dead or windthrown stock, leaving the best trees and shrubs in place. Annual hedge cutting of the shrubs facing onto the footpath will enable a dense boundary hedge to be built up.

- The trees shown within the planted trees screen have not been tagged and have been evaluated as a Group. They have been graded 'B2' as they provide both a future treescape to the area when seen from afar and an immediate screen between the proposed development and the Public footpath.

Tree Screen TG1 when seen from Public path

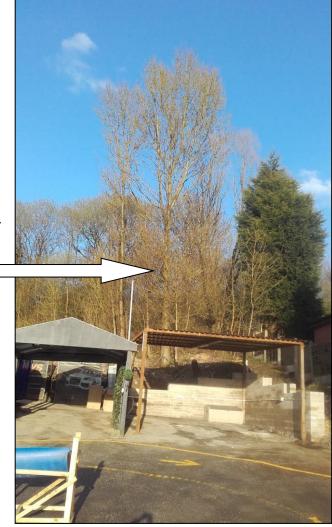
- 4. Some 10-15 years ago a 5-7m wide planting of young trees was installed along the eastern boundary of the site along what would have been the edge of the ballast line of the Railway line removed in the 1960s. The most prolific of the planted species, alder and poplar have self seeded over the site to the west. The diameter size of the self seed is generally less than 75mm diameter while the more formal screen planting has matured and trees with a girth diameter of 100-300mm are dominating lesser and now suppressed trees.

TG2	Self seeded areas of poplar, goat willow and Alder	2-7	25- 100	2	-	Y	Dense self sown areas of alder with occasional poplar and goat willow located on rubbled and poorly prepared ground	G	Remove.	20		U

View from within site showing self seed regrowth TG2
