Arboricultural  
Impact Assessment

**The Barn  
Bank Hall Drive  
Chapel-en-le-Frith  
High Peak**

Client: Mr Rick Curtis  
Project No: AIA.12584  
Issue: 01

Date Issued: 10<sup>th</sup> January 2017  
Status: FINAL

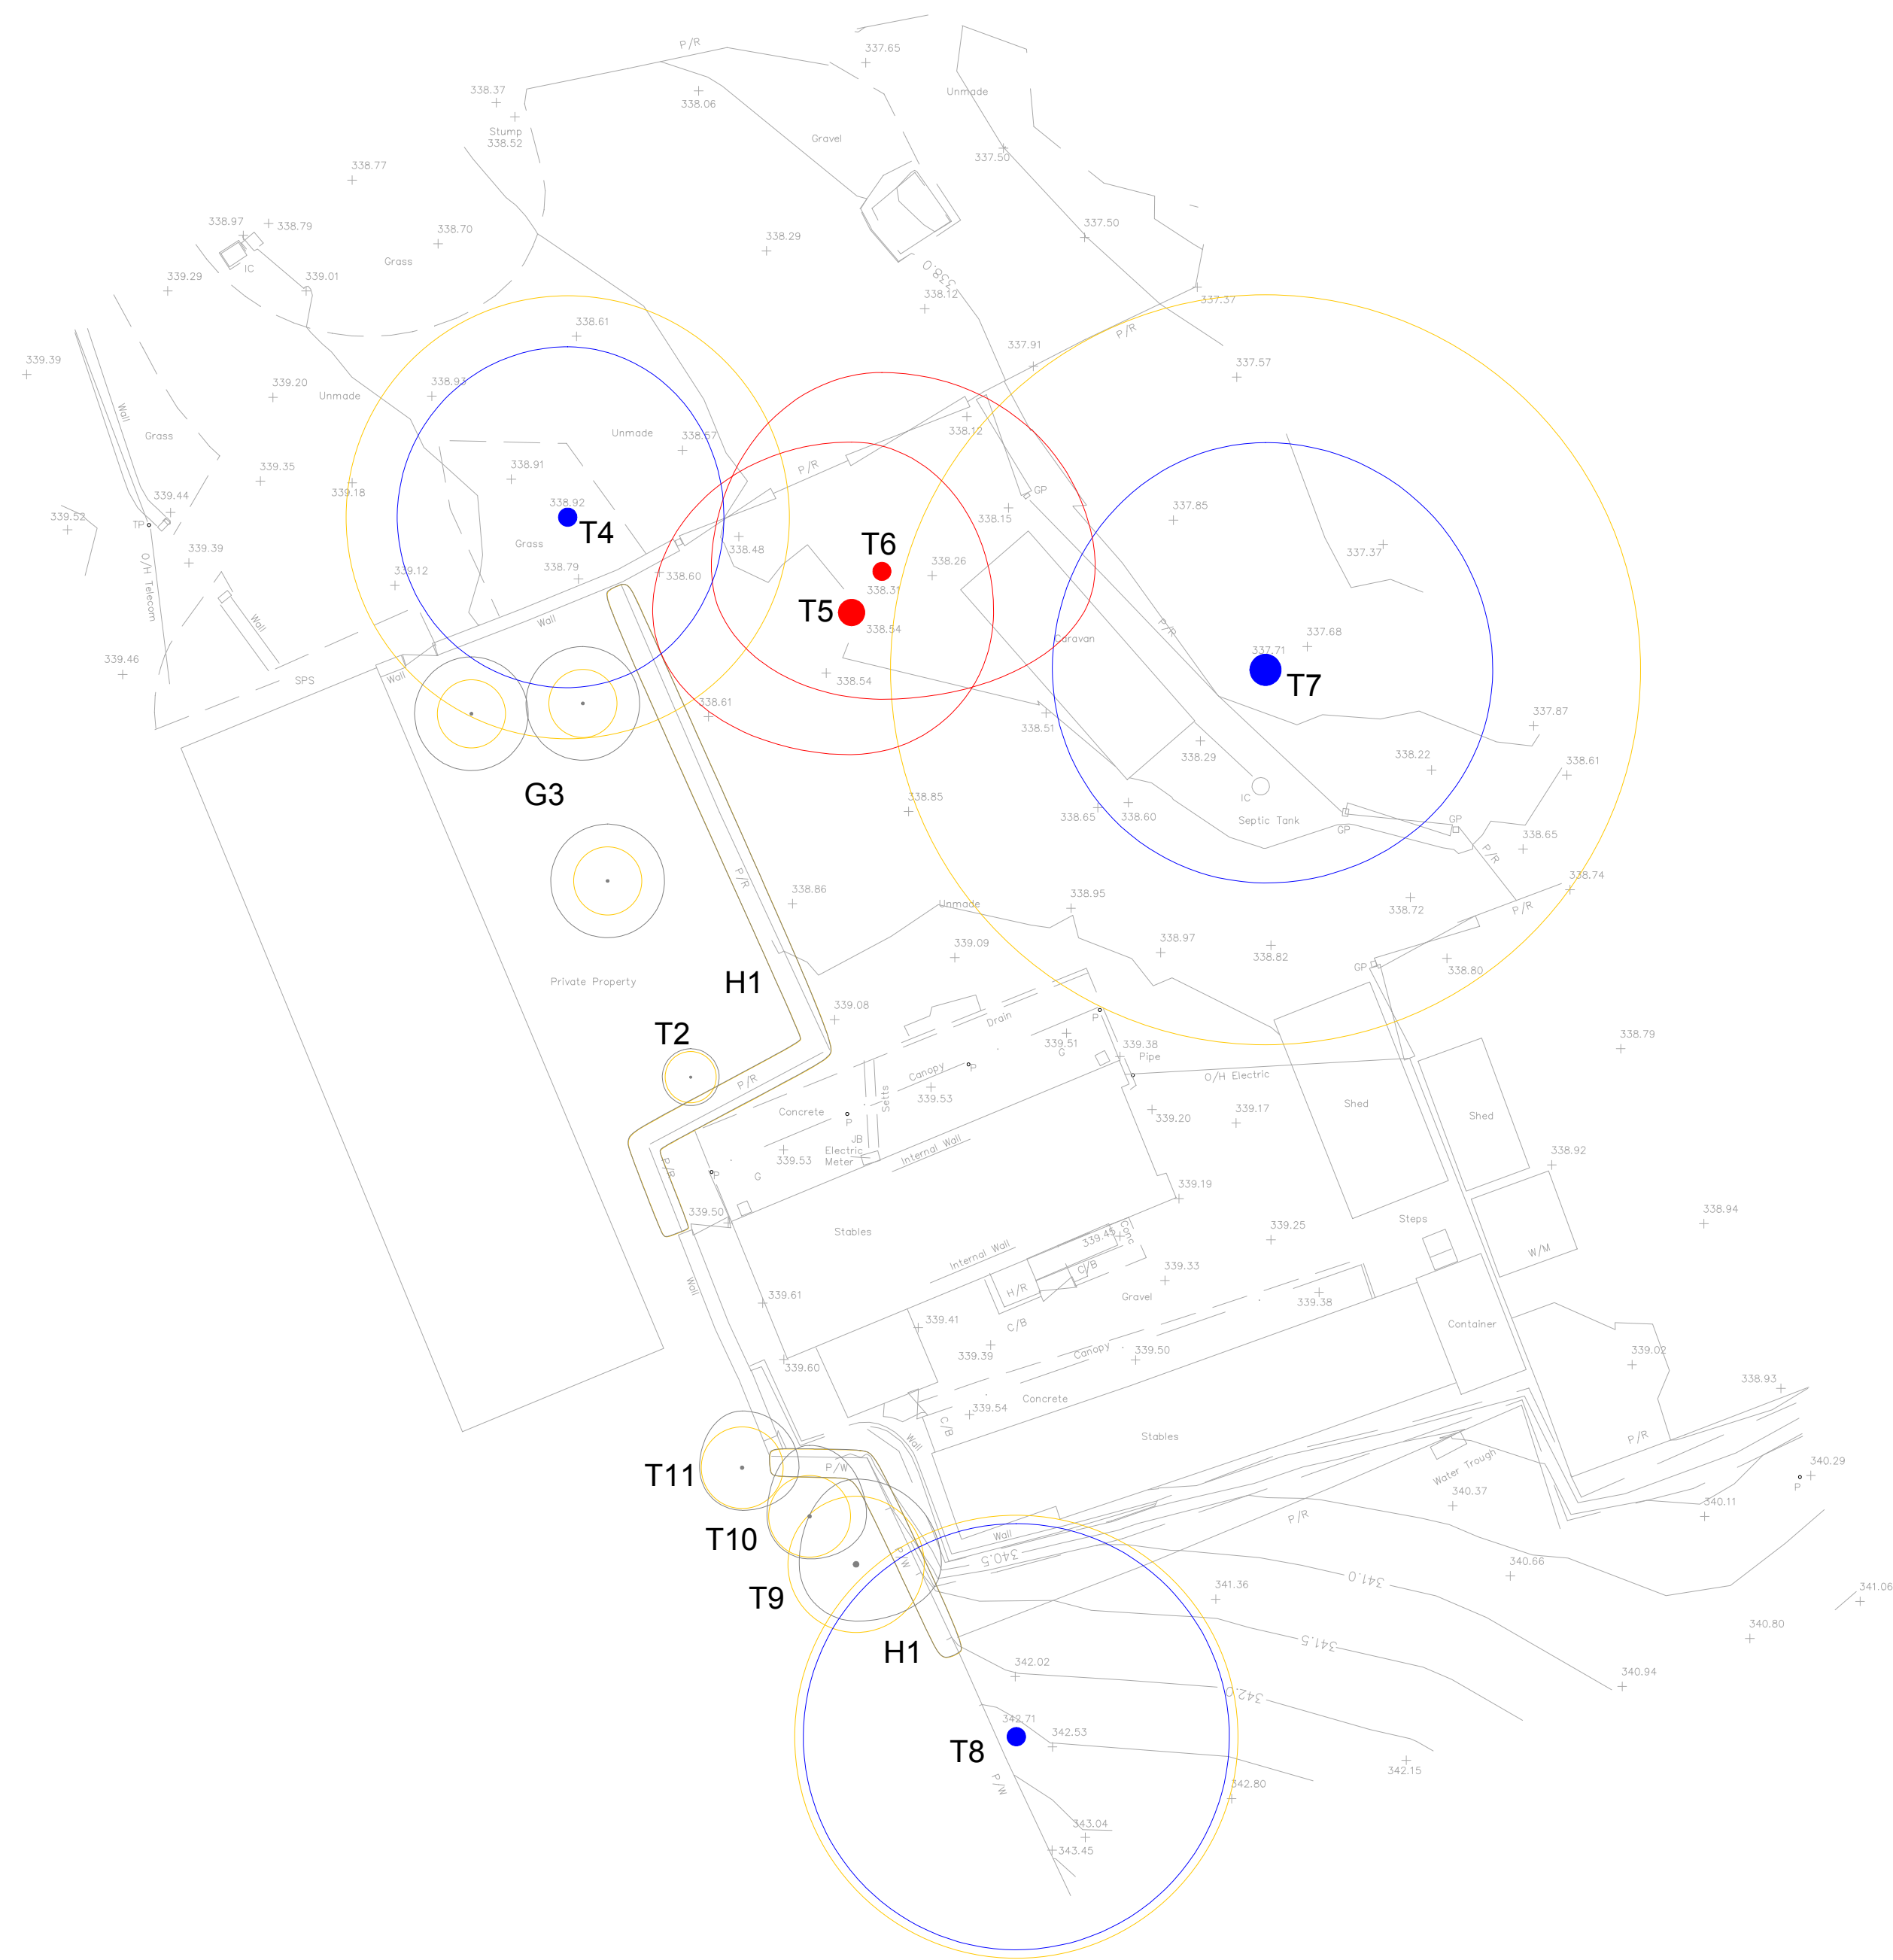
## Drawing 1. Tree Constraints Plan

- 2.1.2 The trees were generally found to be in a good to fair condition however; two individual trees (**T5** and **T6**) were classified as retention category 'U' (unsuitable for retention). Tree **T5** is diseased and poses a high risk of failure, **T6** is in a fair to poor condition and the risk of failure to this tree would increase with the removal of **T5** due to the exposed location of the site. It is therefore considered that **T6** should also be removed as it would become a potential hazard.

- 2.1.3 Please see *Appendix 1* for the detailed list on existing species, age class, dimensions and condition of trees within the site, and *Appendix 2* for an explanation of retention category criteria. Tree locations can be seen on the *Tree Constraints Plan* at the rear of this report (*Drawing 1*).

- 3.2.1. All of the trees surveyed trees could be protected throughout the construction phase, however trees **T5** and **T6** have been recommended for removal due to their condition. Therefore, no trees shall require removal as a result of the construction of the proposed development.
- 3.2.2. It is understood that the removal of **T5** and **T6** will be mitigated as part of a post development planting scheme of well-structured comprised of two new Beech trees that will add to the quality of the area and integrate the proposed development into the surrounding landscape.

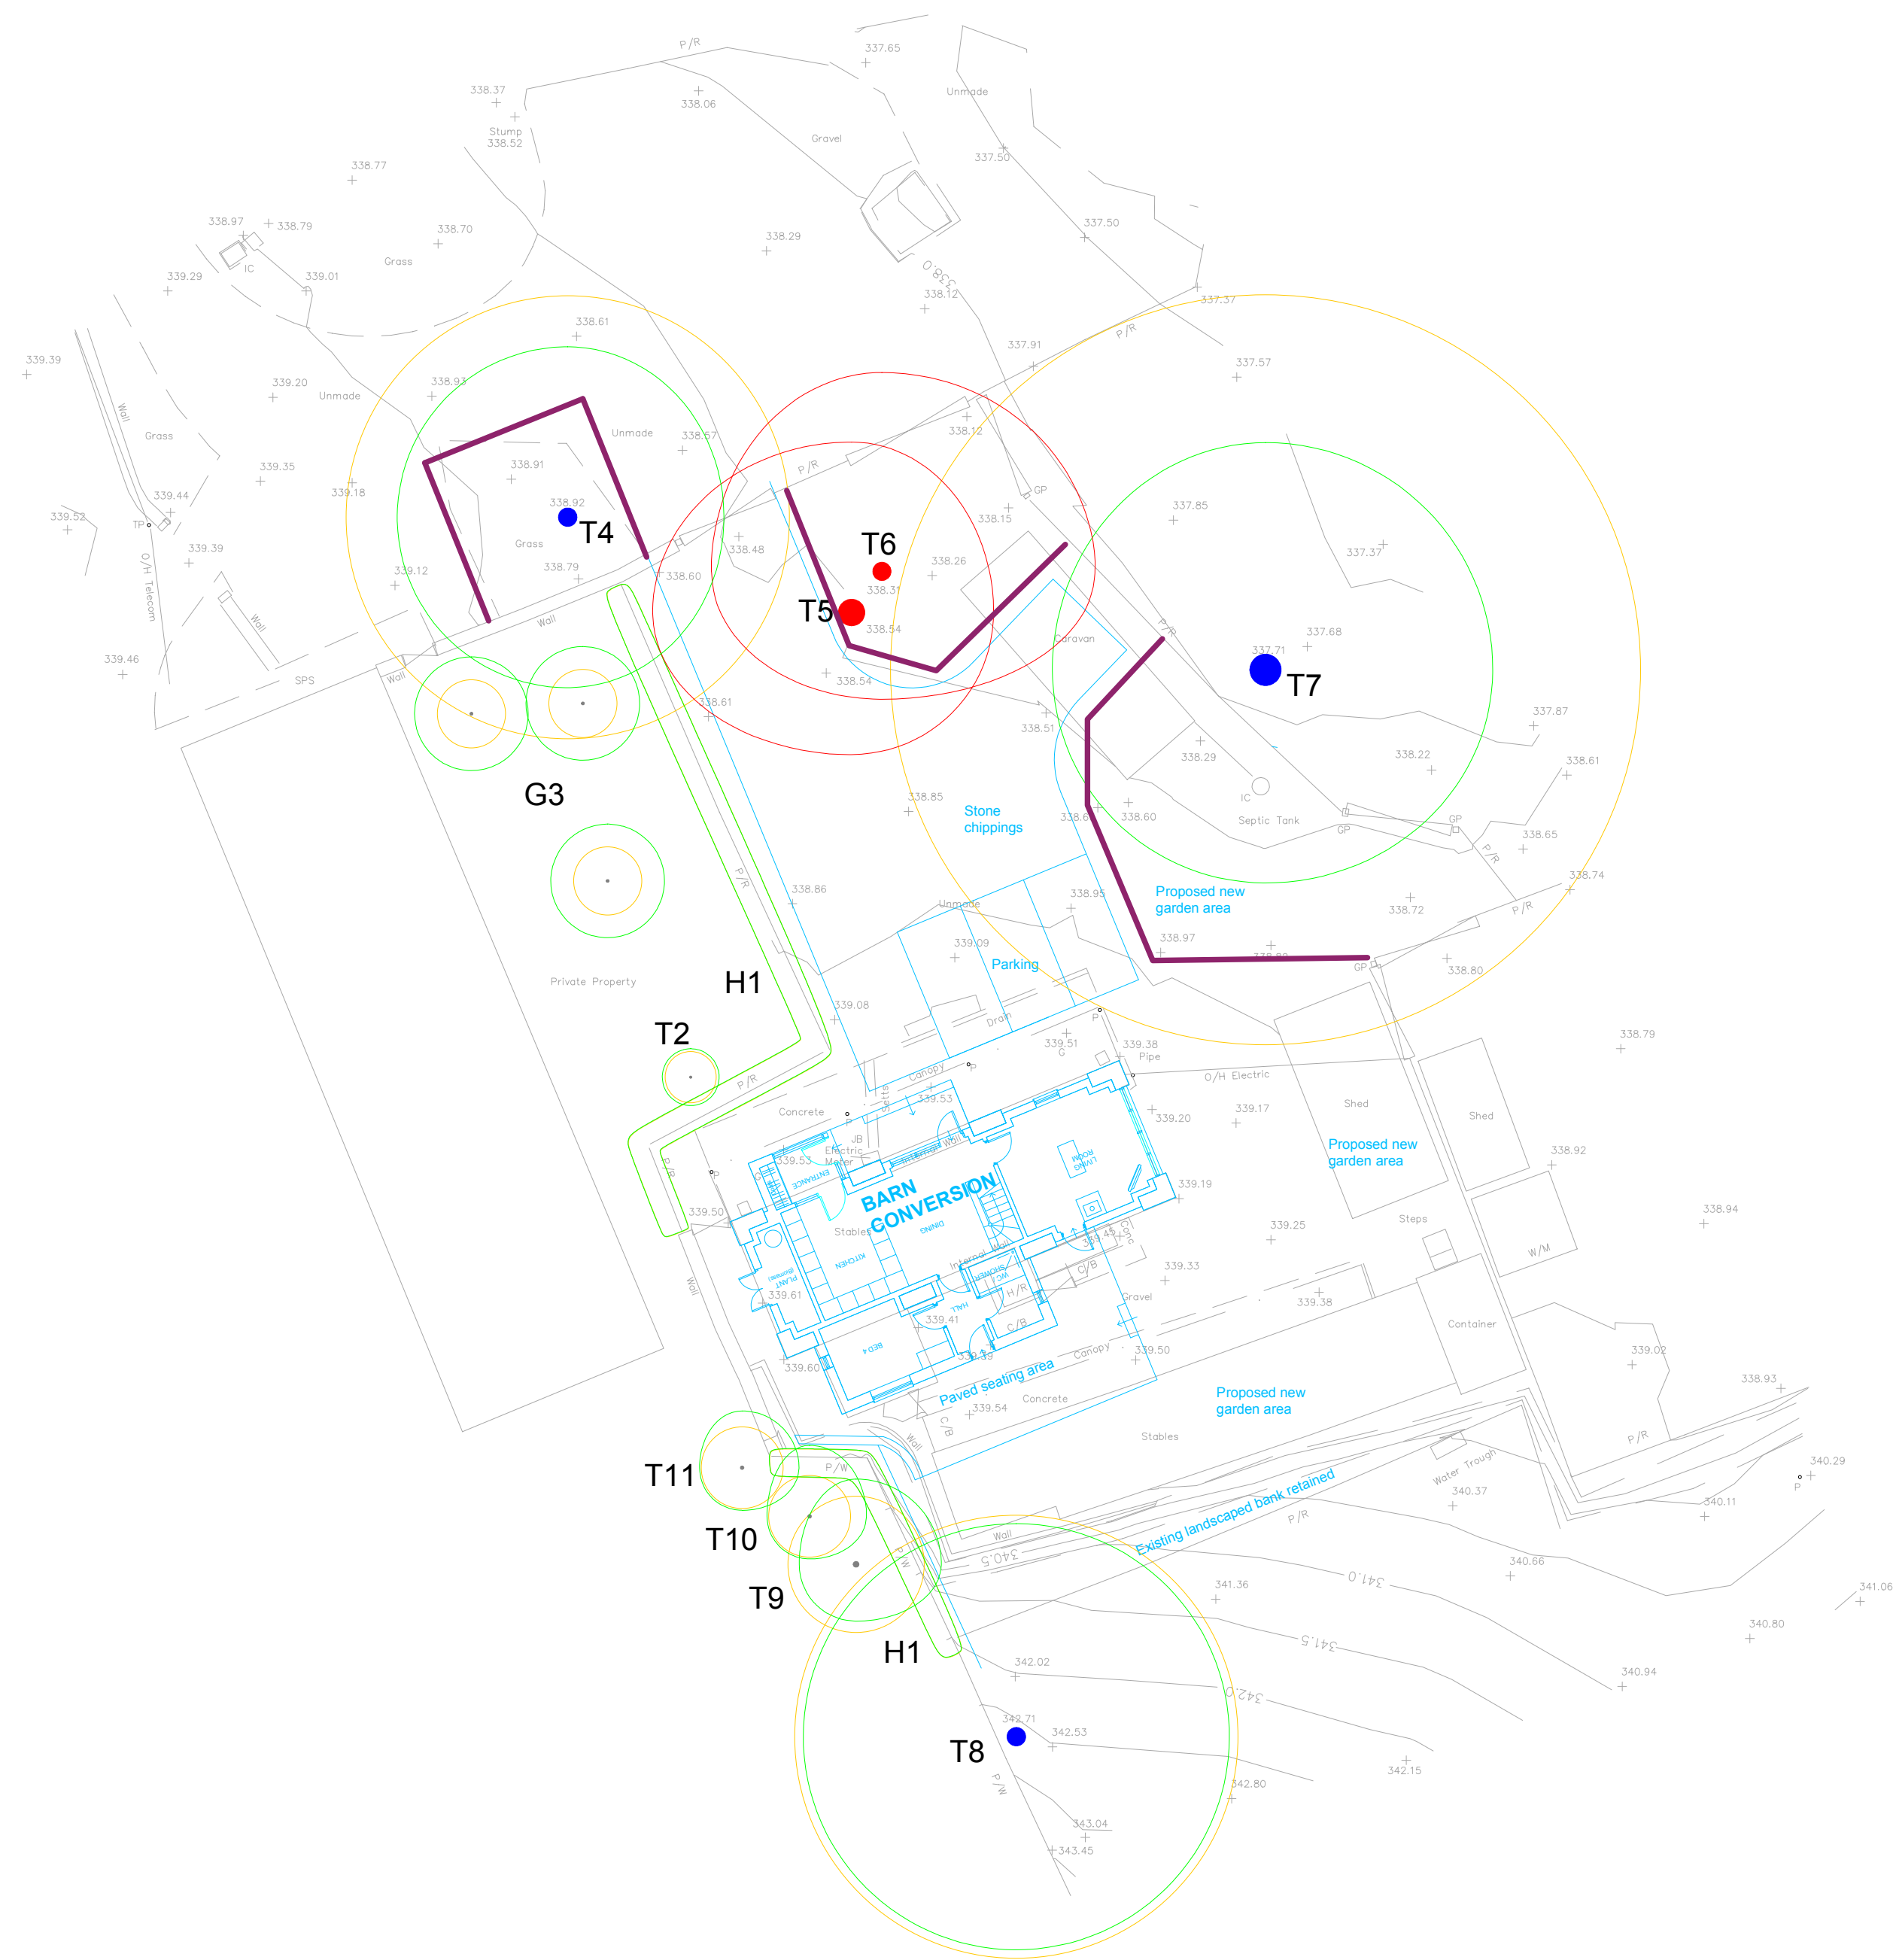
## Drawing 2. Tree Protection Plan

- 3.5.1. A section of RPA from tree **T4** extends beyond the temporary barrier and into the site access point. However, it should be noted that the RPA of this tree is currently located beneath an existing vehicle access point, and as such the proposed works would not put the tree under any increase pressure during the construction phase.

- 3.6.1. A section of RPA from tree **T7** extends beyond the temporary barrier and existing boundary fence and into the area proposed for a hard surface turning point; it should be noted that this area is currently utilised by vehicles, and the proposed surface will be built up upon this existing surface. In addition, it is understood that the finished surface will be stone chippings, which will allow the continued diffusion of soil moisture, air and nutrients to the tree roots.

- 4.2.4. Please see *Appendix 4* for suggested barrier construction detail. It is recommended that in this instance the protective barrier shown in *Figure 1* would be appropriate. The suggested location for protective fencing is shown on the *Tree Protection Plan (Drawing 2)*.

- 4.3.1. It is recommended that for the hard surface adjacent to tree **T7** this area is constructed using a no-dig method of construction; the suggested method for this can be found at *Appendix 5*.
- 4.3.2. The removal of any existing hard surface must be carried out in a cautious fashion avoiding the use of heavy machinery where possible. Any tree roots exposed within the RPA must be left as intact as careful digging with hand tools will allow.
