Re: BT Repeater Station, Manchester Road, Longhill, Fernilee, Buxton, SK17 6ST

This report is a Brief Building Survey in accordance with a request by the loan facilitator's Chartered Surveyors, Edward Cooper Young. I spoke to Stuart Sherwood (Chartered Surveyor) of the aforementioned firm and confirmed that my report will be suitable for their purposes and can be used by their firm in formulating their report and advice to their clients your loan facilitator.

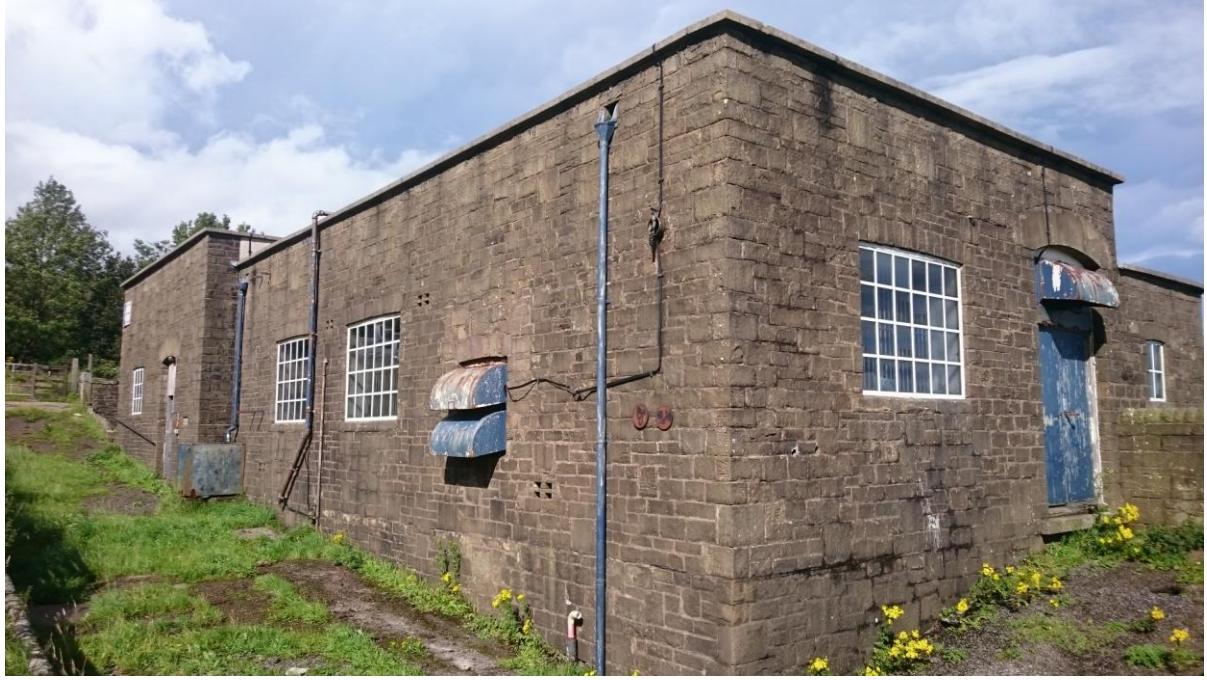
The property is in good structural order with historic settlement cracks to the lower south east corner.

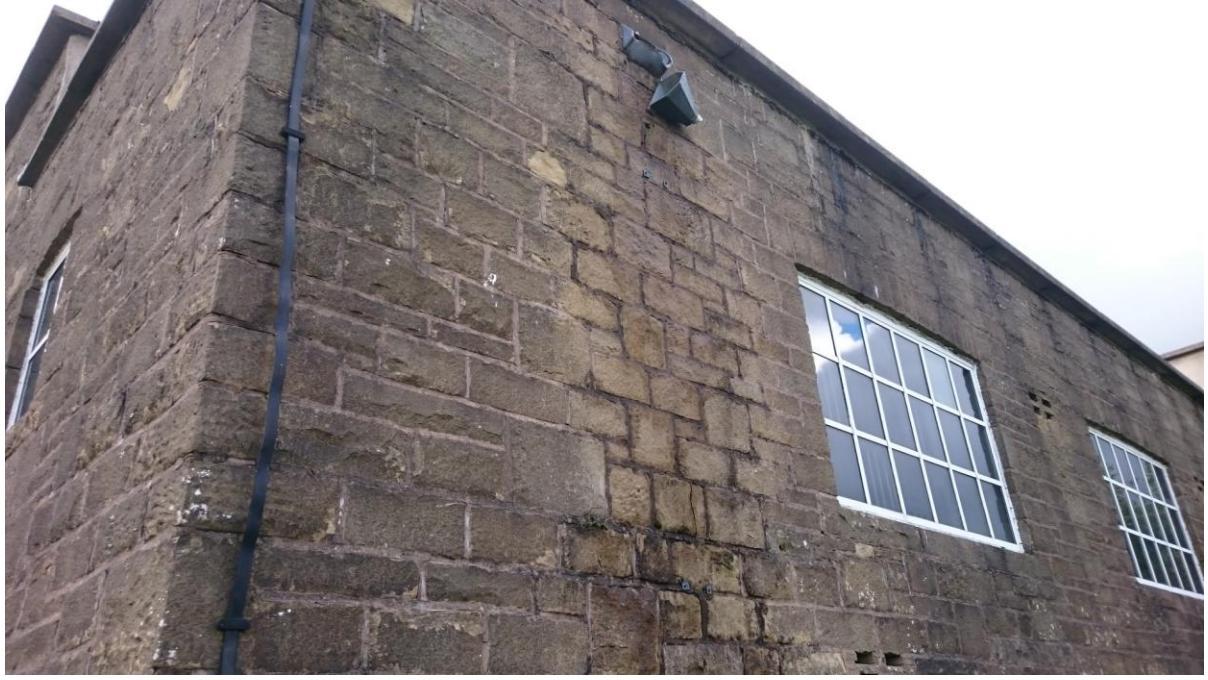
There is a missing downspout to the south corner of the building that is causing damp penetration into Room 4.

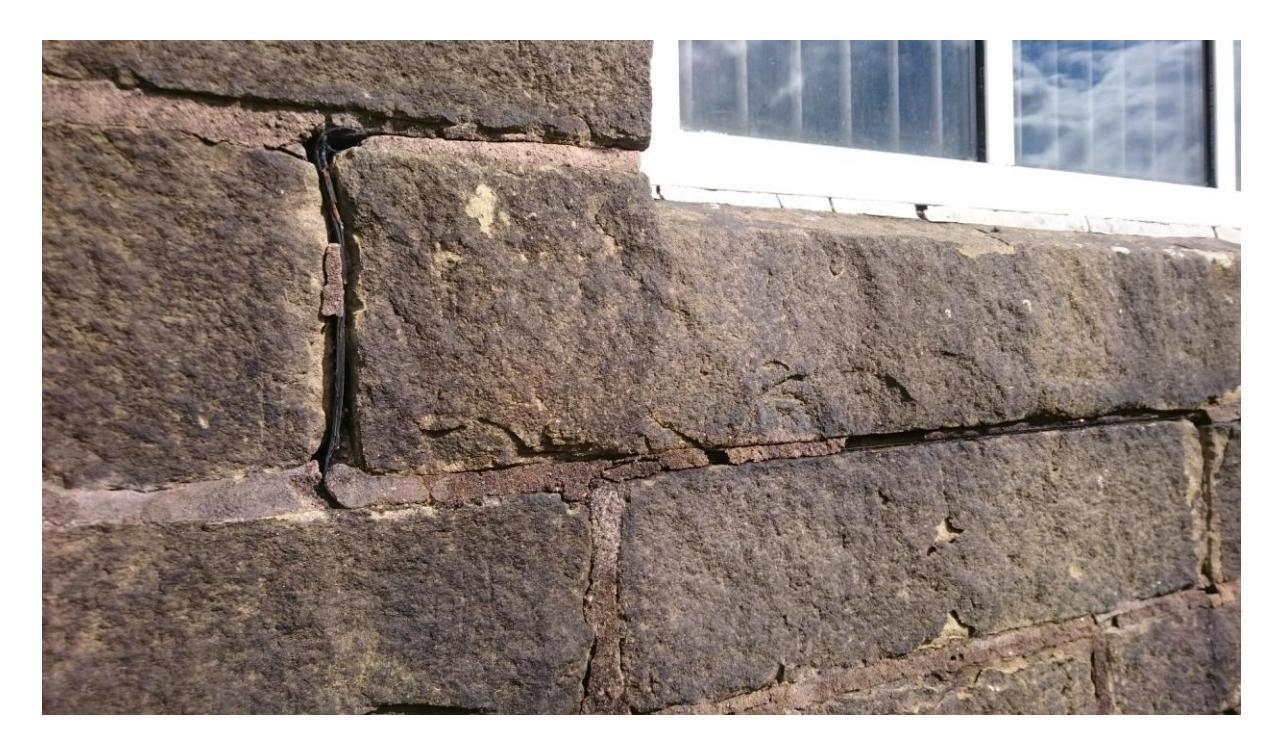
There has been damp ingress under the east and south facing windows of Room 3 which has been remedied by the insertion of a damp proof membrane under the stone sills as shown in the photograph. Dampness is still penetrating the structure beneath the south window. This requires the replacement of the window and resealing to its reveals and an inspection of the damp proof membrane to ensure that it is shedding water out of the structure.

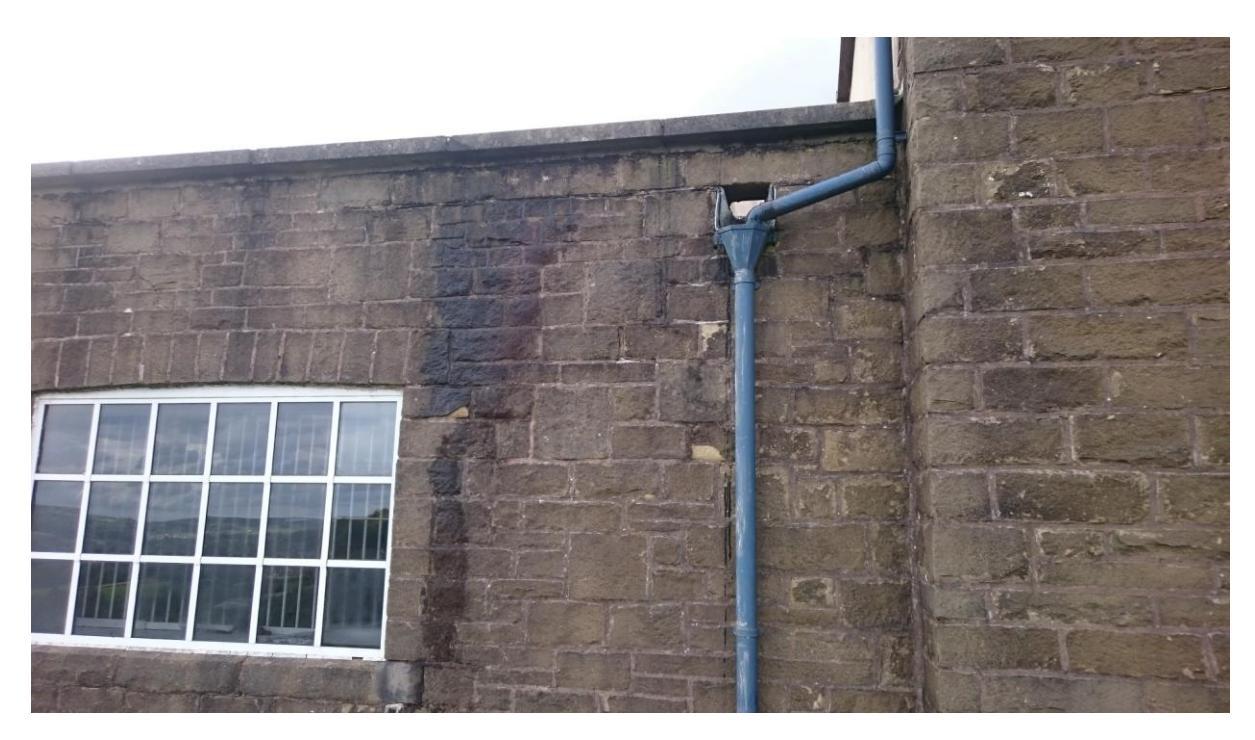
There are parapet walls with concrete flags beneath which are damp proof membranes. Pointing of these flags is required to prevent water running down the stone faces for they should shed water away from the structure.

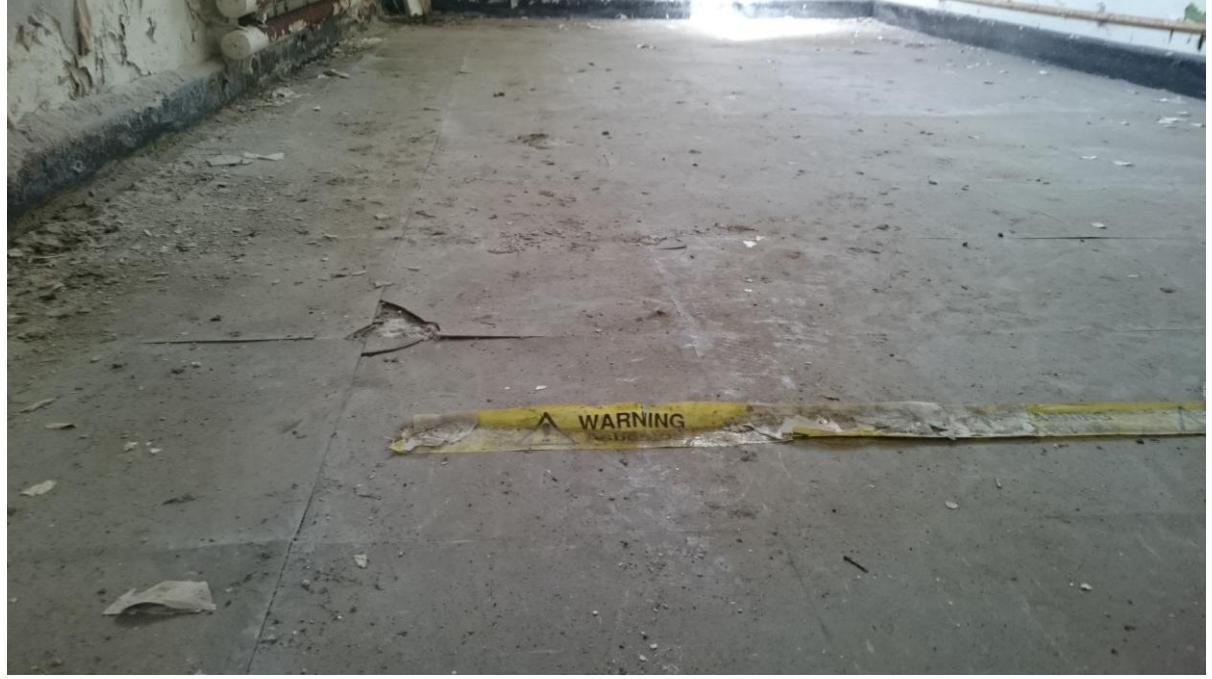
I found the presence of asbestos containing material in the entrance lobby and Room 1. The asbestos is contained within bitumen vinyl tiles to the floor. These tiles can be easily removed and disposed of to specialist waste transfer station site.

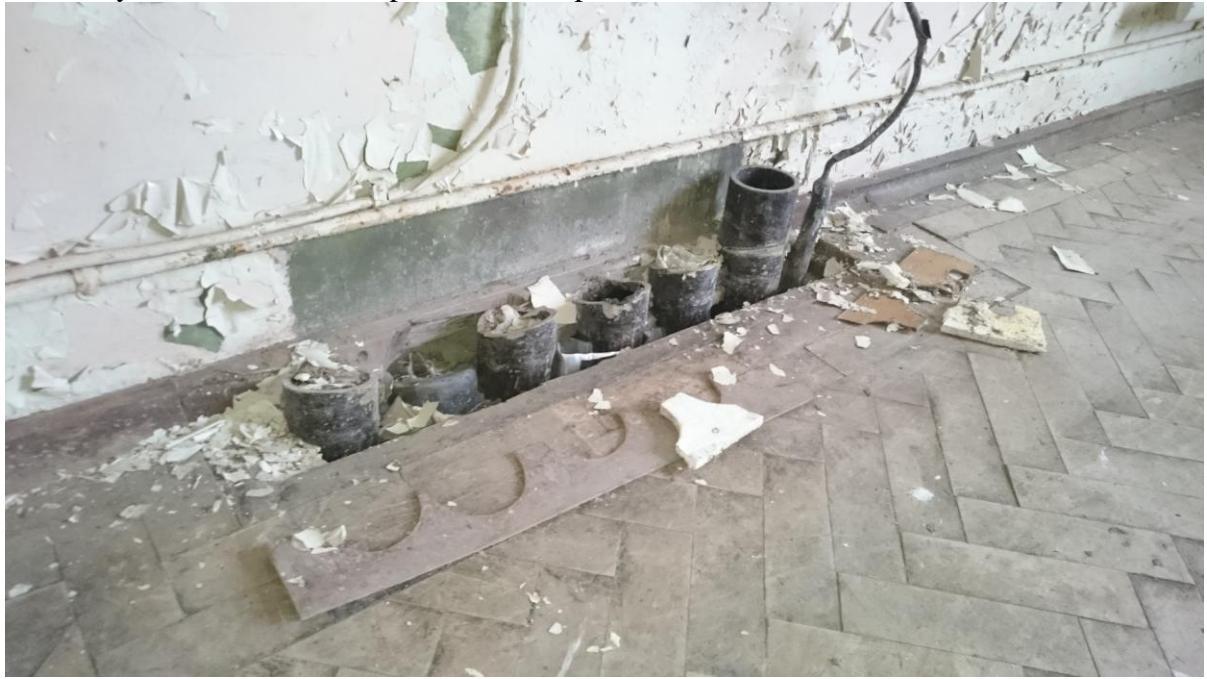
Asbestos cement ducting was present to the floor in Room 2 to its northern wall. This ducting can easily be removed and disposed of to a specialist waste transfer station site.
