Consultant's Advice Note – Derby House

Structural Condition Report

Consultant's Advice Note – Derby House – Final Option

Structural Commentary to Conversion Proposal

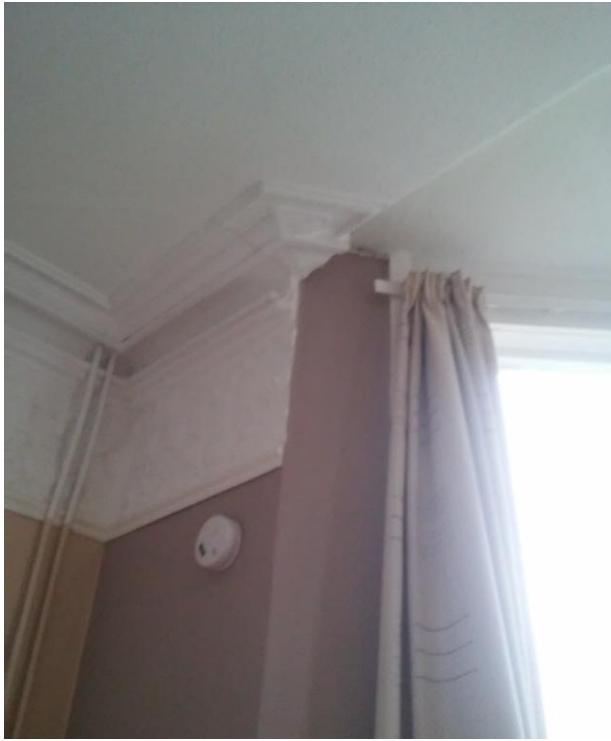
NW corner at first floor– possible evidence of penetrating damp or condensation

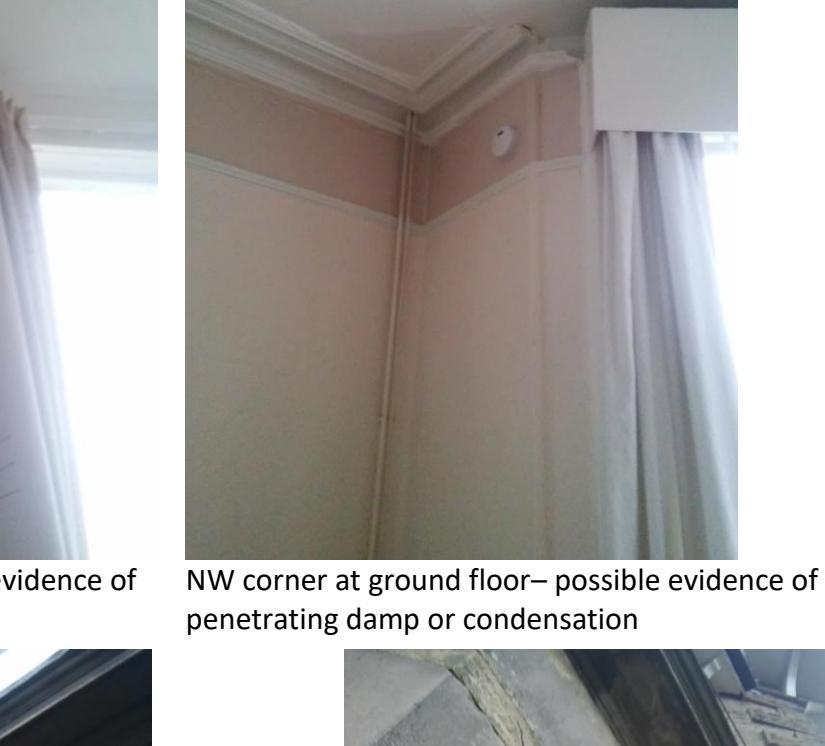
Recent patch repairs to bay window butt joint

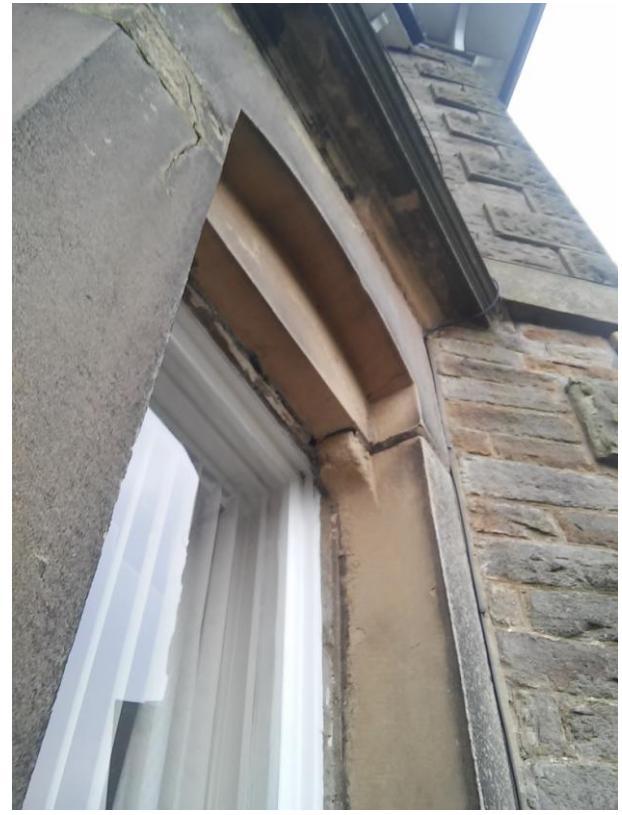
Displaced stone masonry units and cracking to bay window

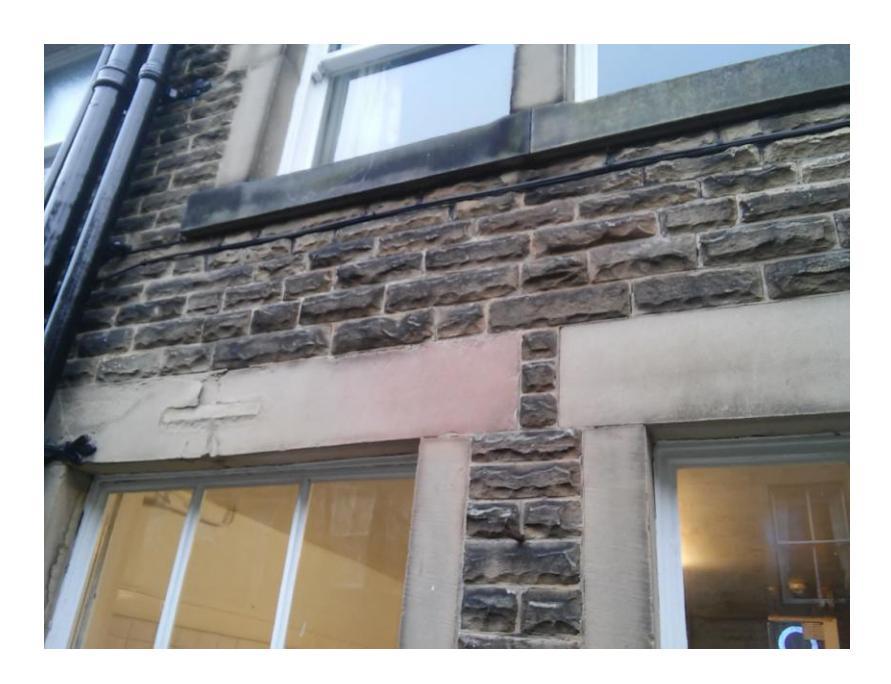
Recent mortar fillet cosmetic repair to butt joint at first floor bay window end mullion

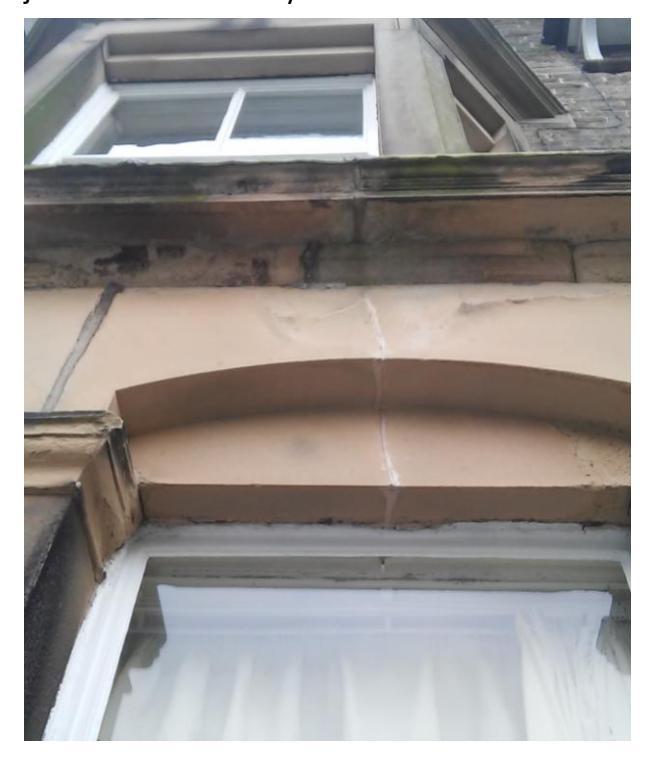
Cracked lintel to squared bay below point load from offset mullion above (splayed bay)

Stitch repair to cracked stone lintel. Note cosmetic paint coating has de-bonded

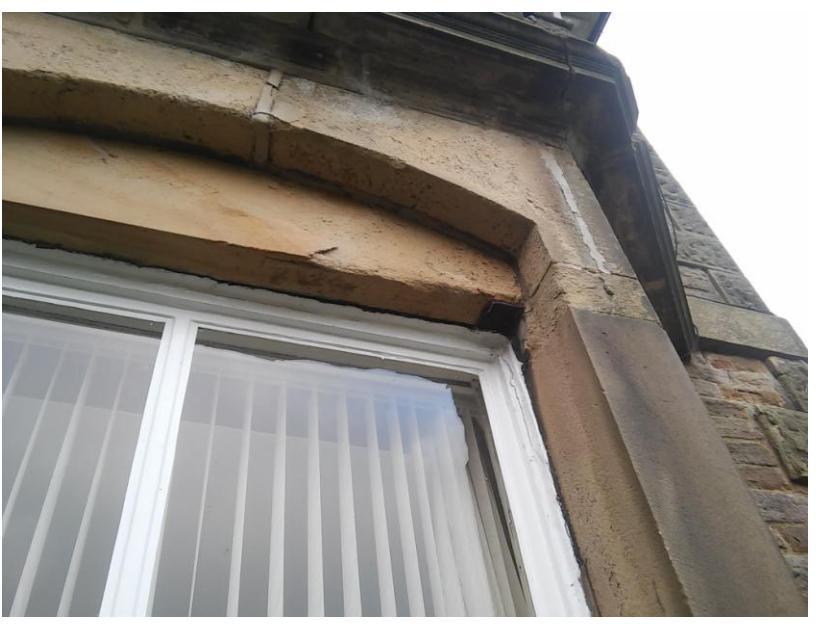
Superficial erosion and mortar repairs to north elevation splayed bay lintel
