British Standard 5837: 2012 – Trees in Relation to Design, Demolition and Construction – Stage One & Two Report:

Tree Schedule Tree Constraints Plan Arboricultural Impact Assessment

November 2020

**Taxal Edge,
Macclesfield Road,
Whaley Bridge,
Derbyshire,
SK23 7DR**

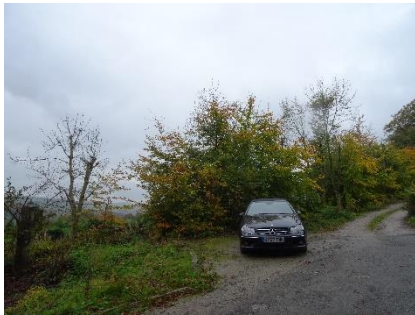
Mixed Group (G3)

Tree and Tag No Species	Hght (m)	Stems		Crown		Age	RP A (m ²) R (m)	Phys Condition	Structural Condition	Preliminary Recommendations Survey Comment	Cat ERC		
		No	Ø (mm)	Spread (m)	Clear (m)								
G3													
A Group --	0	1					A: 0 R: 0	Fair	C: S: B:	See Comment :: Unspecified Vaguely linear, fragmented, mixed species group of young trees located on both sides of boundary wall to the east of the site. Species comprise beech, holly, rowan, birch, alder, ash and sycamore, with undergrowth of mostly bramble. Several trees have been previously 'topped' at 4m to 6m. Ash trees are exhibiting advanced infection of Chalara ash dieback (Hymenoscyphus fraxineus). Recommend remove stems within the site boundary and replace with linear planting of trees with the intention of managing as a hedge. See Arboricultural Impact Assessment.	C.2 10 to 20 yrs		
G5													
A Group --	0	1					A: 0 R: 0	Good	C: S: B:	No action :: Unspecified Linear group of young holly located along north eastern boundary of the site. Previously 'topped' at 2m, top of regrowth currently approximatley 4m. Forms effective screening between properties.	B.2 20 to 40 yrs

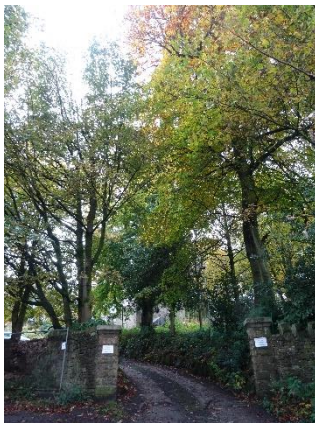
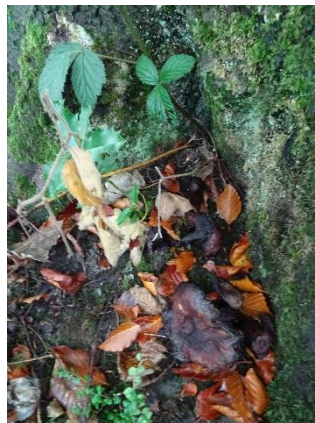
Beech (T4)

T4												
Common Beech <i>Fagus sylvatica</i>	24	1	930	N	7	2	M	A: 391.3 R: 11.16	Fair	C: Fair S: Fair B: Fair	See Comment :: Unspecified Located immediately west of entrance to driveway, to the north east of the site. Fine mature tree. Retaining wall within 3m of main stem. Historic construction of driveway within rooting area. Annual fungal fruiting body at base of main stem, to the north east. Fruiting body in poor condition, heavily discoloured and degraded making accurate identification not possible (see photos). Possibly <i>Armillaria</i> species, but unlikely <i>Armillaria mellea</i> due to lack of ring on stipe. Main stem bifcates at 8m, with open union. Minor deadwood throughout crown. Some apparent reduction in physiological condition, minor crooking of shoot tips. Recommend annual formal inspection and regular informal checks regarding condition and presence of fresh fungal fruiting bodies. Recommend clear surrounding vegetaion within 1m of main stem to facilitate future inspections of base of main stem.	A.1.2 20 to 40 yrs

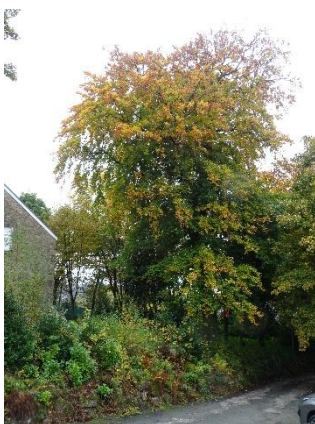
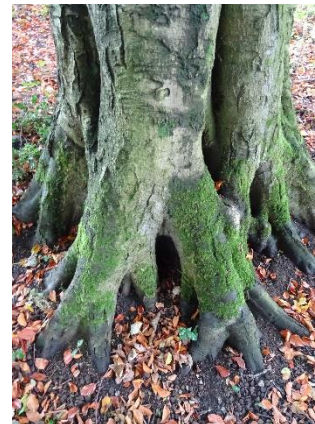
Beech (T13)

Tree and Tag No Species	Hght (m)	Stems		Crown		Age	RP A (m ²) R (m)	Phys Condition	Structural Condition	Preliminary Recommendations Survey Comment	Cat ERC	
		No	Ø (mm)	Spread (m)	Clear (m)							
T12												
Sycamore <i>Acer pseudoplatanus</i>	14	1	270	N	3	5	Y	A: 33 R: 3.24	Fair	C: Poor S: Fair B: Fair	No action :: Unspecified Located within treed area to north east of existing garage. Heavily suppressed by adjacent beech. Extensive squirrel damage throughout. Minor deadwood throughout crown.	C.2 10 to 20 yrs
T13												
Common Beech <i>Fagus sylvatica</i>	25	1	1070	N	6	6	M	A: 518 R: 12.84	Fair	C: Fair S: Fair B: Fair	See Comment :: Unspecified Located within treed area to north east of existing garage and immediately west of driveway. Fine mature tree. Retaining wall within 3m of main stem. Historic construction of driveway within rooting area. Main stem trifurcates at 8m. Main stem slight lean to the west. Minor deadwood throughout crown. Apparent reduction in physiological condition, crooking of shoot tips of upper crown. Lower and inner crown, however, appears full and with good vitality. Past inspections include sounding with nylon mallet and use of a microdrill which suggests minor and localised decay of buttress roots. No fungal fruiting bodies were present at any of my site visits. Recommend annual formal inspection and regular informal checks regarding condition and presence of fungal fruiting bodies. Recommend to crown lift to clear 5m over drive. Climber to report any defects which may not be visible from ground level inspection.	A.1.2 20 to 40 yrs

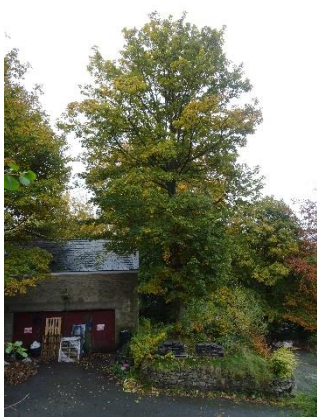
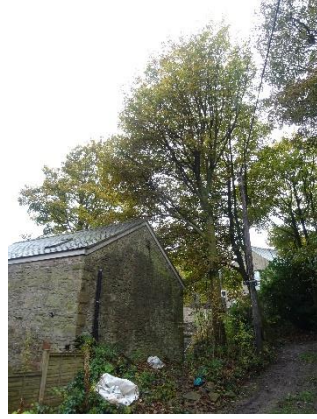
Sycamores (T14 – T17)

Tree and Tag No Species	Hght (m)	Stems		Crown		Age	RP A (m ²) R (m)	Phys Condition	Structural Condition	Preliminary Recommendations		Cat ERC
		No	Ø (mm)	Spread (m)	Clear (m)					Survey Comment		
T15												
Sycamore <i>Acer pseudoplatanus</i>	15	1	410	N	4	6	SM	A: 76.1 R: 4.92	Fair	C: Fair S: Fair B: Fair	No action :: Unspecified Located immediately north west of existing garage. Grown on boundary wall with compromised rooting area. LV power line within 1m of main stem, tree previously heavily pruned to provide clearance, resulting in asymmetric crown which is also within 0.5m of roof of existing garage. Minor deadwood throughout crown. Minor leaf infection by tar spot (<i>Rhytisma acerinum</i>). In my opinion, this tree is likely inappropriate for retention in the context of the proposed development. See Arboricultural Impact Assessment.	C.2 10 to 20 yrs
T16												
Sycamore <i>Acer pseudoplatanus</i>	15	1	410	N	3	6	SM	A: 76.1 R: 4.92	Fair	C: Fair S: Fair B: Fair	No action :: Unspecified Located to the west of existing garage. Immediately west of and contacting boundary wall. LV power line within 1m of main stem, tree previously heavily pruned to provide clearance, resulting in asymmetric crown. Minor deadwood throughout crown. Minor leaf infection by tar spot (<i>Rhytisma acerinum</i>). In my opinion, this tree is likely inappropriate for retention in the context of the proposed development. See Arboricultural Impact Assessment.	C.2 10 to 20 yrs

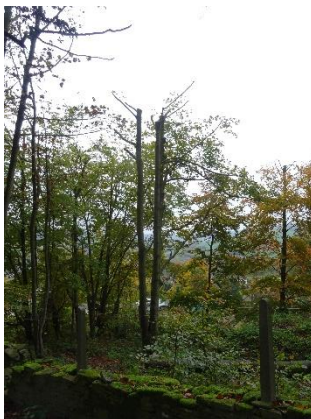
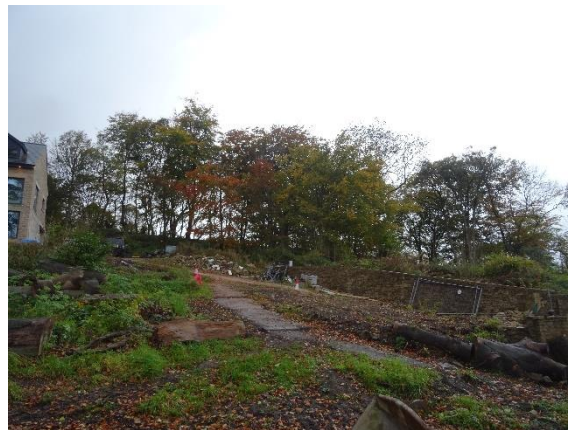
Mixed Group (G22)

Tree and Tag No Species	Hght (m)	Stems		Crown		Age	RP A (m ²) R (m)	Phys Condition	Structural Condition	Preliminary Recommendations		Cat ERC	
		No	Ø (mm)	Spread (m)	Clear (m)					Survey Comment			
G22													
A Group --	0	1					A: 0 R: 0	Fair	C: S: B:	No action :: Unspecified		C.2 20 to 40 yrs	
G25													
A Group --	0	1					A: 0 R: 0	Good	C: S: B:	No action :: Unspecified		B.2 20 to 40 yrs	
T1													
Sycamore <i>Acer pseudoplatanus</i>	14	4	600 (Eq)	N	4	3	SM	A: 163.1 R: 7.2	Good	C: Good S: Fair B: Fair	No action :: Unspecified	C.2 20 to 40 yrs	
Age Classifications:		N	Newly planted	EM	Early Mature	Condition:		C	Crown	Stems:		Ø	Diameter
		Y	Young	M	Mature			S	Stem			(Eq)	Equivalent stem diameter using BS5837:2012 definition
		SM	Semi-mature	OM	Over Mature			B	Basal area	ERC:			Estimated Remaining Contributio

- Group 22 – immediately to the west of plots 6 & 7
- 9.5 Tree Planting and Woodland Management:** I recommend that details of the landscape planting plan and the woodland management plan are finalised in reserved matters / planning conditions / planning agreements.

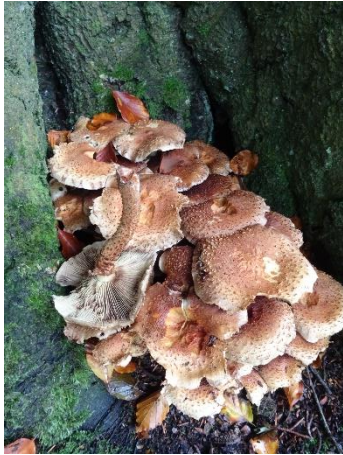
Beech (T26)

Tree and Tag No Species	Hght (m)	Stems		Crown		Age	RP A (m ²) R (m)	Phys Condition	Structural Condition	Preliminary Recommendations Survey Comment	Cat ERC	
		No	Ø (mm)	Spread (m)	Clear (m)							
T26												
Common Beech <i>Fagus sylvatica</i>	26	1	1160	N	10	6	M	A: 608.8 R: 13.92	Fair	C: Good S: Fair B: Fair	See Comment :: Unspecified Located to the south west of the existing detached dwelling, forms group with adjacent mature beech to the west. Fine mature tree. Annual fungal fruiting body at base of main stem, between buttresses to the north. Likely shaggy scaly cap (<i>Pholiota squarrosa</i>), although not confirmed. Area of minor bark dysfunction on the main stem, to the west, mostly covered by calous growth. Single straight stem to crown break. Dominant tree of the group, and closest to the existing detached dwelling. Minor deadwood throughout crown. Some apparent reduction in physiological condition, minor crooking of shoot tips. Recommend annual formal inspection and regular informal checks regarding condition and presence of fungal fruiting bodies. Recommend prune to reduce heavy lateral branches extending to the north through to the north east by approximately 2m.	A.1.2 20 to 40 yrs
