## **Protected Species Surveys**

## **85 and 87 Green Lane, Buxton**

### **Derbyshire**

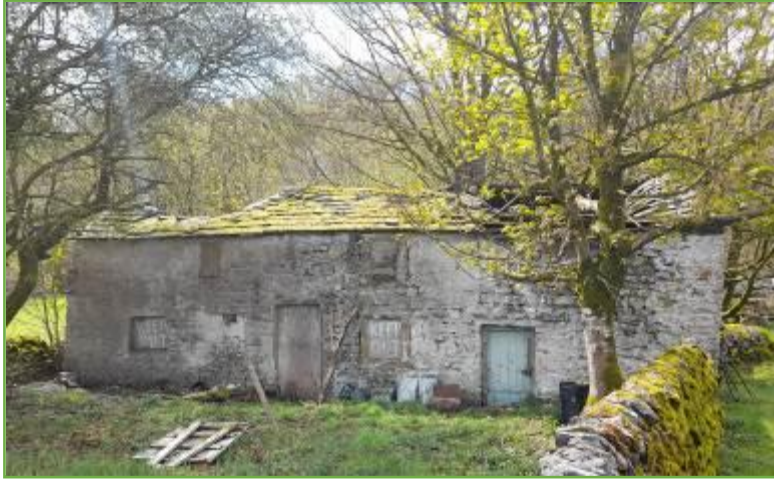
During the updated building assessment in May 2021 no evidence of bats was recorded externally. No access was possible to the interior of either building due to health and safety concerns with large sections of both pitched roofs collapsed along with first floor joists through years of water ingress. The interior of the buildings (85 and 87 Green Lane) were well illuminated through collapsed sections of roof and unglazed windows. Observations during the survey revealed the interior of both buildings to be very damp as a result of the deterioration. No external evidence of occupation by bats was identified during the survey.

**Picture 1: Front view showing extent of damage**

However, as a precautionary approach the remaining sections of roof should be removed under supervision by an Ecological Clerk of Works (ECoW) with all cavities again checked by the ECoW with the use of an endoscope. Once completed the building will be left in situ for 24 hours before the remaining works are completed.

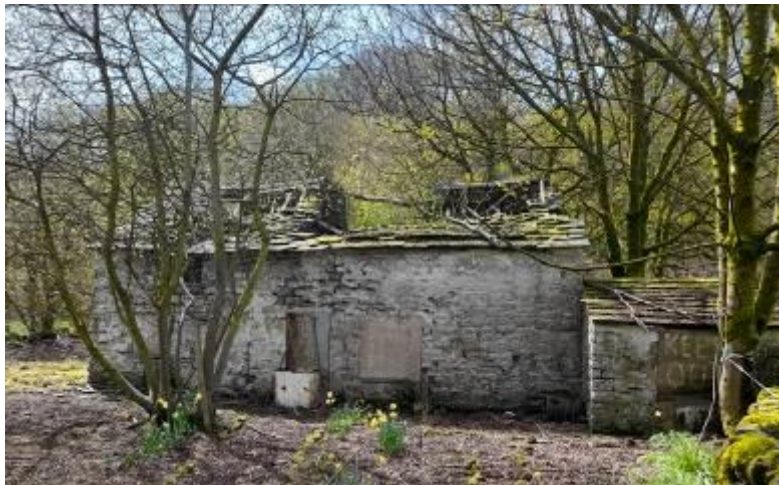
**Picture 2: showing surrounding tree cover and roof damage**

It is considered both 85 and 87 Green Lane are likely to further decrease in suitability for roosting bats and potential collapse if left in situ. During the updated building assessment no evidence of bats was observed. Although bat droppings can often be hidden in cavities the buildings are largely shaded by adjacent tree cover and damp and therefore unlikely to be utilised by bats since the previous 2018 nocturnal survey.

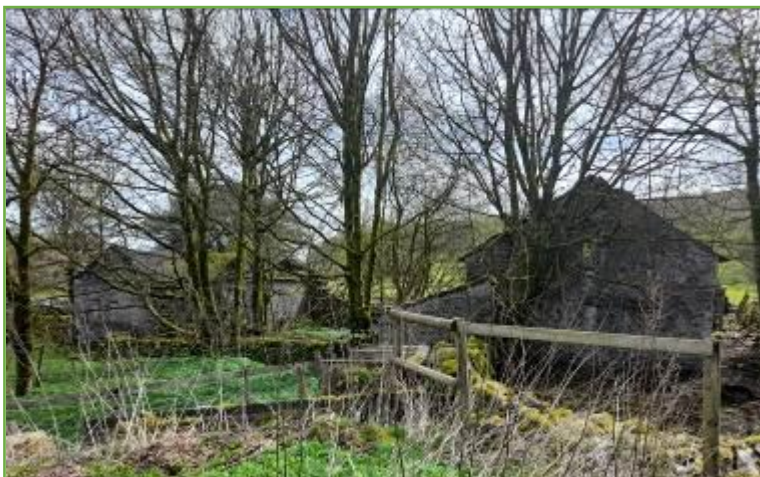
**Picture 3: View showing 85 and 87 Green Lane and extent of tree cover**

Any updated nocturnal survey is unlikely to provide any significant difference with both buildings being in a poor state of repair and open to water ingress, and continual damp conditions as a result of the overhanging tree canopy and collapsed sections of roof. As such it is considered any updated nocturnal survey would be disproportional based on the results of the 2021 building assessment.
