**BAT SURVEY REPORT (UPDATE)**

**BUCKINGHAM HOTEL**

**BUXTON**

| Report Title: | Bat Emergence and Activity Survey (update) |

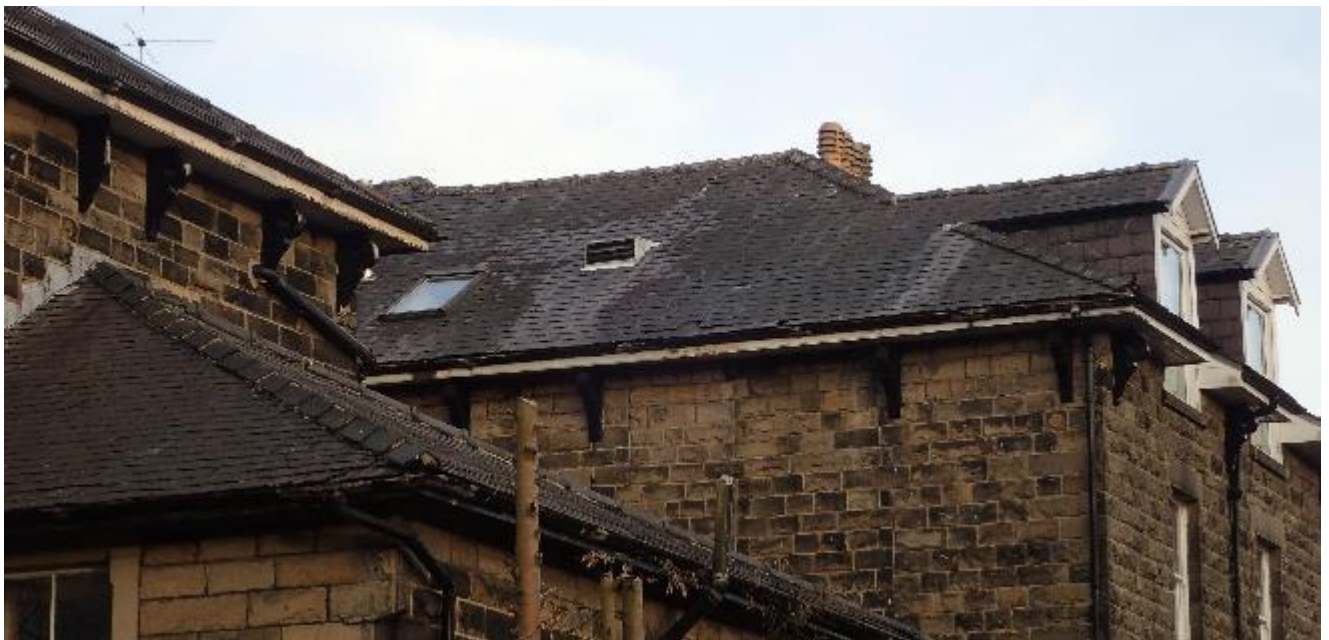
The ridges and hips are covered with stone ridge tiles and gaps could be seen underneath these tiles particularly among the complex of roofs at the west aspect. There is potential for bats to access these gaps and roost along the ridge beam or the underside of the tiles.

*Photograph 4: Roofs at west aspect and rear of Buckingham Hotel where numerous gaps were identified beneath the ridge tiles*

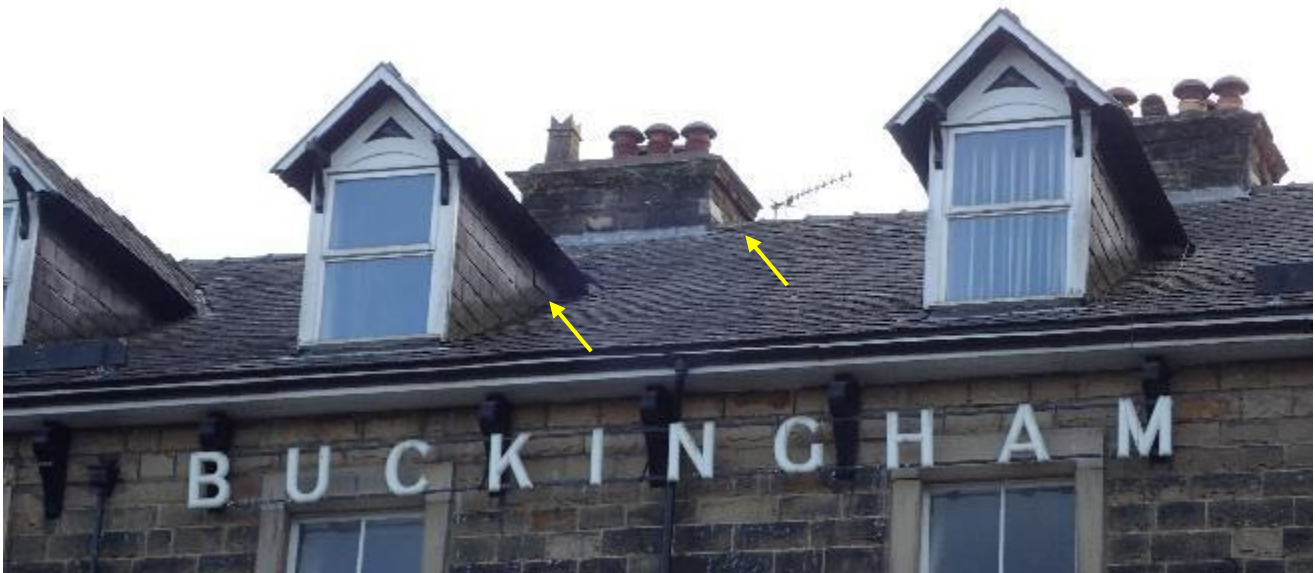
The slate roof covering and the slates cladding the sides of dormer windows have numerous crevices with potential to support crevice dwelling bat species such as the Pipistrelles.

Photograph 5: West aspect of Buckingham Hotel with gaps noted underneath raised slates

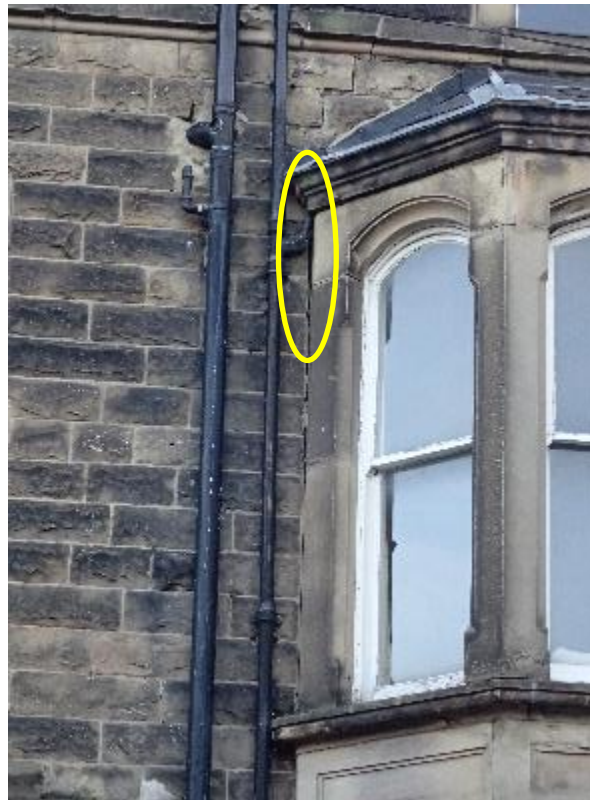
The stonework in the main is in good condition however some areas of missing mortar were noted at the east elevation.

Photograph 6: East elevation of Buckingham Hotel with gap indicated in stonework adjacent to bay window

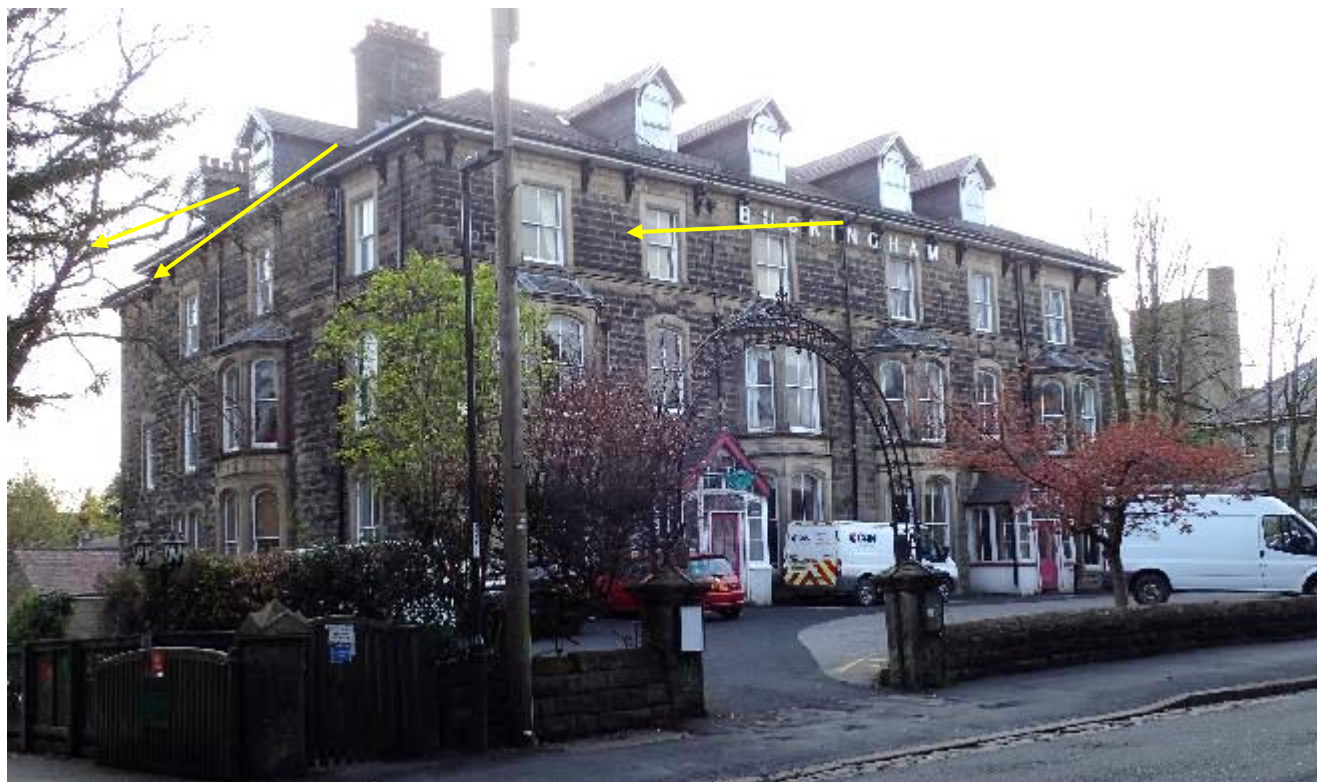
Three bats, all Common Pipistrelles were observed emerging from the south pitch roof at 21:11, 21:31 and 21:33 by the surveyor positioned at the south east corner. Two of the bats emerged from between the two dormers situated on the south side of the building and the third bat emerged from east side of the east dormer.

Photograph 7: Annotated photograph of east and south aspects of Buckingham Hotel with emergence points indicated
