LAND OFF CORBAR ROAD AND THE COACH  
HOUSE, BUXTON

PRELIMINARY ROOST ASSESSMENT AND  
GROUND LEVEL TREE ASSESSMENT FOR BATS

April 2026

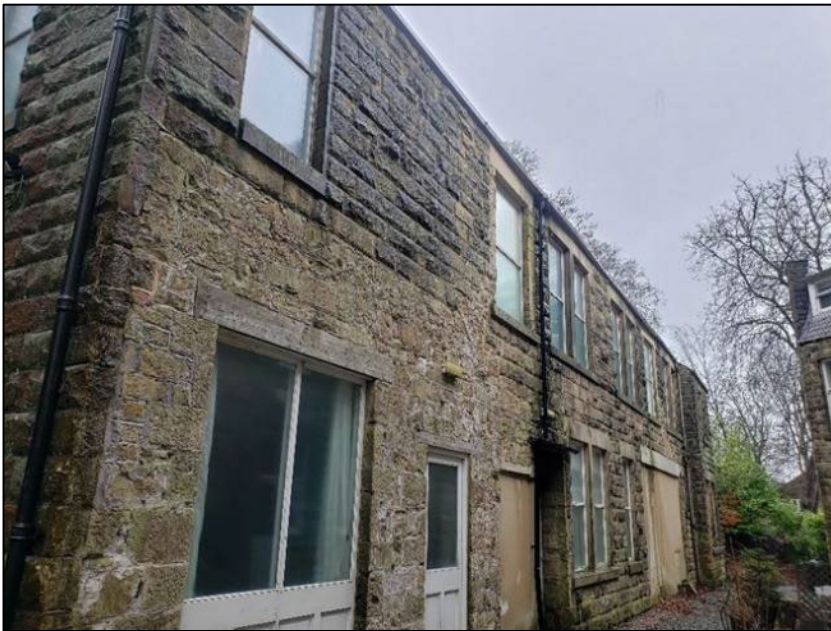
- 3.5 The Coach House is a two-storey, stone building in moderate condition with multiple signs of wear and damage to the walls, roof edges and roofs (Photograph 1, Appendix 2). There are some single storey sections to the main structure.

**Photograph 1**  
**The Coach House southern elevation**

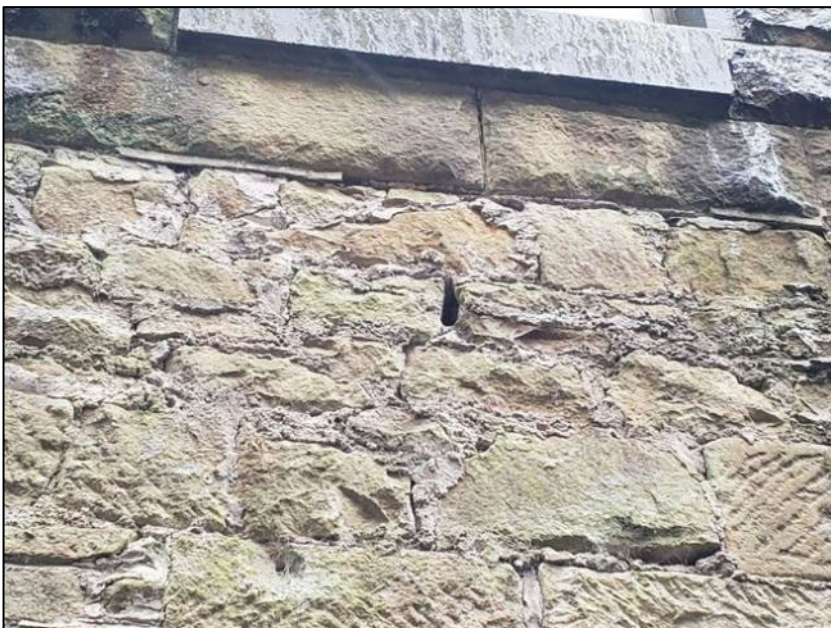
**Photograph 2**  
**A section of missing mortar within the southern elevation stonework**

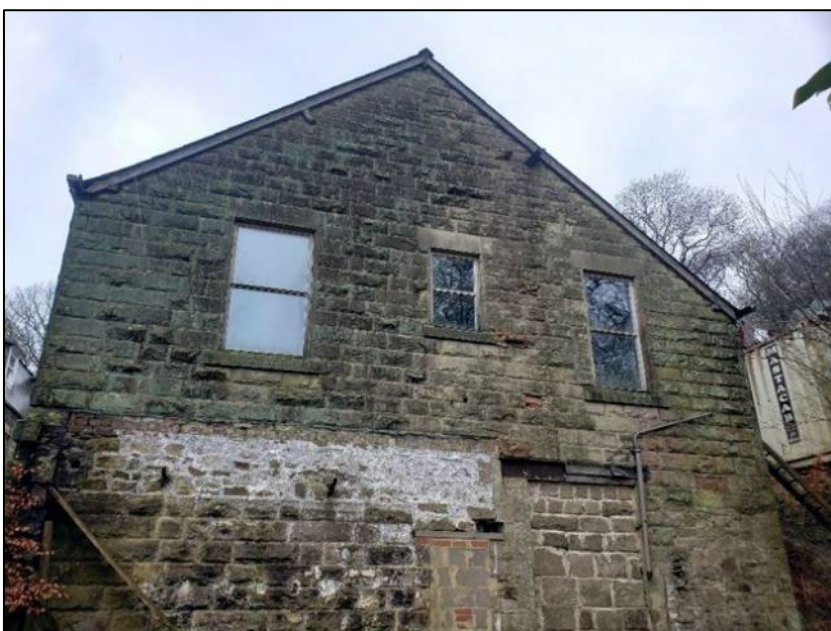
**Photograph 3**  
**Showing the evidence of a previous extension on the eastern elevation and the associated gaps along with gaps and crevices at the gable behind the bargeboard**

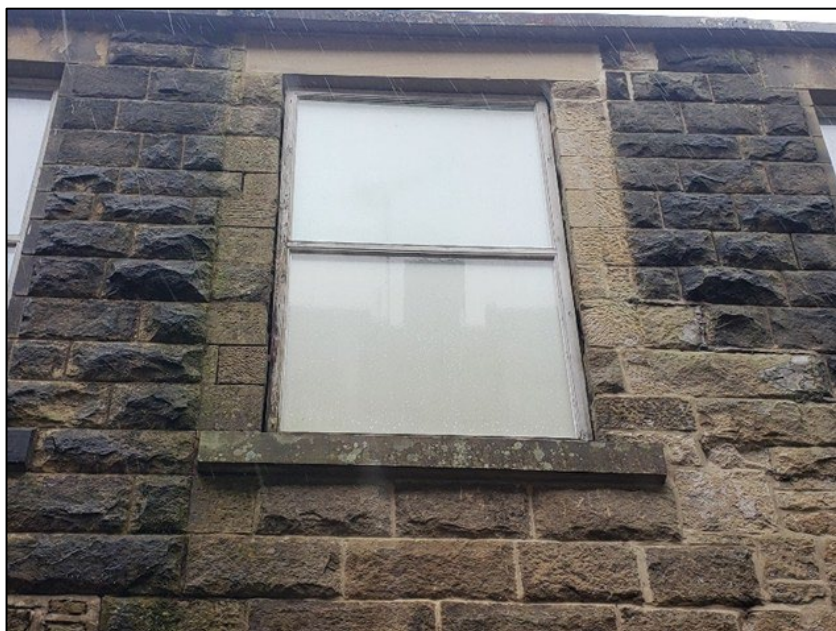
**Photograph 4**  
Showing evidence of more recent works to first-floor windows, with surrounding small gaps and the associated newer masonry

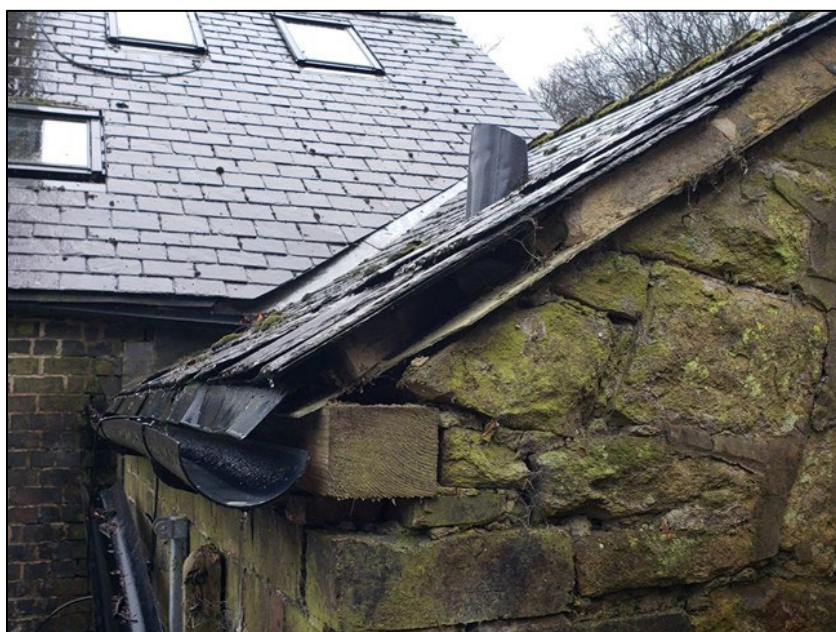
**Photograph 5**  
Small split-level section on the northern elevation which shows an example of the condition of the roof edges at the gables of the building

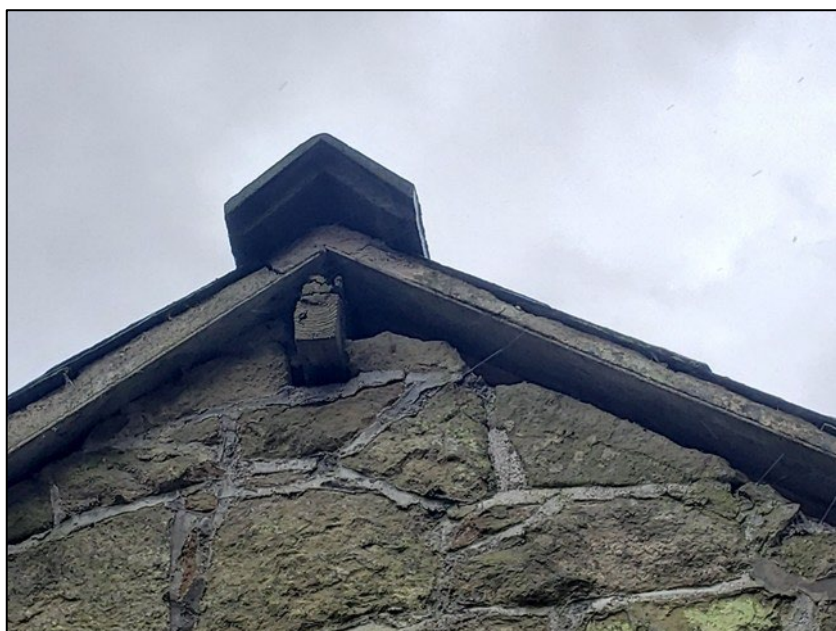
- 3.8 The roof edges provide multiple potential access points for bats. The roof edges at the northern and southern elevations (not gables) feature possible access points under areas of gutters, however, visibility was not suitable to provide confirmation of this. The eastern and western elevations which feature gables, as well as the small split-level section on the northern elevation (Photograph 5), provide many potential access points. The roof edges feature multiple areas of missing mortar as well as areas where the roof board and purlins extend out of the wall to the exterior of the building and provide potential access points at the edges or where the wood has rotted away (Photograph 6).

**Photograph 6**  
Showing the roof edge of the single-storey, split-level section on the northern gable of the Coach House with the missing mortar and exposed roof board

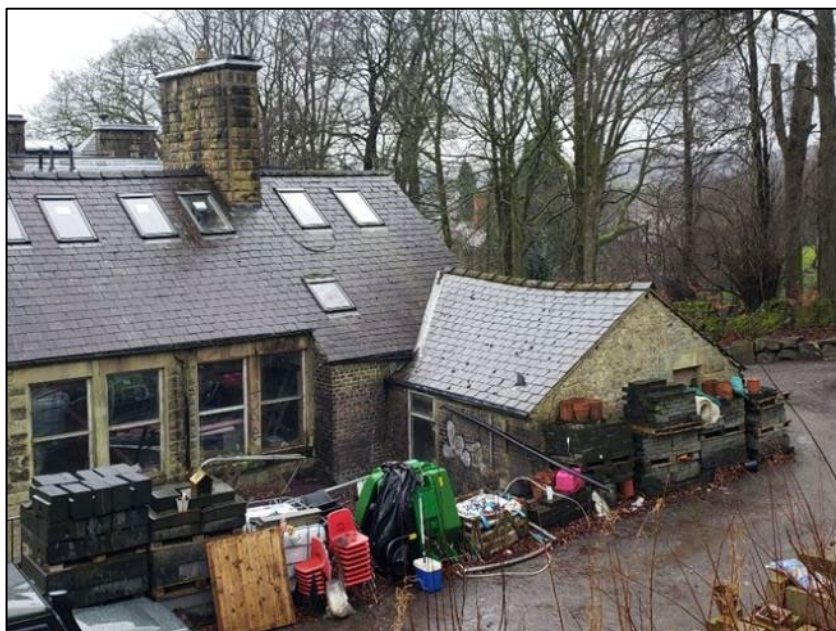
- 3.9 The roof of the building appears to be in moderate condition with some areas of lifted, cracked, or missing tiles (Photograph 7). The building also features several lifted ridge tiles which could provide potential access or roosting for bats (Photograph 8). The roof valleys appear to be in good condition with the lead flashing intact and in place. The lead flashing surrounding the chimney stack is partially lifted and could provide a potential access point.

- 3.10 Skylights are present along the length of the northern elevation roof (Photograph 7). These skylights are largely in good condition and are well-sealed to the surrounding roof, however, the third skylight from the eastern edge of the roof features a lifted section at the base which could provide bat access or roosting potential (Photograph 9).

**Photograph 7**  
**Showing the northern elevation roof with some missing or cracked tiles visible on the (smaller) split-level section**

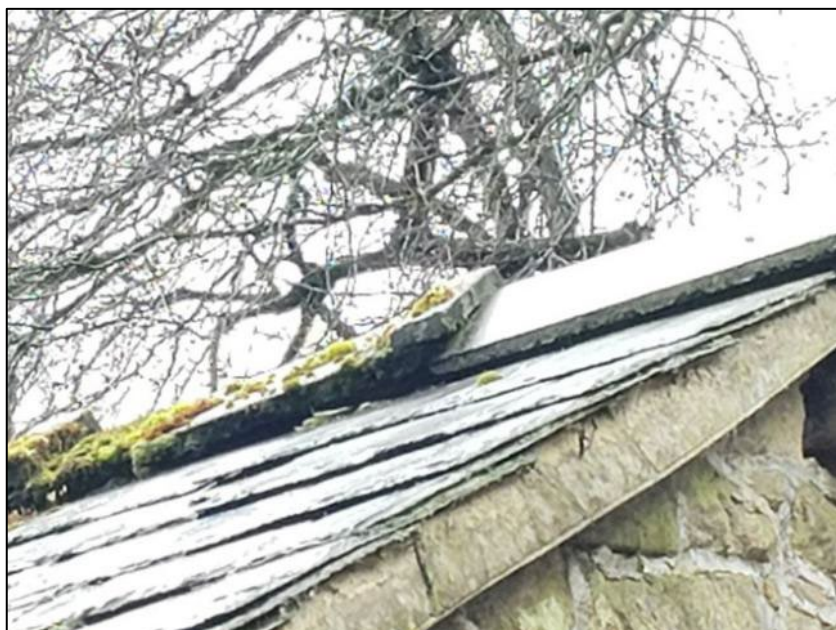
**Photograph 8**  
**Showing a lifted ridge tile on the roof of the split-level section on the northern elevation**

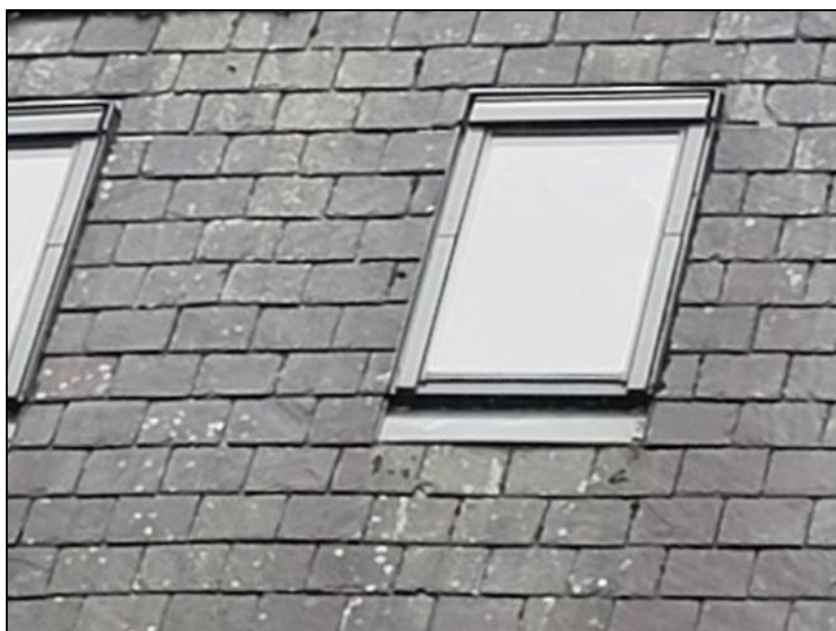
**Photograph 9**  
**Showing an area at the base of the skylight on the main roof, which is lifted away from the roof tiles**

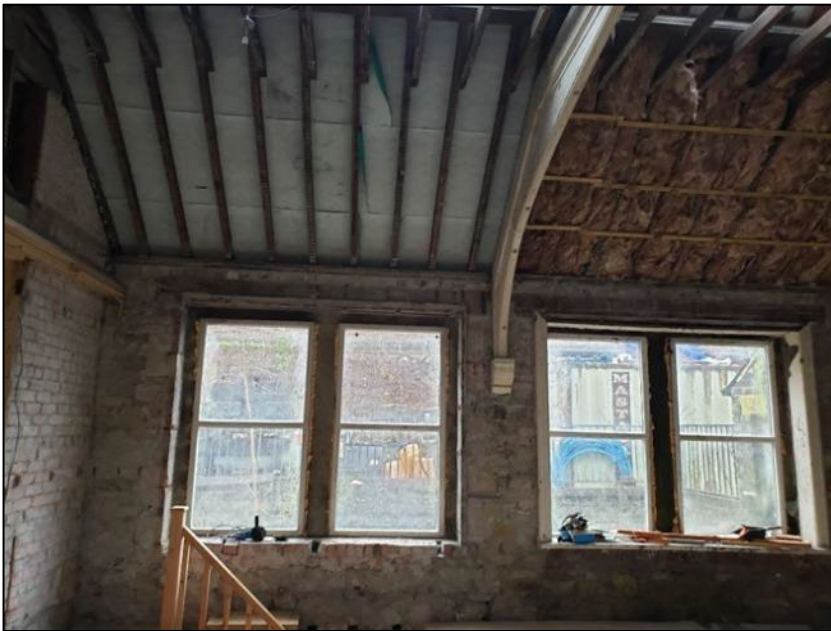
**Photograph 10**  
Showing the exposed masonry and exposed roof lining and insulation of the first floor

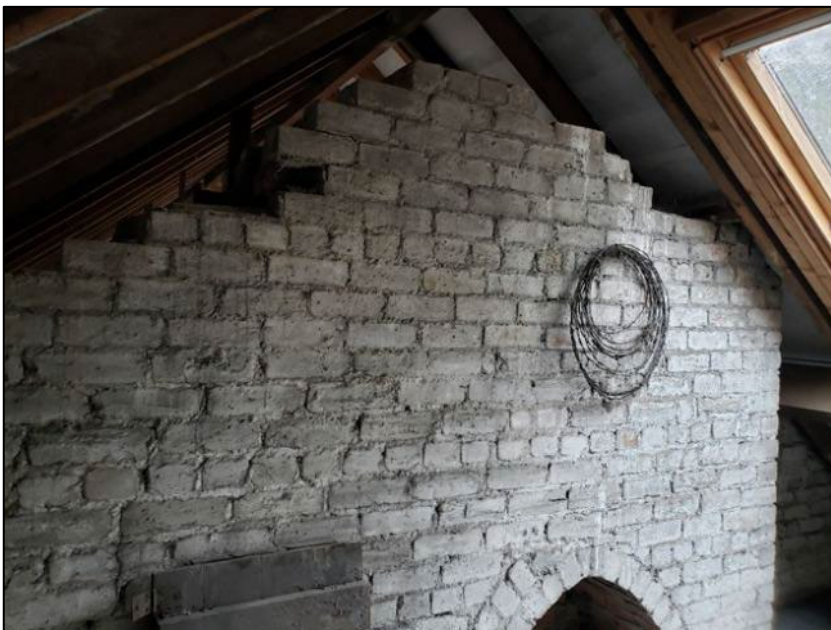
**Photograph 11**  
Showing the open void above the eastern rooms allowing access from the void into the rest of the first floor rooms

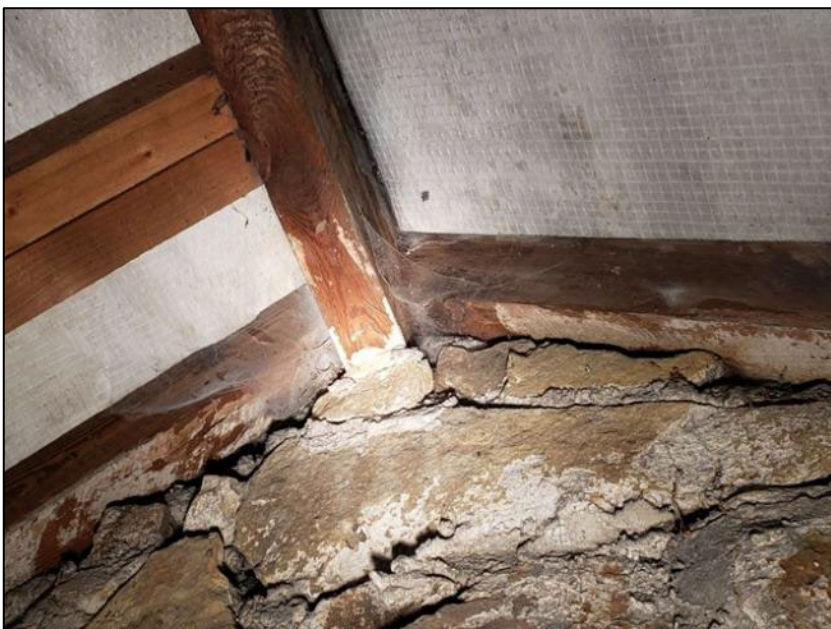
**Photograph 12**  
Showing the potential access point at the interior of the eastern gable apex

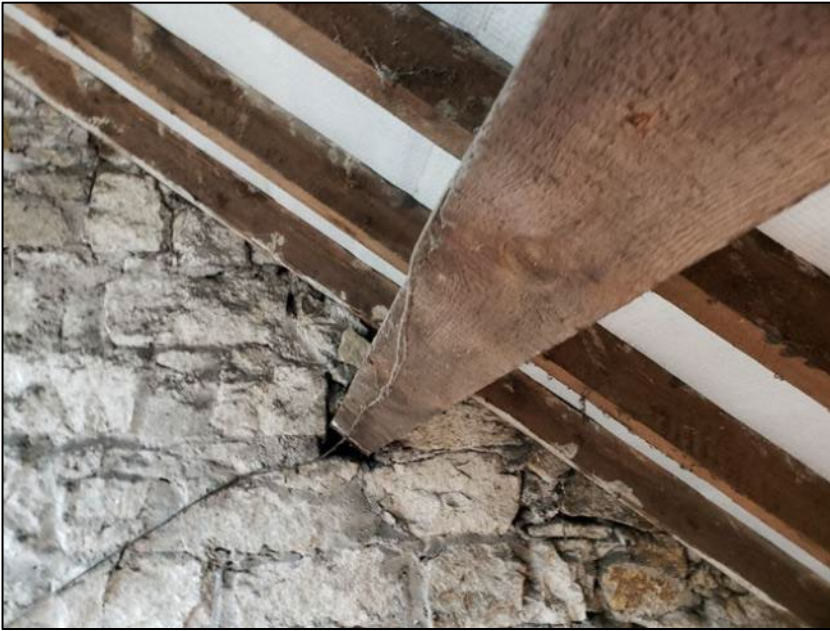
**Photograph 13**  
**Showing the potential access**  
**point around the roof purlin**  
**on the eastern gable**

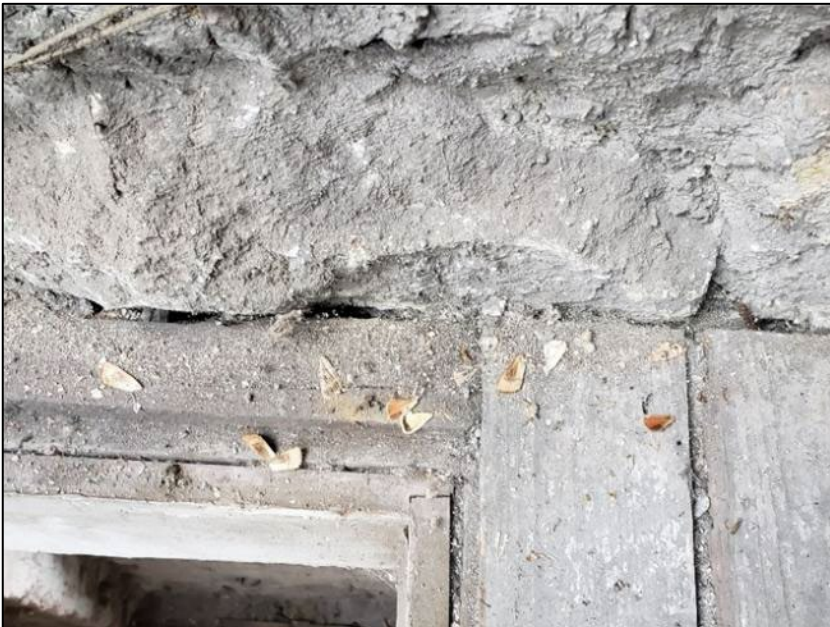
**Photograph 14**  
**Showing the accumulation of**  
**feeding remains within the**  
**eastern gable void, likely**  
**from a yellow underwing**  
**moth species**

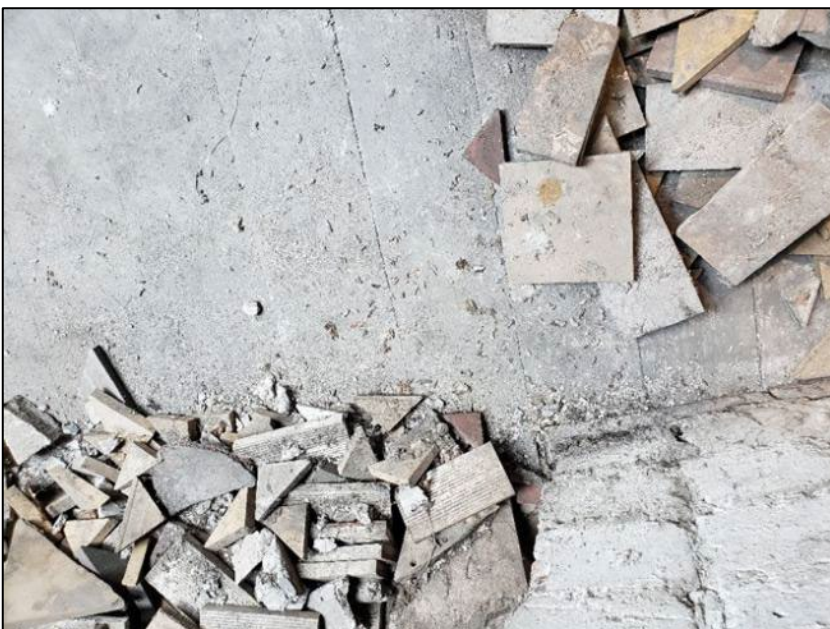
**Photograph 15**  
**Showing an accumulation of**  
**bat droppings beneath the**  
**apex within the eastern gable**  
**void**

4.14 Bat droppings were carefully collected by the surveyor during the PRA survey, and it is recommended that these are sent for DNA analysis to confirm the bat species using the building.

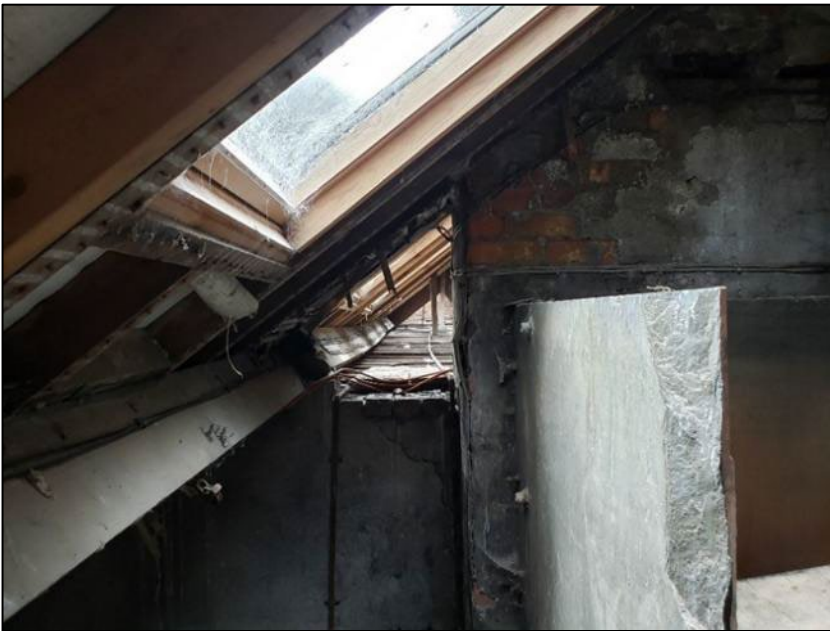
**Photograph 16**  
Showing the void above the western gable rooms which is open to the remaining first floor

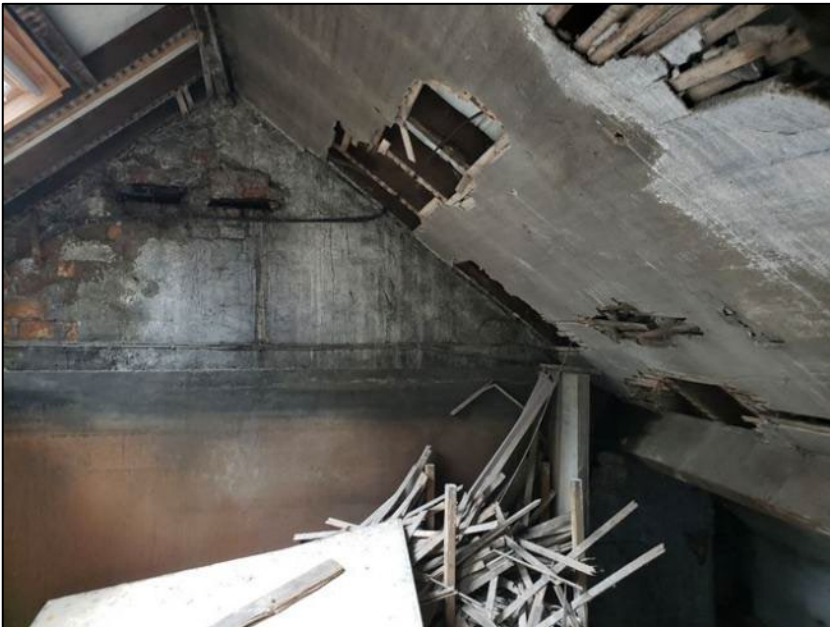
**Photograph 17**  
Showing the section of roof void where lining is partially dismantled within the western gable void

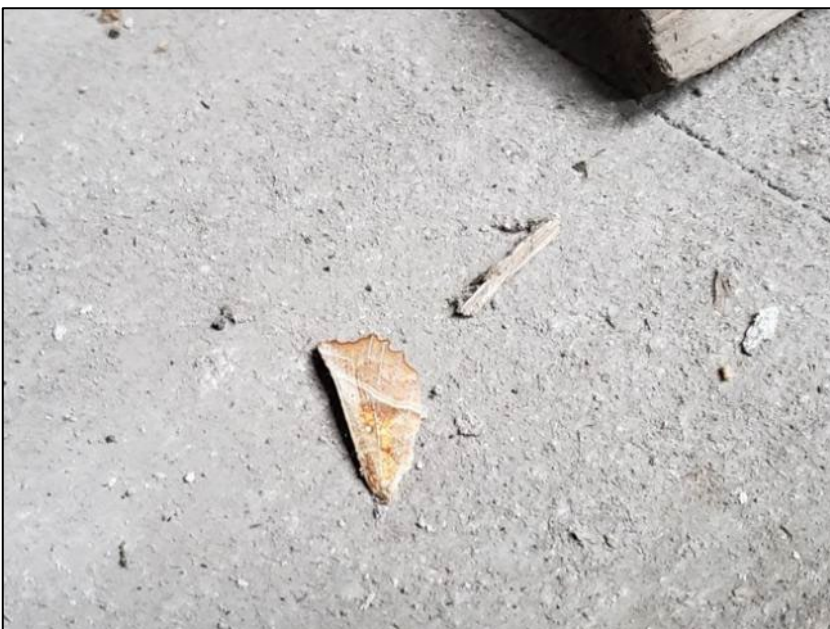
**Photograph 18**  
Showing a Lepidoptera wing feeding remain within the western gable void

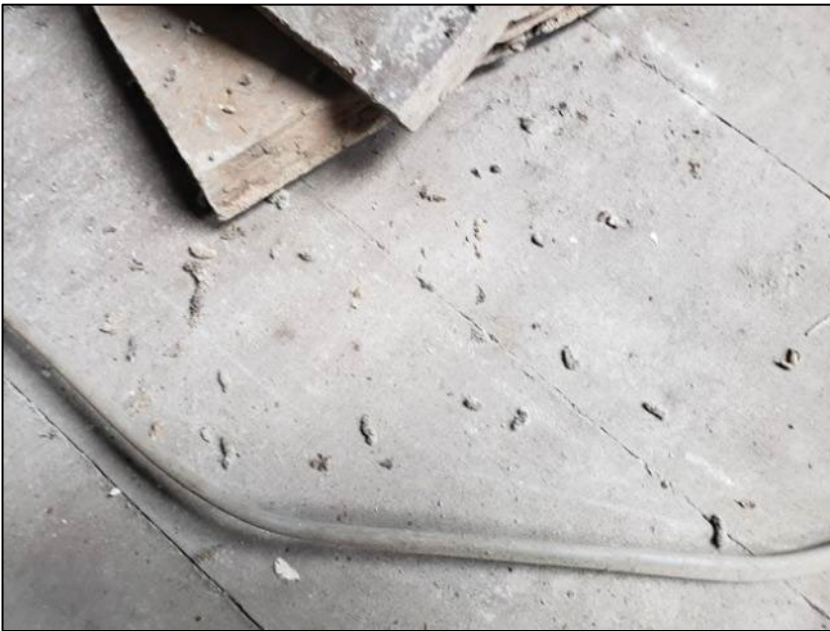
**Photograph 19**  
**Showing the accumulation of bat droppings within the western gable void, with a covering of dust**

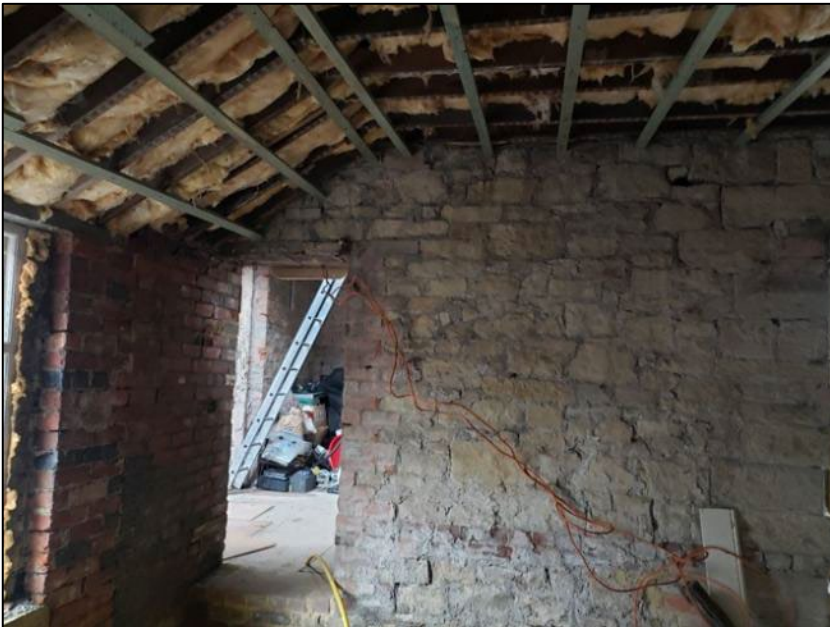
**Photograph 20**  
**Showing the interior of the split-level room on the north-western portion of the first floor with the indication of a small inaccessible void at the apex**

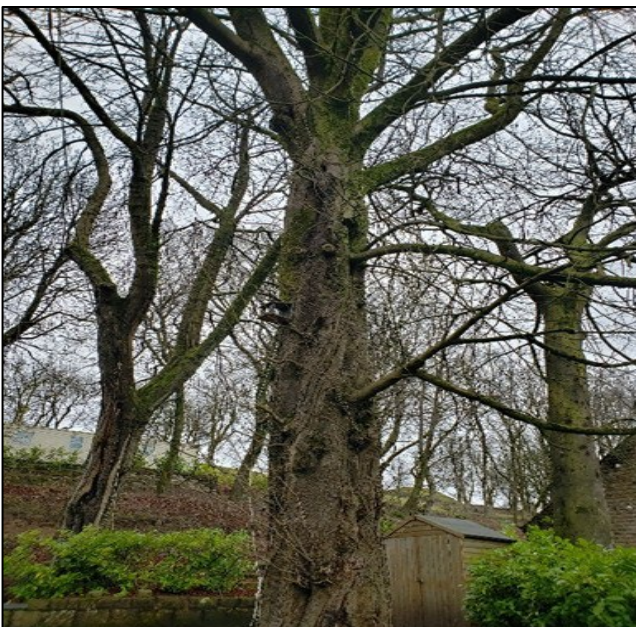
- T2 – limited and localised works to the eastern section of the Coach House building occur within approximately 20m of the tree. The expected nature, scale and duration of works result in negligible potential for impacts on this PRF-M tree. No further recommendations;

**Photograph 21**  
**Tree T2 overview (PRF-M)**

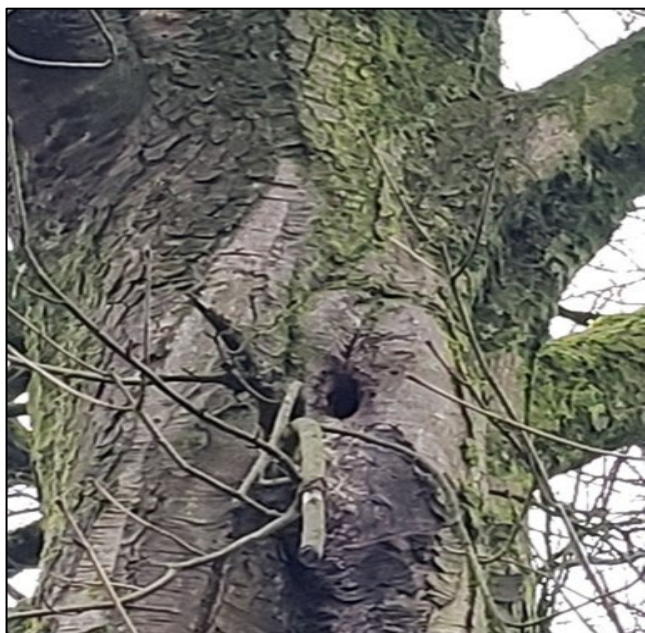
**Photograph 22**  
**Showing the knot hole on the southern elevation of the stem of T2 (PRF-M)**

- 4.20 Given the lack of direct impacts (including on any RPA) and limited indirect impacts predicted in relation to trees, it is recommended that a Precautionary Working Method Statement (PWMS) approach is applied to manage any potential impacts on PRF-M trees.

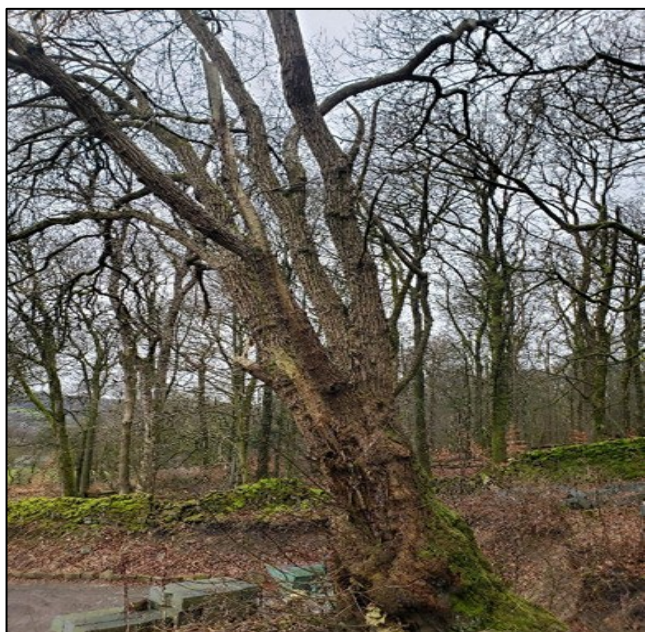
| Tree Ref. | Species | Photo No(s). | Description of Tree and PRF Present | Bat Roost Potential |
|---|---|---|---|---|
| T18 | Willow ( <i>Salix</i> spp.) | 23 | Mature tree with low burl within woodland area. Small pruning scar on the eastern face of the stem roughly 2m from the ground. Inspected and found to house slugs, spiders and only a small cavity. | PRF-I |

**Photograph 23**  
**Tree T18 with a small pruning scar on stem (PRF-I)**

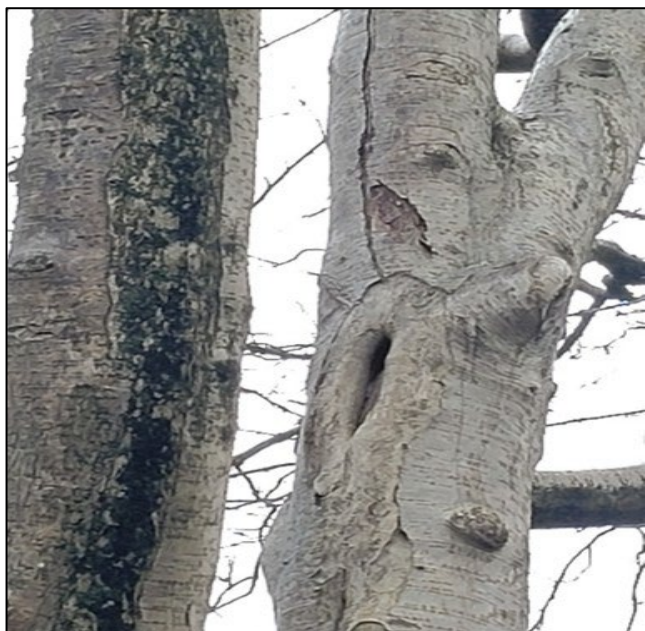
- 4.19 Four trees (T2, T26, T27, T30) with PRF-M classifications support rot features that could be used by roosting bats. All these trees are located off the application site (i.e. are not directly impacted) and at some distance from the proposed dwelling. The trees remain well-connected to the wider woodland habitats around the site.

**Photograph 24**  
**Tree T26 knot hole which appears to lead to a larger cavity (PRF-M)**

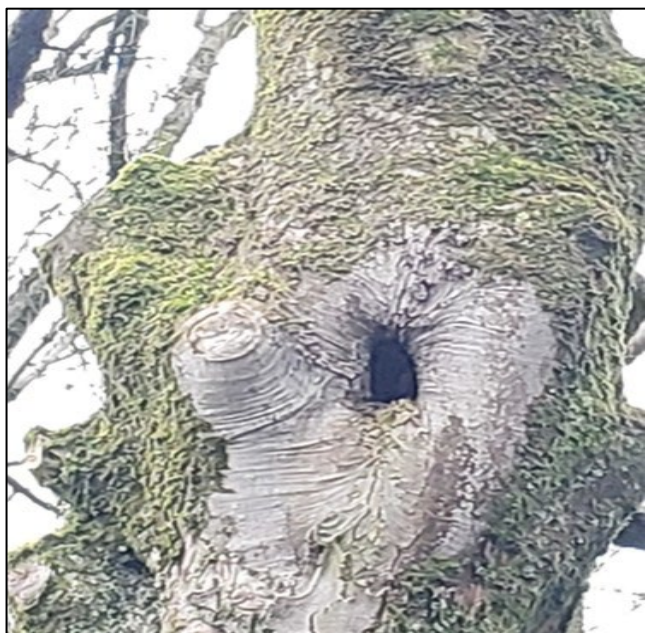
**Photograph 25**  
Close up of Tree T27 with a knot hole leading to a cavity (PRF-M)

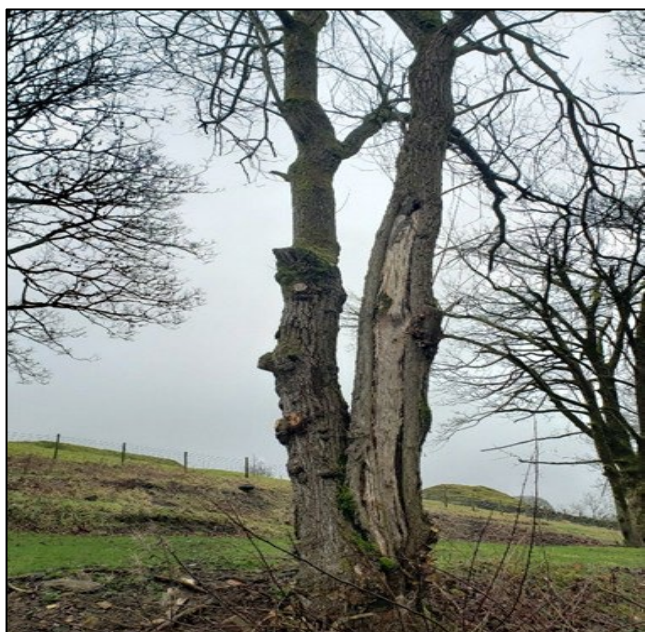
| Tree Ref. | Species | Photo No(s). | Description of Tree and PRF Present | Bat Roost Potential |
|---|---|---|---|---|
| T30 | Willow | 26 | Mature tree with multiple PRF. <ul style="list-style-type: none"> <li>Limb tear from stem roughly 3m from ground level on the western face which could possibly lead to a cavity;</li> <li>Hazard beam on a limb on the northern face of the tree roughly 4m from ground level;</li> </ul> | PRF-M |

| Tree Ref. | Species | Photo No(s). | Description of Tree and PRF Present | Bat Roost Potential |
|---|---|---|---|---|
| | | | <ul style="list-style-type: none"> <li>• Another hazard beam on another north-facing limb roughly 4m from ground level; and</li> <li>• Major limb tear along the western face of the tree from roughly 0 to 2m from ground level. A very small crevice is present at the edge of this feature.</li> </ul> | |

**Photograph 26**  
Tree T30 with a major limb tear forming rot (PRF-M)

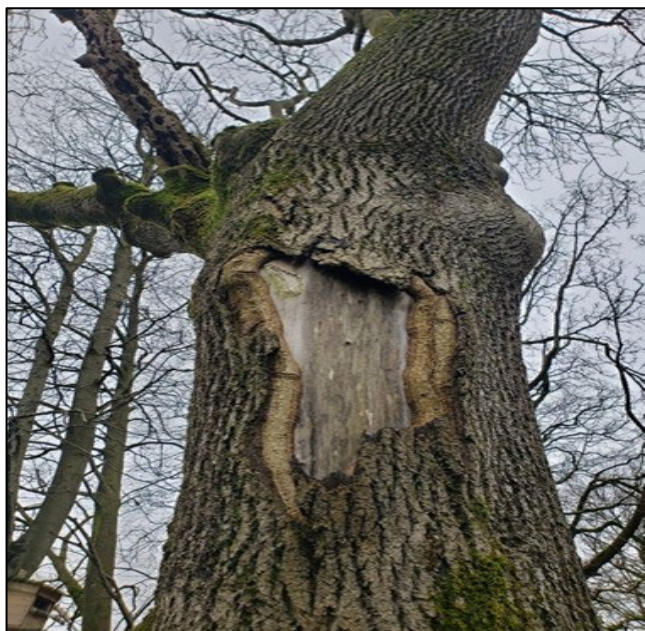
**Photograph 27**  
Tree T37 pruning scar and associated peeling bark providing only shallow crevices (PRF-I)

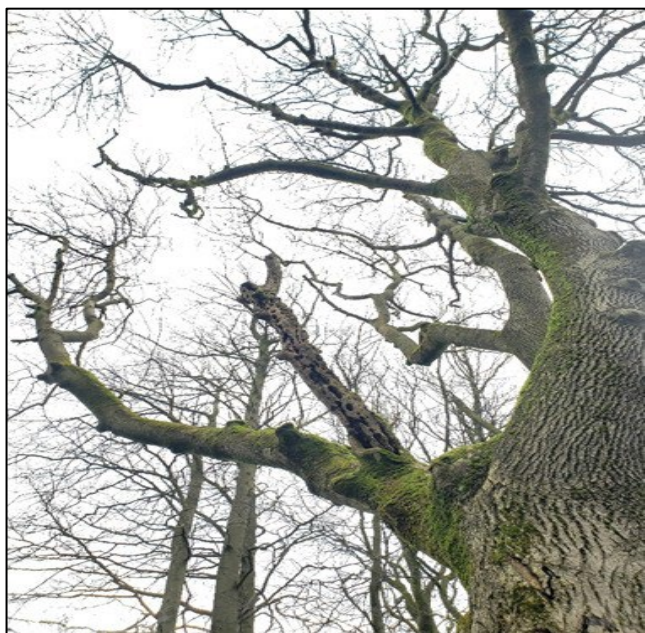
**Photograph 28**

| Tree Ref. | Species | Photo No(s). | Description of Tree and PRF Present | Bat Roost Potential |
|---|---|---|---|---|
| T38 | Beech | 28 | Mature tree with a small dead limb roughly 3 to 4m from the ground much decay. | PRF-I |

**Tree T38 showing a small rotten limb with much decay resulting in numerous features but all very exposed to weather (PRF-I)**
