**STIRLING LLOYD, BIRCH VALE.**

**BAT SURVEY.**

**Ref No:- 091212.**

**Date: 15<sup>th</sup> December 2009.**

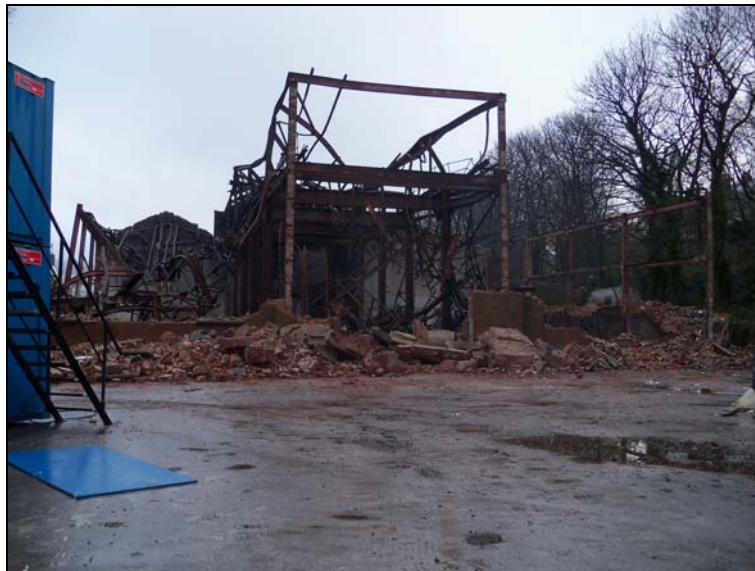
#### 3.2.4. *Building 1.*

3.2.4.1. Building 1 is the remains of a large burnt down factory building. Some solid brick walls remain, some metal framework and roof beams also remain but are all in a poor and unstable state.

3.2.4.2. The east end wall of the building is still intact and there are a number of cylindrical tanks stood up against this wall.

3.2.4.3. There is a long lean to along the south side of the building with breeze block walls that are still intact and a corrugated roof that is in a poor state.

3.3.1.1. No bat field signs were identified in or around building 1.

3.3.1.2. There is no potential for roosting bats in building 1 as all the remaining walls are solid and there is no roof left on the building.

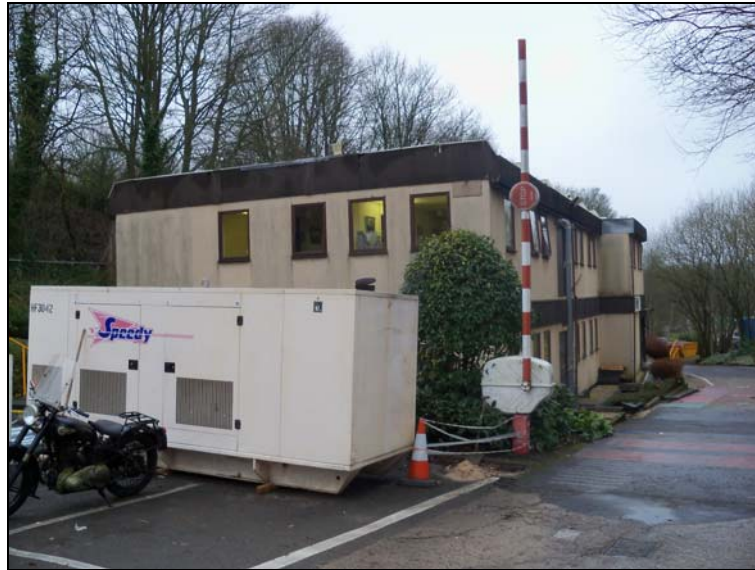
### 3.2.5. *Building 2.*

3.2.5.1. Building 2 is a two storey pre-fabricated building with pebble dashed walls and weather boards around the middle and top of the building. The weather boards on the north and south elevations are extended outwards to conceal some guttering. There are some gaps behind the some of the weather boarding around the top of the building.

3.2.5.2. The roof comprises a series of low pitches constructed from a waterproof membrane.

3.2.5.3. All windows and doors are well sealed.

3.2.5.4. Inside building 2 is currently used as offices and has suspended ceilings.

3.3.2.1. No bat field signs were identified inside or around building 2.

3.3.2.2. There is no loft space in this building, just a void between the roof and suspended ceiling that provides little potential for roosting bats as it is too low for bats to fly around in easily.

5.1. It is recommended that the demolition of buildings 2 and 3 is carried out with care and in the unlikely event that a bat is found it must be kept safe and professional advice must be sought immediately.

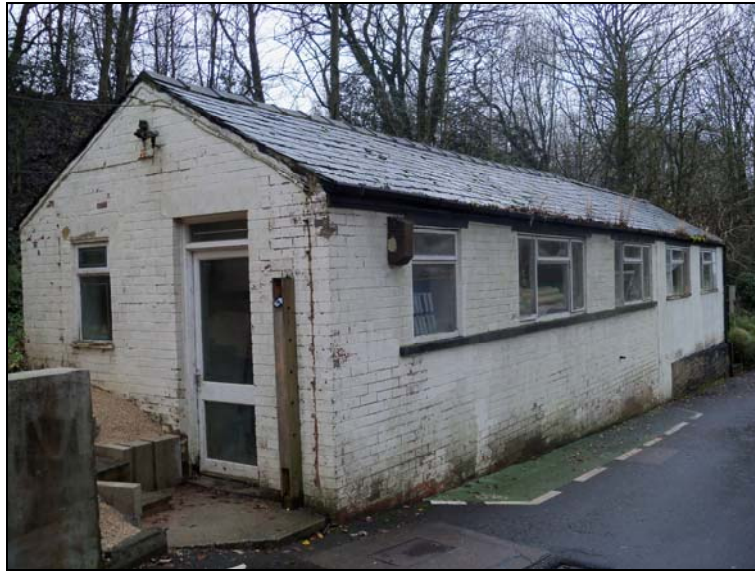
### 3.2.6. Building 3.

3.2.6.1. Building 3 a single storey outbuilding. The east half of the building comprises brick walls that are well pointed and have been painted. The west half has rendered concrete block walls.

3.2.6.2. The roof is a pitched slate roof with some gaps under the slates and ridge tiles, in particular on the south elevation of the pitch.

3.2.6.3. The west half of the roof is lined with felt and the east half has no roof lining.

3.2.6.4. There is a loft space that extends the full length of the building that has a solid brick partition between the west and east halves.

3.3.3.1. No bat field signs were identified inside or around building 3.

3.3.3.2. The loft spaces are assessed as low potential for roosting bats as the east loft space is split into two by a suspended ceiling and is assessed as too being too low and with too many obstacles for bats to fly around in easily.

3.3.3.6. The gaps under the roof slates and ridge tiles may provide opportunities for individual pipistrelle bats during the summer months.

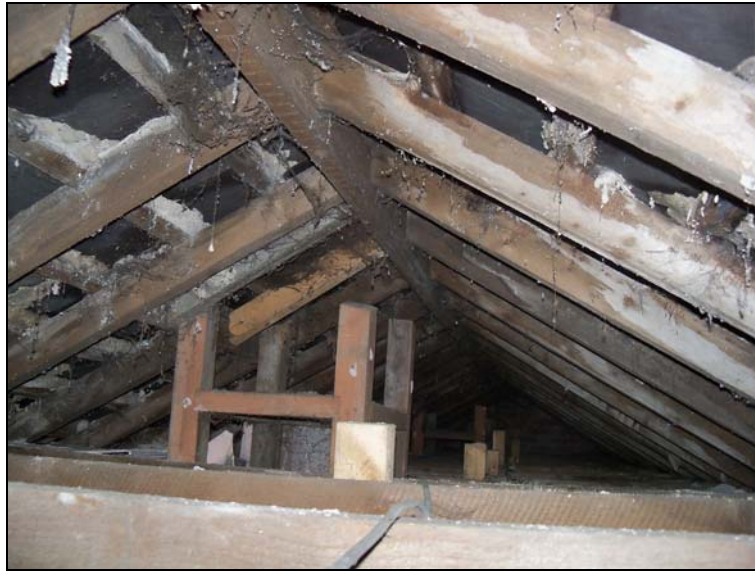
3.2.6.5. The east half of the loft space has a suspended ceiling with some holes in. There is a gap of approximately 12 inches between the loft floor and the suspended ceiling, with insulation on the loft floor and there is a height of approximately 24 inches between the suspended ceiling in the loft space and the ridge of the roof. There are wooden beams extending upwards into this space. It was not possible to access this section of loft space due to the space restriction.

3.2.6.6. Photograph to show roof space between ridge and suspended ceiling.

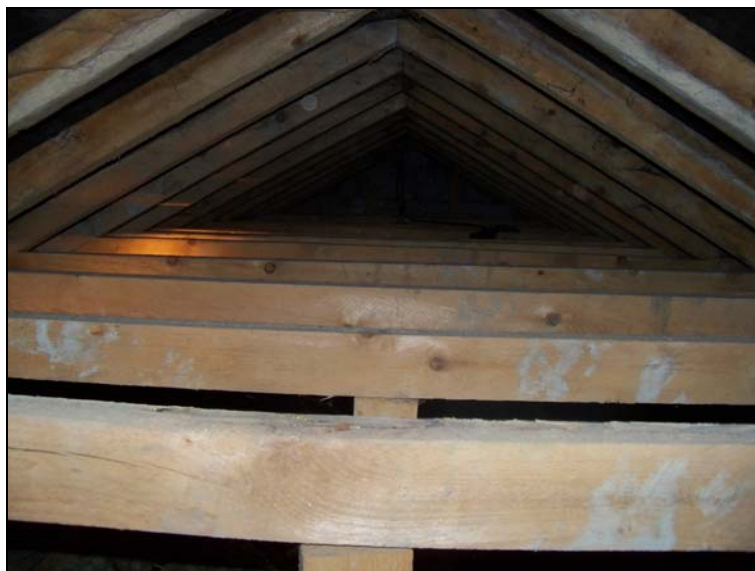
3.2.6.7. The west half of the loft space is one continuous loft space with collar beams throughout that are placed very close together and there are single wooden beams resting on the loft floor supporting the collar beams down the centre of the loft. The majority of the loft space has loft floor insulation. Again due to the space restrictions it was not possible to access the entire loft space.

3.2.6.8. Photograph to show the west loft space.

3.3.3.3. The west loft space is large enough for bats but the roof beams inside the loft space create an obstruction making it difficult for bats to fly around the loft space easily.

3.3.3.4. Although the loft spaces were not accessible during the survey it was possible to look down the west loft space and it was evident that all the collar beams were clean and no obvious concentrations of bat droppings were visible on the loft floor.

3.3.3.5. A number of animal droppings were identified inside the west loft of the building that were assessed as either squirrel or rat.
