**TAXAL LODGE
LINGLONGS ROAD
WHALEY BRIDGE
HIGH PEAKS
DERBYSHIRE**

ECOLOGICAL WALKOVER ASSESSMENT
Including
BAT and BARN OWL SURVEY

**Ruttle Contracting Ltd
Lancaster House
Ackhurst Road
Chorley
Lancashire
PR7 1NH**

May 2010

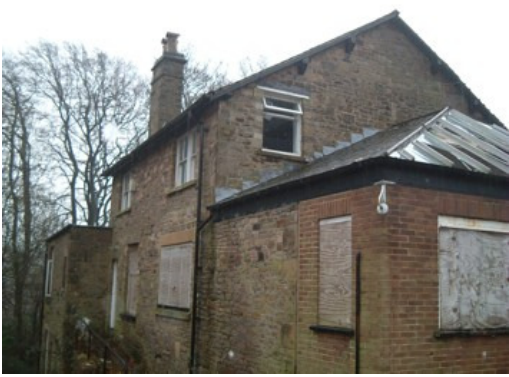
- 2.2.4 **Building 4** is located to the north-east of the site (see photograph 5, Appendix 2). The building is two-storey and of stone construction. The main section of the building has a pitched slate roof which is in a poor state of repair with large numbers of missing slates. The loft space is exposed to the elements and the roof timbers are unsound.
- 2.2.5 **Outbuilding 1** is a single storey brick and corrugated sheet shed located to the north of the site (see photograph 6, Appendix 2). The building is open to the roof on the interior.
- 2.2.6 **Outbuilding 2** is a single storey timber shed with a shallow pitched felt roof (see photograph 7, Appendix 2)
- 2.3 The site layout is shown in Drawing No.2 (Appendix 1).
- 2.4 The site is bordered by mature trees and areas of woodland (see photograph 8, Appendix 2) with the River Goyt located approximately 100m to the east of the site.

5.2.5 The roof of **building 4** is in a poor state of repair making the loft space damp and draughty and therefore unlikely to be suitable as a roosting site for significant numbers of bats. Single or small numbers of bats could however roost beneath the remaining roof slates or in gaps in the walls of the building.

<p>Photograph 5</p> <p>Building 4 to north-east of site</p>

- 8.1.3 Potential for bats to roost in buildings 2, 3 and 4 and inaccessible areas of building 1 was identified during the survey. Further dusk or dawn activities surveys of these building between May and September are recommended in order to identify any roosts not detected during the daytime survey.

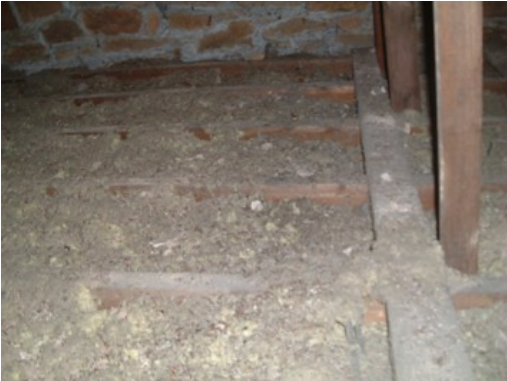
5.2.9 R1 - Several hundred bats droppings of varying ages from 1 year to several years old were found in the 2 metre high loft space above the northern section of the main school, **building 1** (see photographs 9 and 10, Appendix 2). The droppings were characteristic of the Brown long-eared bat (*Plecotus auritus*). The droppings were primarily concentrated beneath the ridge line of the north-western and northern sections of the roof. The droppings would

<p>Photograph 10</p> <p>Bat droppings in loft of main building</p>

- 8.1.1 The northern section of the roof of the main school building contains field evidence of what is considered likely to be a summer/maternity roost of Brown long-eared bats. A Natural England bat mitigation license will be required for any works that would result in loss, alteration or disturbance of the roost area. It is likely that such a license will include timing restrictions on the proposed works (dependent on their scope) and mitigation measures to ensure that bats are retained on site. Wherever possible bats should be retained within their existing roosting areas and these areas should be left undisturbed during the site works. It is likely that additional bat activity surveys at dusk or dawn during the active period (May to September) will be required to be undertaken in order to confirm the species of bat, the type and size of the roost and to determine the location of access points into the roost before a licence can be granted. Such a survey should be undertaken to review the status of the bat roost prior to works commencing onsite and will be used to advise upon any mitigation measures required.

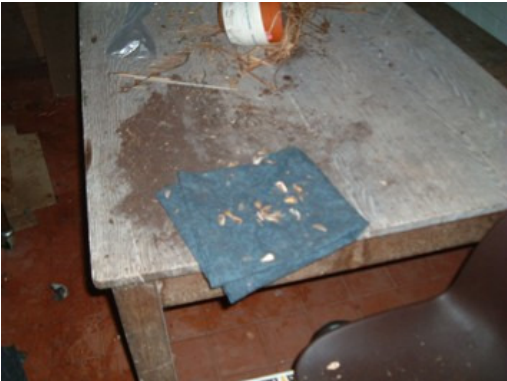
5.2.10 R2 - Approximately 15 droppings characteristic of the Brown long-eared bat (*Plecotus auritus*) and a number of moth wings were found beneath the curtain rail of a second floor window on the western aspect of the main school, **building 1** (see photograph 11, Appendix 2). The droppings and moth wings indicate a Brown long-eared feeding perch which has been used within the last year.

5.2.11 R3 - Approximately 20 bat droppings characteristic of the Brown long-eared bat and over 50 moth wings were found beneath a strip-light in a changing room extension to the north of the main school, **building 1** (see photograph 12, Appendix 2). The droppings and moth wings indicate a brown long-eared feeding perch which has been utilised repeatedly within the last year. Access is thought to be through the open door to the changing room area.

<p>Photograph 11</p> <p>Feeding perch in second floor room of main house</p>	 
<p>Photograph 12</p> <p>Feeding remains beneath strip-light in extension to north of main building</p>

- 8.1.2 A number of feeding perches were noted around the site. Wherever possible existing feeding perches should be retained or replaced as part of the proposals.

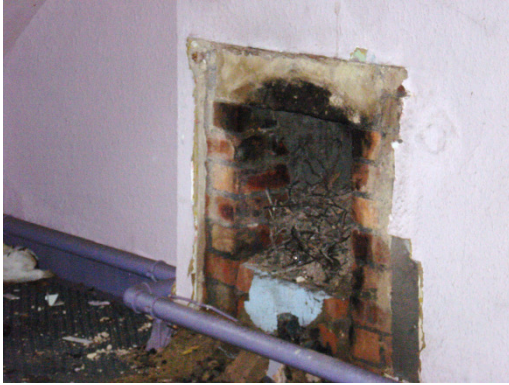
4.2.9 Within the main lodge building, there was evidence of previous and repeated nesting bird activity within the chimney stacks. Photograph 13, appendix 2 shows one of several fireplaces which contained exposed nest debris assumed to be that of jackdaw.

<p>Photograph 13</p> <p>Evidence of nest debris inside fireplace</p>

8.3.2 It is recommended that works which might affect nests, e.g. Restoration of chimneys, slate stripping, tree felling, mowing of areas used by ground nesters and grubbing out of existing shrubbery to make way for soft landscaping should be carried out outside the breeding season (March-August) to avoid any unnecessary or reckless disturbance. **However vegetation removal and ground clearance works may only commence once the presence or absence of slow worms at the site has been clarified following a full presence/absence survey for the species in order to prevent any offence being committed. Similarly, a number of mature trees within the survey area were identified as having potential to support roosting bats. Additional bat activity surveys should be undertaken if any of these trees are to be lopped or felled.**

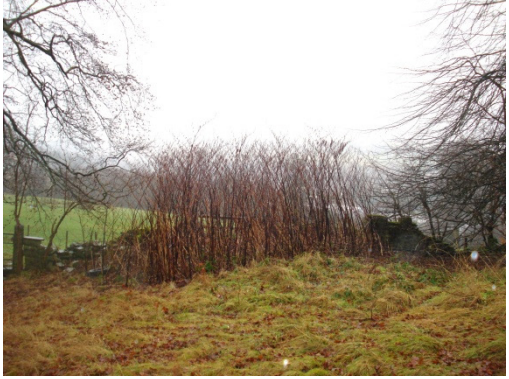
4.2.7 Several large stands of Japanese knotweed (*Fallopia japonica*) (shown in photograph 14, appendix 2) were recorded along the northern edge of the site boundary with a smaller stand located to the west of the small timber building (outbuilding 2) opposite the sports hall (building 3).

<p>Photograph 14</p> <p>Japanese knotweed along northern site boundary, stands also occur along western boundary</p>

Japanese knotweed, liability may also extend in situations where a landowner has knowingly permitted the spread of the plant onto neighbouring land. There are therefore implications for development with regards to this species (control and removal). However any proposed treatment of this plant will need to be considered the potential for slow worms to be present at the site. Topical treatments for the weed (glyphosate) when applied under the recommended site conditions are unlikely to cause any offence in relation to slow worms, however **should any treatment be proposed that requires 'breaking ground' or strimming to a height shorter than 200mm, such works should only commence once the presence or absence of slow worms at the site has been clarified following a full presence/absence survey for the species in order to prevent any offence being committed.**

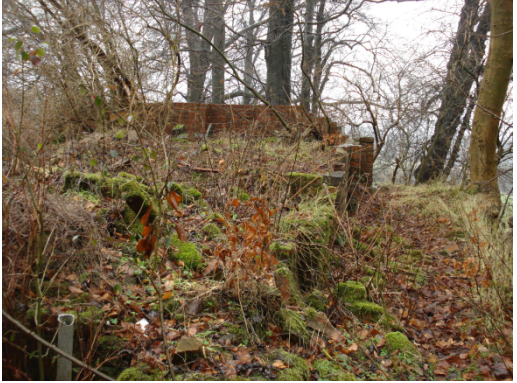
4.2.8 Numerous piles of stone and rubble litter the eastern section of the site to the rear of the main lodge. Much of which is assumed to be tumbled sections of ornamental walling and steps which would have originally lead towards pathways through the woodland to the south. Bramble (*Rubus fruticosus*) has colonised many of the rubble piles and such habitat is considered highly suitable for slow worms which are known to be present within the woodland immediately beyond the rear wall. There was also evidence of a tumbled brick built outbuilding to the north of building 4, again with many associated rubble piles suitable for harbouring reptiles.

<p>Photograph 15</p> <p>Remnants of tumbled brick outhouse onsite, now overgrown providing possible shelter for slow worms</p>

8.2.2 The optimum survey window for this species is March to June and September to October. It is recommended that provision for such a survey be secured as a condition of planning permission. If slow worms are found to be present at this site an exclusion and capture programme shall be implemented in order to safeguard the species during the restoration of the overgrown grounds.
