**Protected Species (Bat & Bird) Report**

**Birch House, Birch Vale, New Mills**

**17<sup>th</sup> March 2011**

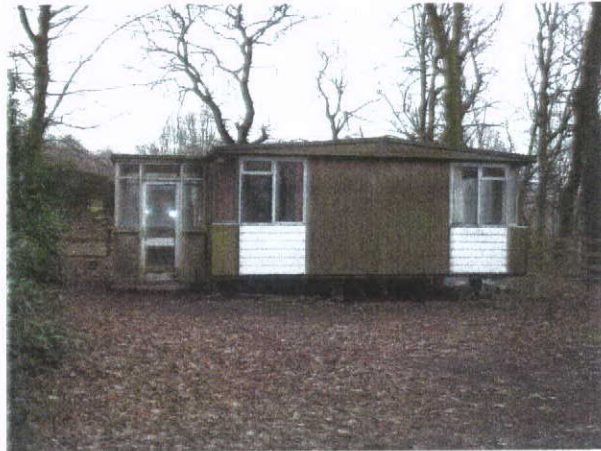
This is basically a large caravan with plastic walls and some wooden planks added making it appear as a wooden chalet. A small entrance porch has been built around the main door. It is jacked up off the ground and still has its wheels in place.

**View from the west**

The unit is decorated and furnished, and has been used until recently as accommodation. The glazed windows and door allow in light to every room. There are no suitable bat roosting places in any wall or on the ceiling.

The slightly pitched roof has no crevices that could be used by bats and no signs of bats are present. The eaves are slight and well-sealed allowing no bat access points. The walls are mostly plastic sheets with some timber planks. There are no suitable gaps that bats could use for roosting behind the planks and no signs of bats are present. This mobile home is not used by bats and there are no bat signs.

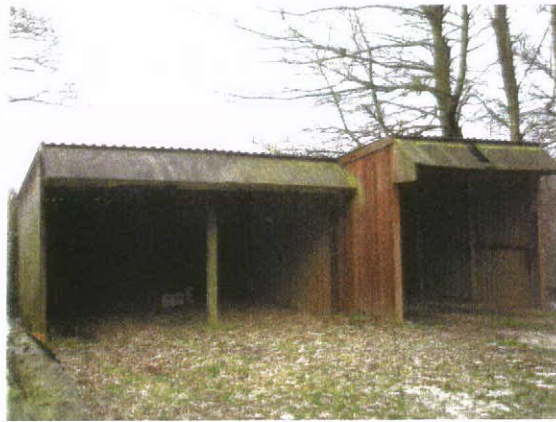
There are four wooden structures on this plot. The southern two are both shelters, open to the west. The northern one is a wooden barn with a hayloft used for stabling and storage, and the other is a short row of wooden horse stables with stable doors and windows in the north wall.

**View from the west**

These have walls of unlined wooden planks, and an unlined corrugated metal roof. Being open on one side makes the inside light and draughty. Inside there are no suitable roosting places for bats and no bat signs. Outside the roof and walls hold no roosting opportunity for bats. There are no bat signs. Neither is suitable for roosting bats

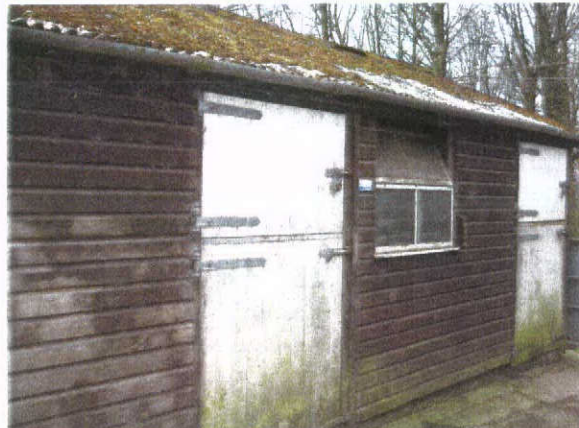
**View from the north**

This short wooden row of stables has unlined wooden plank walls. The corrugated asbestos roof is closely lined with insulating boards. The stables are in regular use by horses, so are regularly disturbed. Inside the stables are all light due to the doors and windows in the north wall.

Inside there are no signs of bats nor any suitable roosting places. There are no bat droppings or other signs on any stored materials.

Outside the roof has no suitable crevices that bats could utilise for roosting. The wooden walls have no suitable crevices either. There are no bat signs.

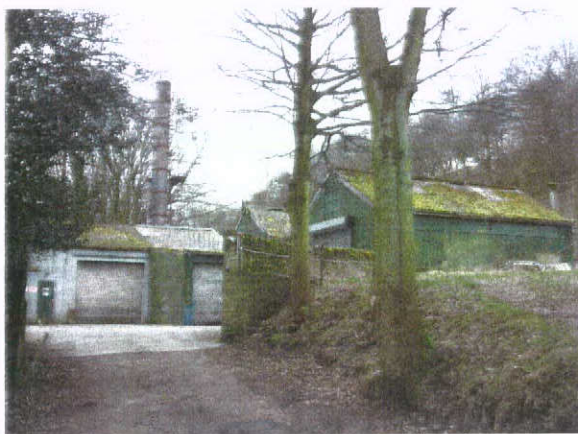
This is constructed of brick and concrete block walls with a corrugated asbestos roof. The south end of the unit is used as offices and the north-west corner houses a small furnace. Access to the units is via roller shutter doors in the south and east walls, with a wooden door for the offices which has glazed windows in the east and south wall.

**View from the east**

The corrugated asbestos sheet roof is partly lined with insulation panels but provides no suitable roosting places for bats and there were no bats signs. The western section has skylights making the interior light.

The corrugated asbestos roof has no crevices that bats could use for roosting. There is no boxing at the eaves that bats could utilise.

The walls are solid and painted with no crevices that bats could use. Overall there are no bat signs.

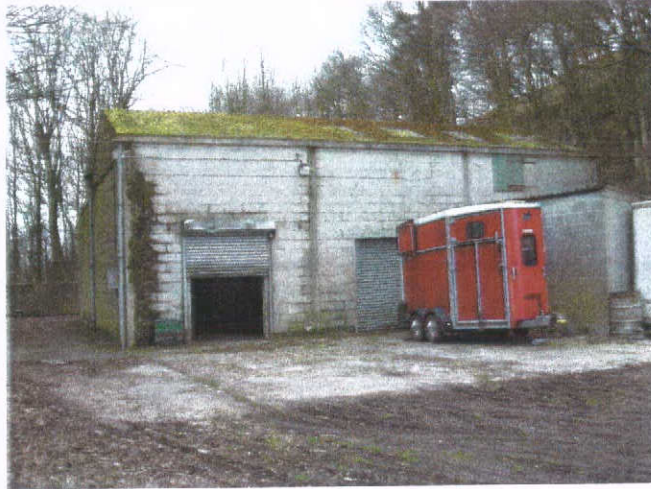
This has a similar construction to Unit 1. This unit has no offices, just an open shell inside. The roofs of this unit have skylights allowing in plenty of light and are constructed of unlined corrugated asbestos sheets. Roller shutter access doors are present in the east wall. There is an open shelter on the west end, again with a corrugated asbestos roof.

**View from the east**

The roof has no roosting crevices for bats and is unsuitable for bat roosting.

The roof is unsuitable for bats

The solid block walls have no suitable crevices for bats to use.

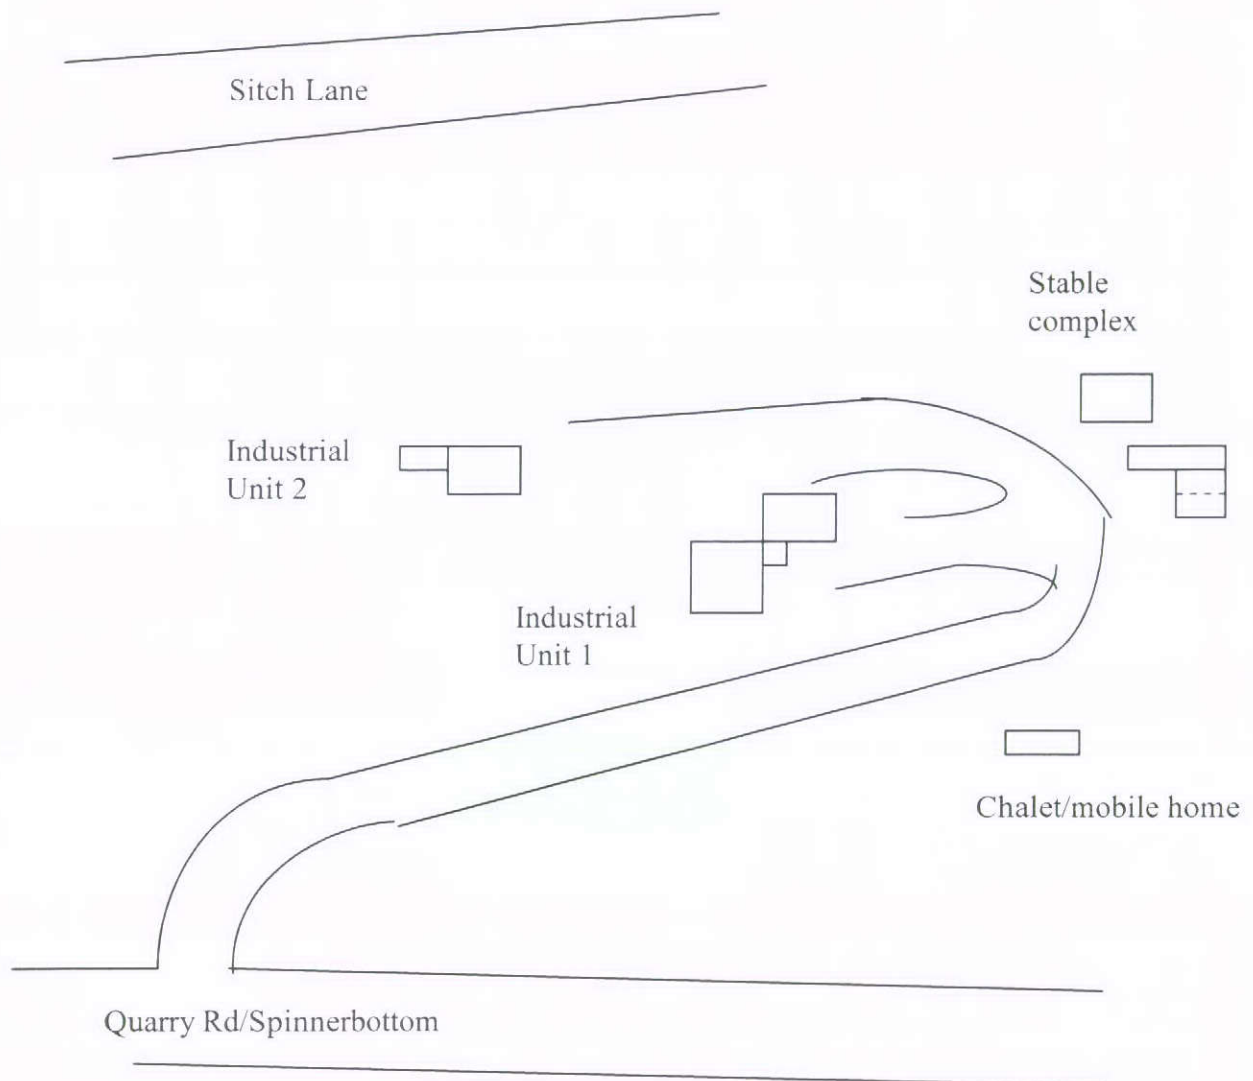
### Appendix 3. Plan of buildings

The industrial units, perhaps up to 50 years old, are constructed of concrete block with corrugated asbestos roofs, the horse stabling is mainly wooden and mostly modern, and the mobile home is perhaps 20 years old. The building plan is in the Appendix.
