Michael Gavaghan Wildlife Consultancy

Internal and External Inspection Survey for Bats & Birds

Hurst Farm, Derbyshire Level.

December 2011

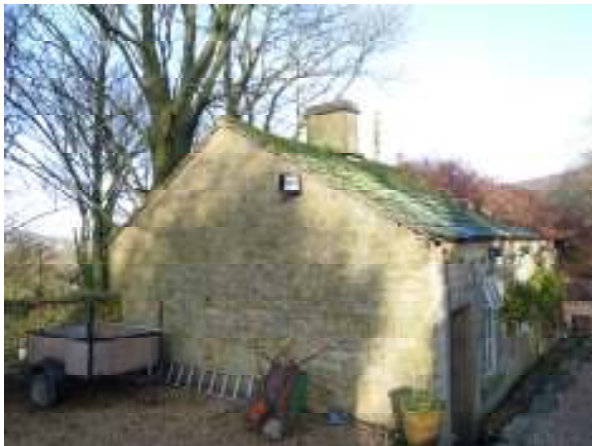
Plate 1: showing Coach House to be re-developed.

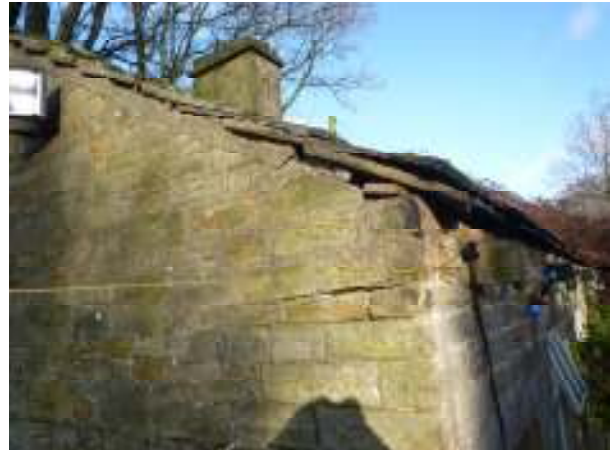
The roof of the building is slated and has few raised or dislodged tiles though the gable ended coach house showed missing mortar which would provide access into the building what raised tiles were evident and were missing mortar was noted these were inspected for bat activity i.e. droppings though none were identified during the inspection. Moss was noticeable accumulating on the slated roof covering up any potential raised tiles and ornamental climber was dominating North West elevation of the building.

Plate 2: showing Coach House potential access point for bats and birds

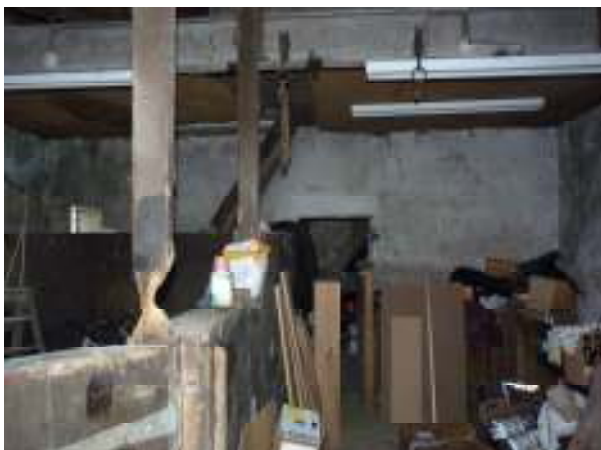
- 4.2 The internal inspection of the coach house is divided up into three separate rooms on the ground level and two small roof voids. The three ground rooms are currently used as storage, the inspection found part of the roofing was visible by the damaged ply board, during the inspection a small amount of crevices were visible for potential bat roost opportunity these were inspected with care and vigilance using a video endoscope to locate any bat activity during this inspection no bat activity was identified. The two small roof voids were also inspected for bat potential and activity the roof voids showed little opportunities for bats to utilize due to the lack of crevices and the high density of cob webs as with the ground floor inspection the roof void was checked for any signs of bat activity.

Plate 3: showing Coach House internal view

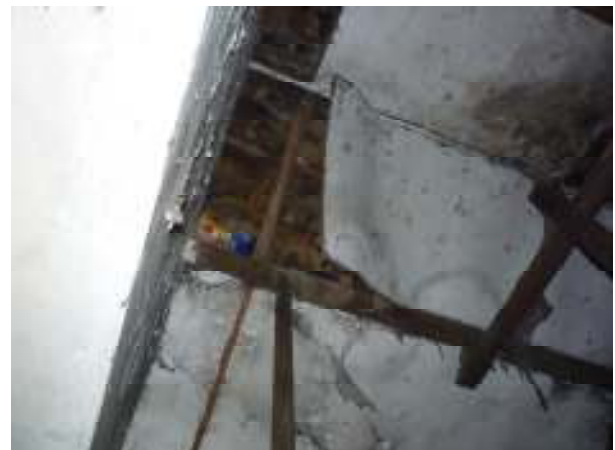
Plate 3: showing Coach House potential roosting and nesting opportunity
