# Bat Survey for Brookbottom Methodist Church, New Mills.

**14 August 2012**

**MAMPAM CONSERVATION**

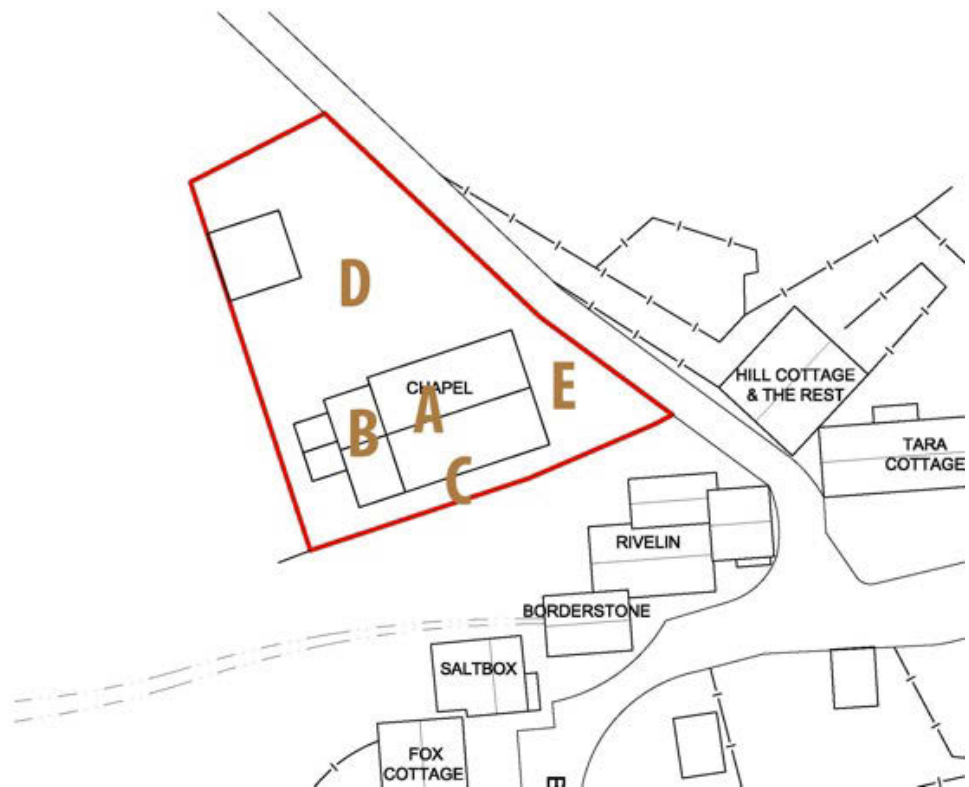
Figure 2. Main nightvision, ultrasound and visual monitoring points for observing roost access. Points A and B are within attic space.

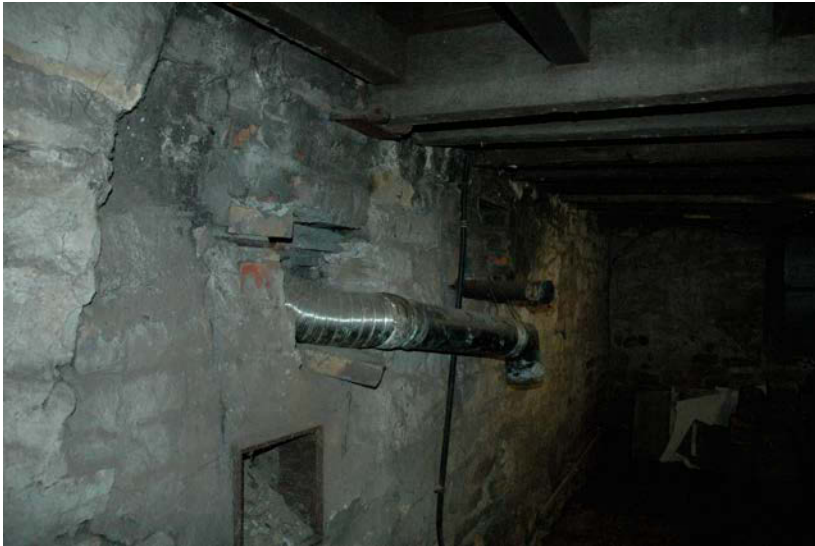
The cellar of the building contained numerous crevices suitable for bats and multiple potential entry/exit points (Figures 7&8). All such crevices were investigated endoscopically, but no signs of bats were found anywhere in the cellar.

Figure 7. Cellar space at Brookbottom Methodist Church.

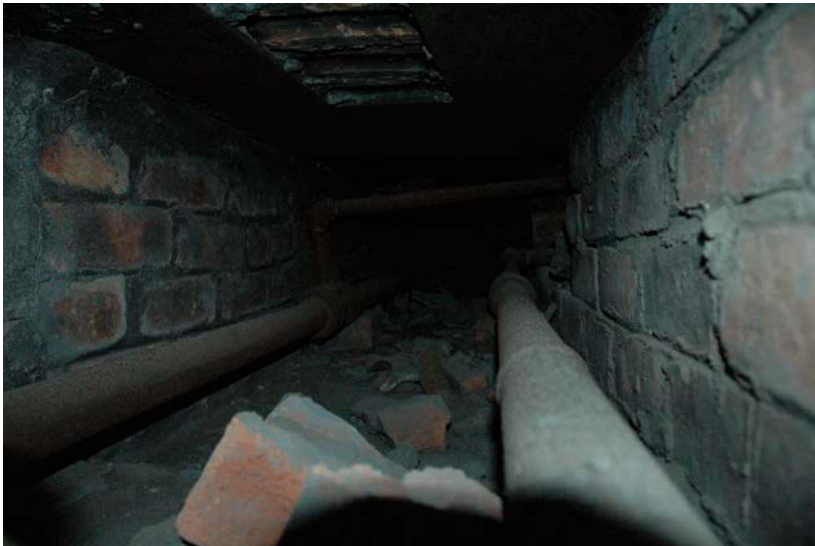
Figure 8. Cavities in cellar at Brookbottom Methodist Church.

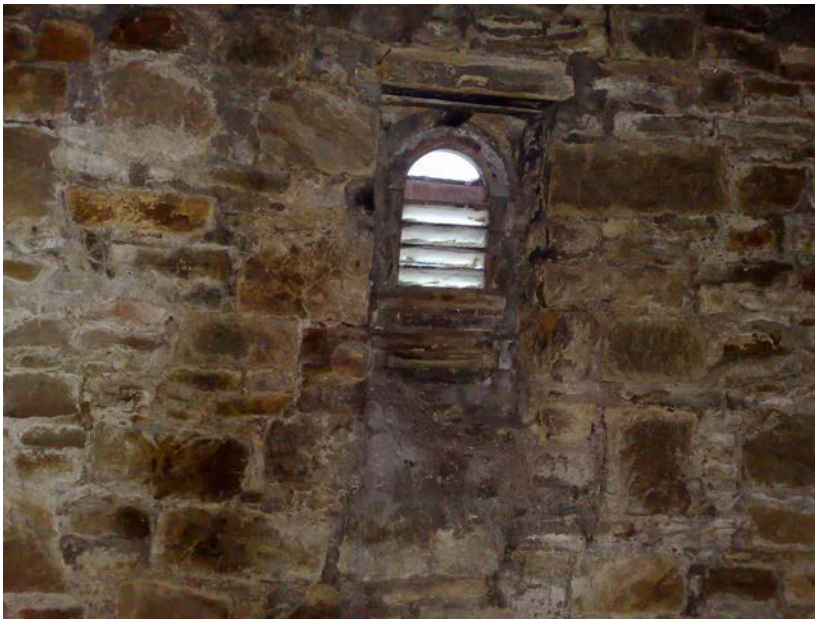
Figure 10. Main roost access point in west end of Brookbottom Methodist Church. Note cavity above window frame.

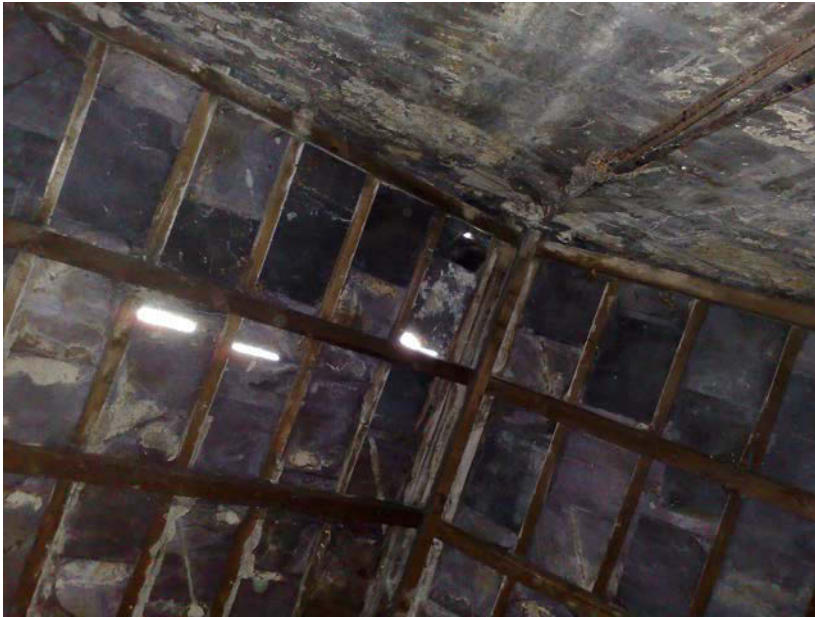
Figure 11. Vestry roof showing spaces between tiles in Brookbottom Methodist Church.

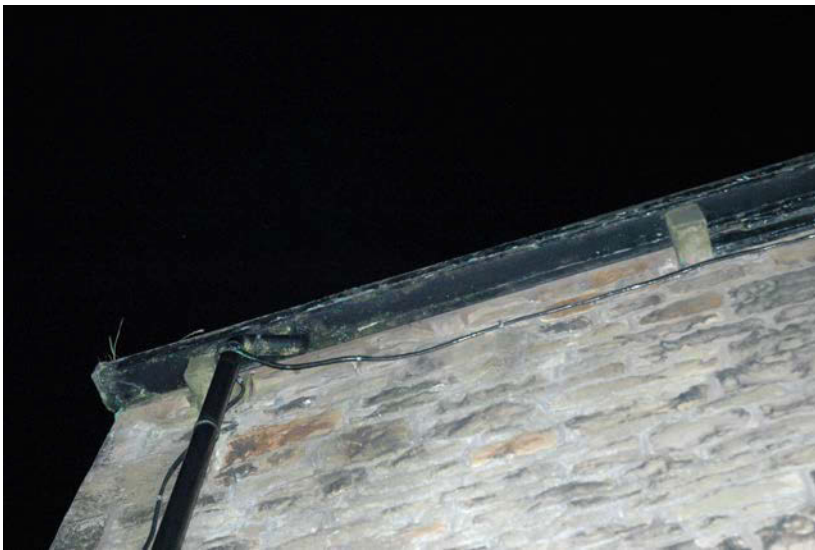
Figure 14. Missing fascia board on western end of south wall, showing roost entry point.

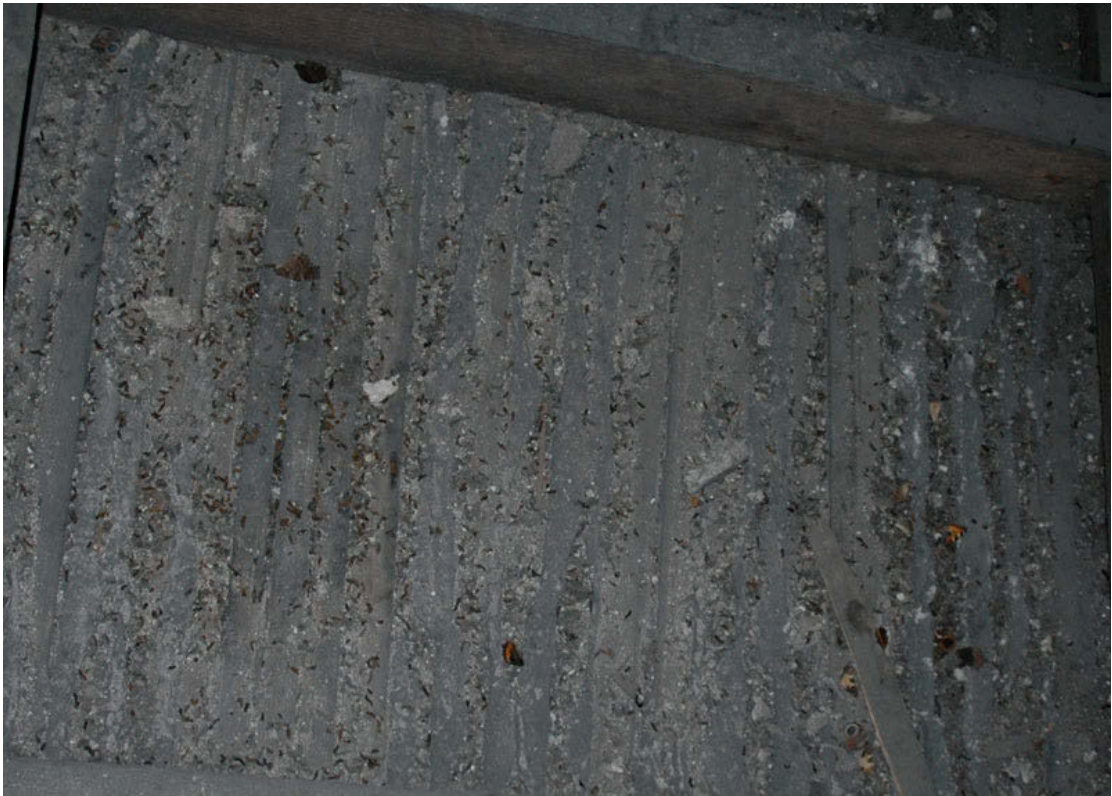
There was evidence of bats (droppings and lepidopteran wings) in the church attic space and in the vestry attic space (Figure 16-18). In both attic spaces droppings and lepidopteran wings were concentrated along the apex of the roof. The quantities of droppings and lepidoterans wings suggested that the church attic space was more heavily utilised by bats than the vestry attic space, and indicated either a low colony size or very recent utilization of the roost.

Figure 16. Faeces/feeding signs of bats in the church attic.

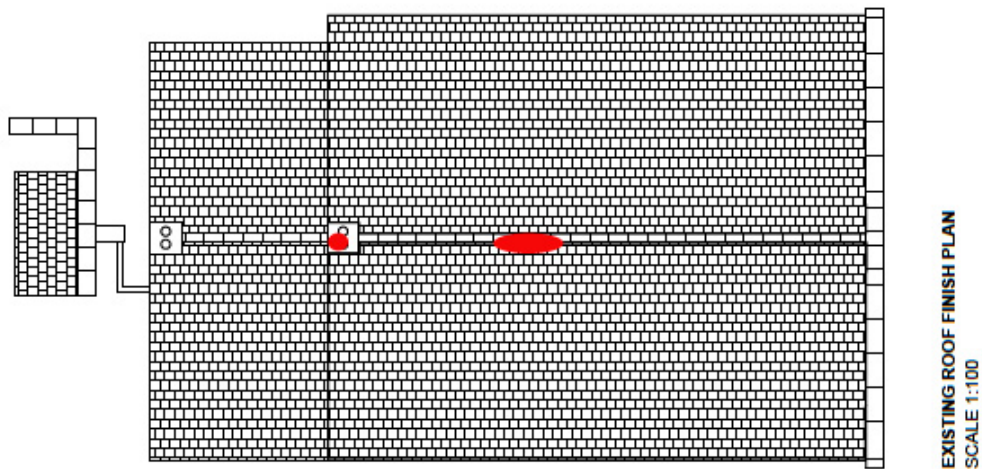
Figure 18. Position of concentrations of faeces/feeding signs below ridge beams in left space, top view.

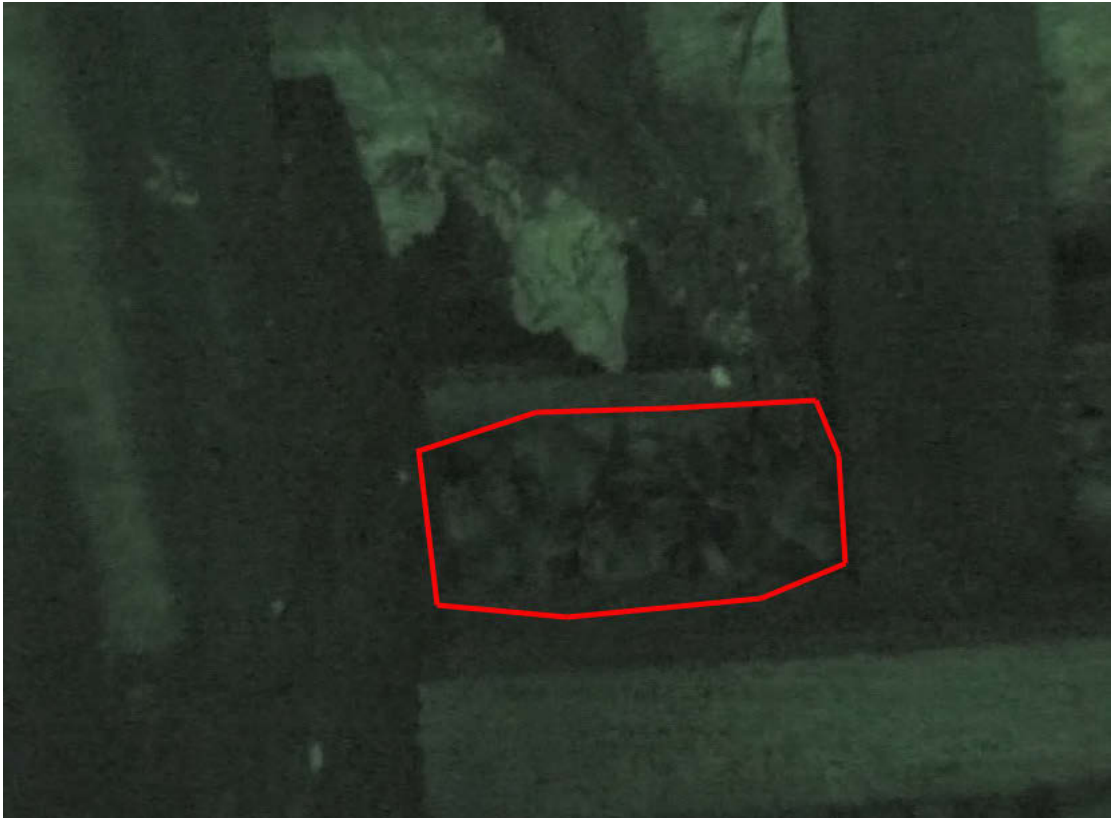
During the bat roost potential survey, a cluster of about 10 long-eared bats (*Plecotus auritus*) was discovered hanging between beams near the ridge of the church roof by the western king post (Figure 19). Because of the possibility that newly born bats were present, the animals were only examined with nightvision equipment and were not disturbed. This area has an open attic floor with no

The largest estimate of colony size is at least ten individuals, based on a cluster of bats observed in the church attic on 6<sup>th</sup> July 2012 (Figure 19 and Appendix 2). Counts from activity surveys (Appendix 2) suggest that 5 – 9 bats entered or left the roost by the western gable window or the missing fascia board on south side of the church on all three evenings of the survey.

Figure 19. Group of about ten long-eared bats (circled), ridge of church attic space, Brookbottom Methodist Church.

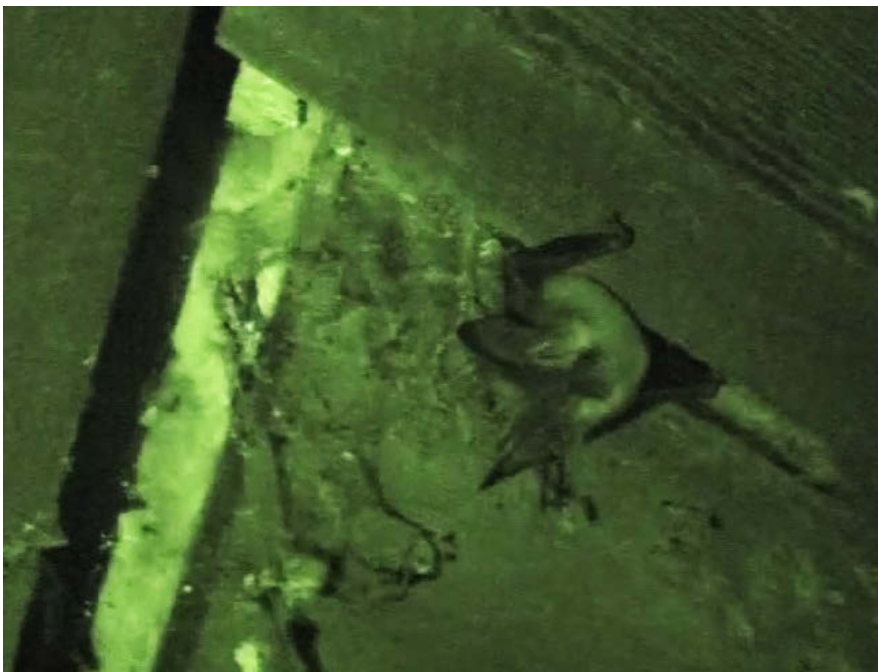
built in access. Subsequently bats were also seen in the vestry attic space (Figure 20). Areas where bats were observed to rest are given in Figure 21. Bats were mainly seen hanging near the intersections of ridge beam and rafters and also seen entering a crevice around the window frame on the western wall of the building (Figure 10). Bats may also occupy crevices where purlins, beams and rafters insert into walls, and in chimney structures.

Figure 20. Long-eared bat on rafter near ridge of vestry attic, Brookbottom Methodist Church.

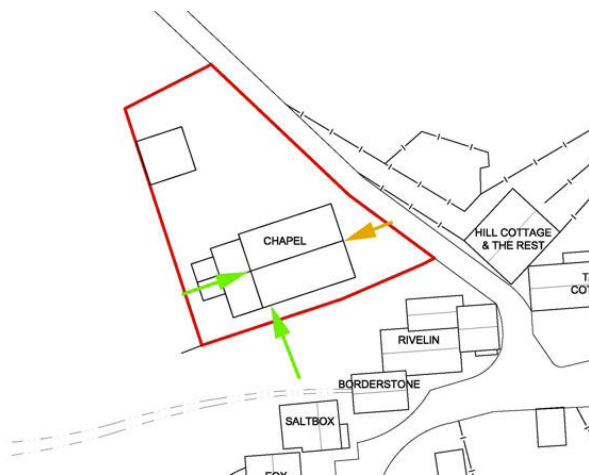
Long-eared bats were observed at three entry points to the roost (Figure 22). The western window was used by bats during all activity surveys. Bats regularly flew through the space created by the dislodged top slat of the window, occasionally resting on the slat. They were also recorded flying through other slats in the window (Figures 22&23). Early in the morning of July 24<sup>th</sup> at least five long eared bats were seen to enter the roost via a missing fascia board on the south side of the building (Figure 14). This point was monitored from 21:00 to 00:00 and 03:20 to 05:30 during the survey on August 5<sup>th</sup> but no bats were seen to use the entry point. Bats often flew around the eastern window of the church but were not recorded entering the roost by this route.

Figure 22. Roost entry points (green=observed to be used, brown= probably used)

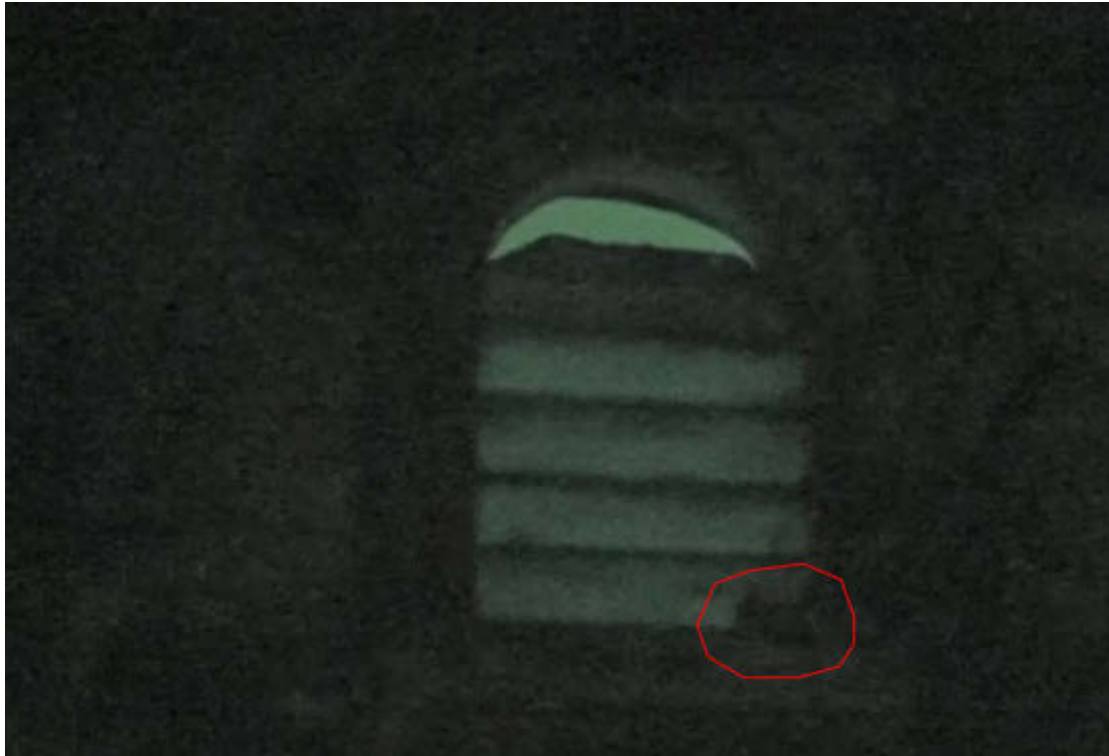
Figure 23. Long-eared bat (circled in red) leaving roost through lowest slat of the west window, 22:08, 24<sup>th</sup> July 2012.
