The Old Cross, Old Glossop

Heritage Statement

26th October 2012

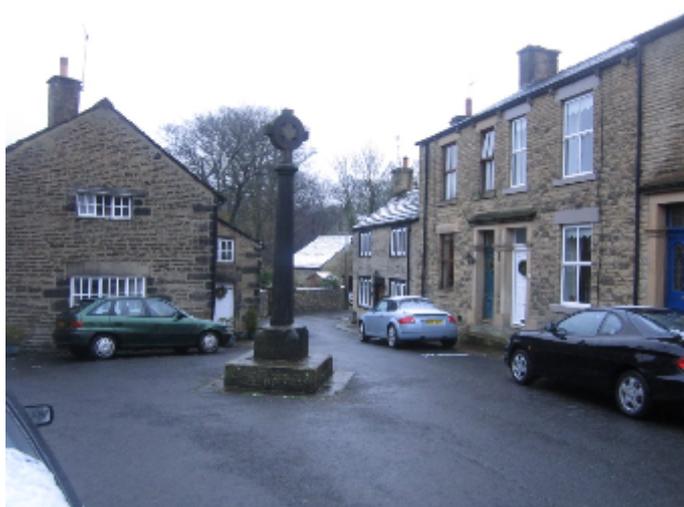
Figure 1) The Old Cross in late 2011, prior to the vehicle collision.

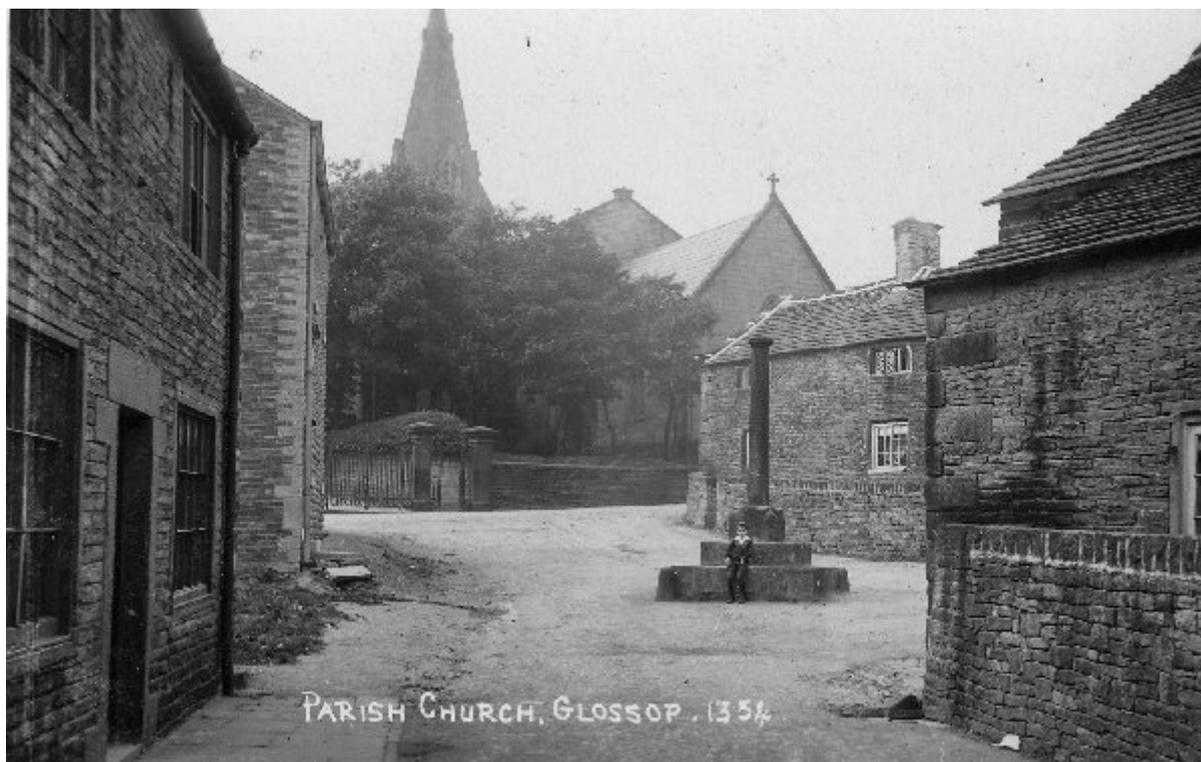
The predominant materials used for construction of buildings and boundary walls are sandstone and Millstone Grit coursed stonework, whilst the Old Cross itself is Millstone Grit to the cross-shaft and plinths. The Celtic Cross at the top of the cross-shaft is a 20th century addition as Figure 2 below shows in the late 19th Century with no Cross:

Figure 2) The Old Cross in the late 19th Century, not the absence of the Celtic Cross.

The repair is to restore the Cross to its late 19th Century appearance, with the base plinth being exposed, although the Celtic Cross will be retained in position. Assumed buried existing support stones to corner of base plinths (as shown in image 'The Old Cross, late 19th Century' above) to be lifted and installed or new in Millstone Grit stone to match existing stone to exposed parts of Cross. Pointing is to be undertaken with Hydraulic Lime mortar, with the shade to be agreed with the Conservation Officer.

The works are to not only repair the damage caused by the vehicle collision but also the opportunity is being taken to raise the Cross by approximately 150mm to expose the base plinth again and provide support stones, as per those shown on the 'The Old Cross, late 19th Century' image, to all corners of the Cross.
