**Land off Gisbourne Yard, Old  
Road, Whaley Bridge**  
Daytime Bat Survey Report

<b>Client</b>	William & Sebastian Bates
<b>Job</b>	Land of Gisbourne Yard, Old Road, Whaley Bridge
<b>Report title</b>	Daytime Bat Survey Report
<b>Draft version/final</b>	FINAL
<b>File reference</b>	6807_R_APPR_150313

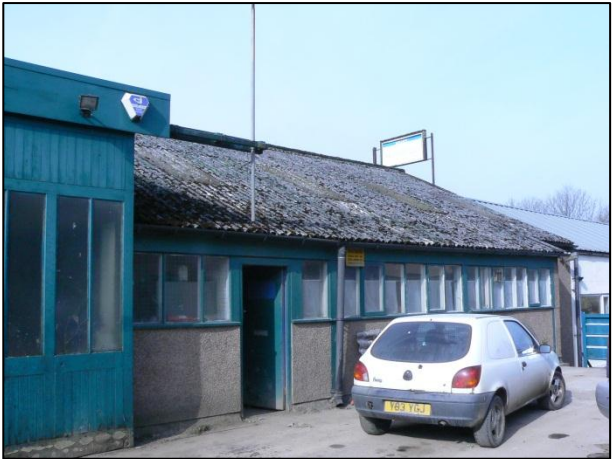
- 3.3 The photos referred to below can be found in Appendix 2.
- 3.4 The site is a single storey industrial building, built in the 1960s (Photo 1). Internally, the building comprises an open plan room with visible steel joists (Photo 2) and a small, sectioned off, office space. The building is currently used as a lorry maintenance depot. The walls of the building are brick built and covered externally by a pebbledash render (Photo 1). No gaps are present between the render and the wall.

<p><b>Photograph 1: Northern section of building</b></p>	<p><b>Photograph 2: Internal view of the roof</b></p>

<p>A photograph showing the northern section of a building with a green-painted wooden exterior and a grey stone roof. A white car is parked in front of the building.</p>

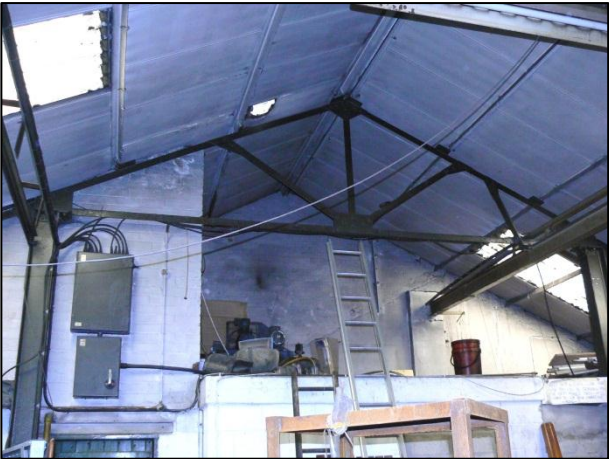
- 3.5 The roof comprises corrugated sheets of asbestos or cement fibre, lined internally with asbestos or cement fibre boards (Photo 2). Occasional translucent corrugated skylights are also present. No insulation is present between the corrugated sheeting and internal boards. No roof void is present in the building and the roof is not considered to provide any features suitable for roosting bats.

<p>An internal view of the roof structure, showing a corrugated metal roof sheeting supported by a wooden frame. A ladder is visible leaning against the wall.</p>
<p><b>Photograph 3: Blocked ridges of corrugated roof sheeting (arrow denoted where material has slipped leaving a gap).</b></p>	<p><b>Photograph 4: Gap at northern end of metal ridge tile</b></p>

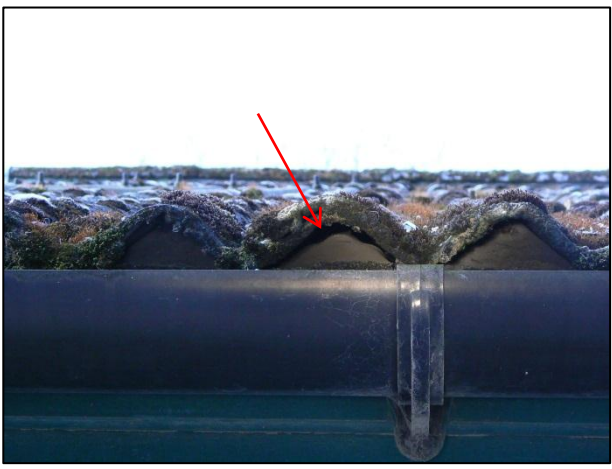
- 3.6 The gaps under the ridges of the corrugated sheeting are mostly sealed, however, on occasion, the material used to seal the hole has slipped, leaving a gap (Photo 3). It is possible that bats could access the underside of the corrugated sheeting where gaps are present; however, the corrugated sheeting is considered unlikely to offer suitable roosting habitat for bats. The ridge tile is composed of hollow metal. A hole is present at the northern end of the ridge tile (Photo 4); the hole could allow bats access to the ridge tile but the metal construction is considered unlikely to offer suitable roosting opportunities for bats.

<p>A close-up photograph of the corrugated roof sheeting, showing a gap between the sheets. A red arrow points to the gap.</p>

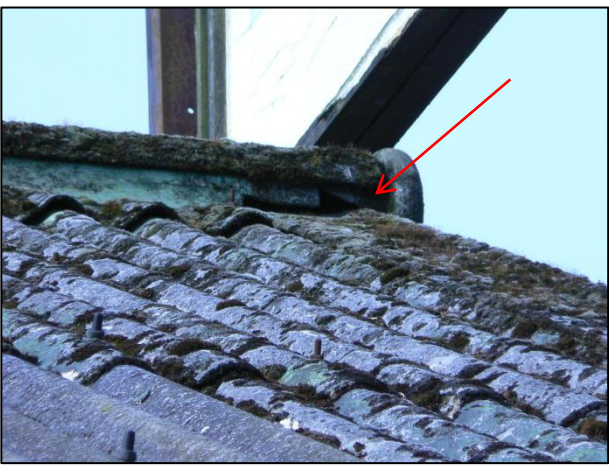
<p>A close-up photograph of the metal ridge tile at the northern end of the roof, showing a gap. A red arrow points to the gap.</p>

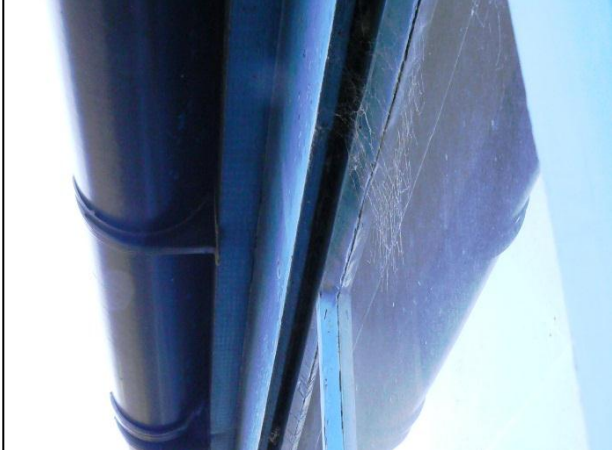
- 3.7 A row of wooden framed windows runs the length of the building on both the eastern and western elevations (visible in Photo 1). The window frames are old but intact. A wooden fascia board is present and a small gap is present between this board and the wall (Photo 5), however, the gap is shallow, is covered in cobwebs along much of its length and is considered unlikely to support roosting bats. No evidence of bats, such as droppings on the window below, was located.

<p><b>Photograph 5: Gap behind fascia board</b></p>	<p><b>Photograph 6: Flat roof structure in centre of building housing sliding doors</b></p>

<p>A close-up photograph of the fascia board, showing a gap between the board and the roof structure.</p>

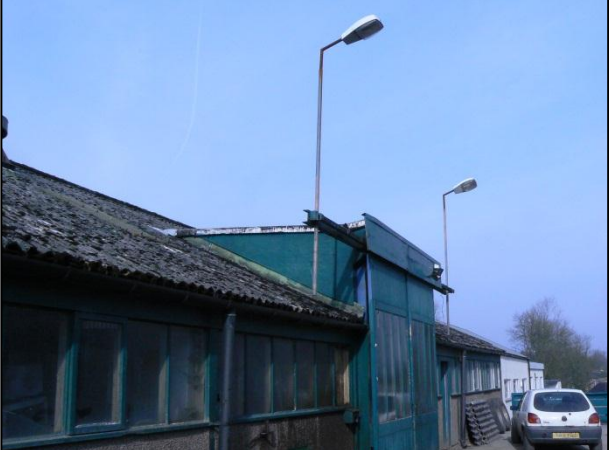
- 3.8 Two flat-roofed sections are present on the eastern elevation of the building. One, in the centre of the building, houses wooden sliding doors (Photo 6). A small gap is present in the frame of the structure where the wood has rotted (Photo 7). This gap does not appear to lead anywhere within the wooden frame and due to its proximity to the runners of the sliding door it is likely to be subject to high levels of disturbance. It is considered unlikely, therefore, that this gap would offer suitable roosting opportunities for bats.

<p>A photograph showing the flat roof structure in the center of the building, which houses sliding doors. A white car is parked in front of the building.</p>

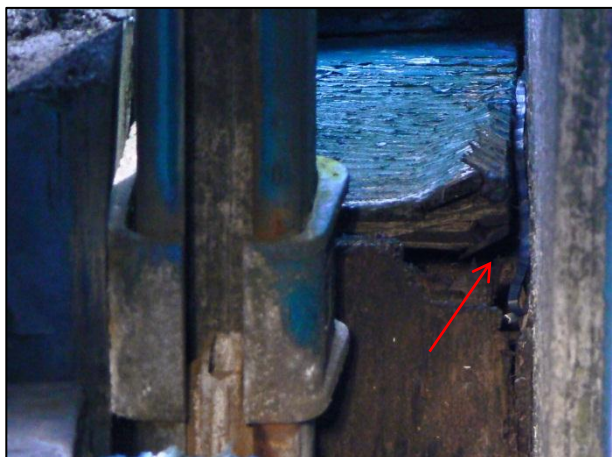
**Photograph 7: Rot hole in frame of sliding door**

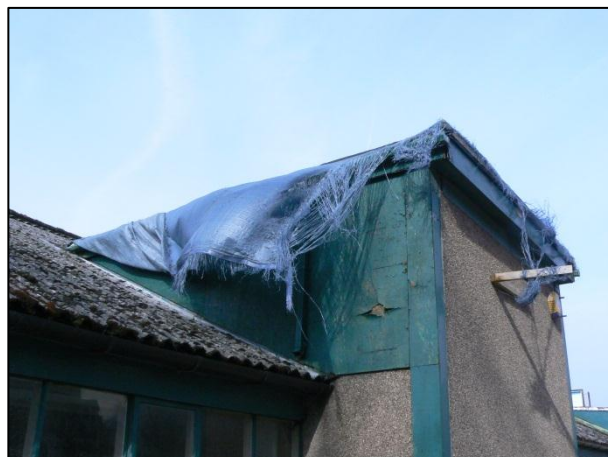
- 3.9 The other flat-roofed section, at the southern end of the building, is a small extension (Photo 8). A gap is present between the wooden frame and the roof of this section; however the gap leads directly into the open building. Both roofs are covered in bitumen felt and leak badly (pers.comm., W. Bates, 4<sup>th</sup> February 2013); the southern roof is currently covered by tarpaulin.

**Photograph 8: Flat roof structure at southern end of building with tarpaulin on roof**
