Buildings off Sheffield Road,
Chapel-en-le-Frith, Derbyshire
(NGR: 406400, 380928)

PROTECTED SPECIES INVESTIGATION SURVEY REPORT (BATS)

December 2011

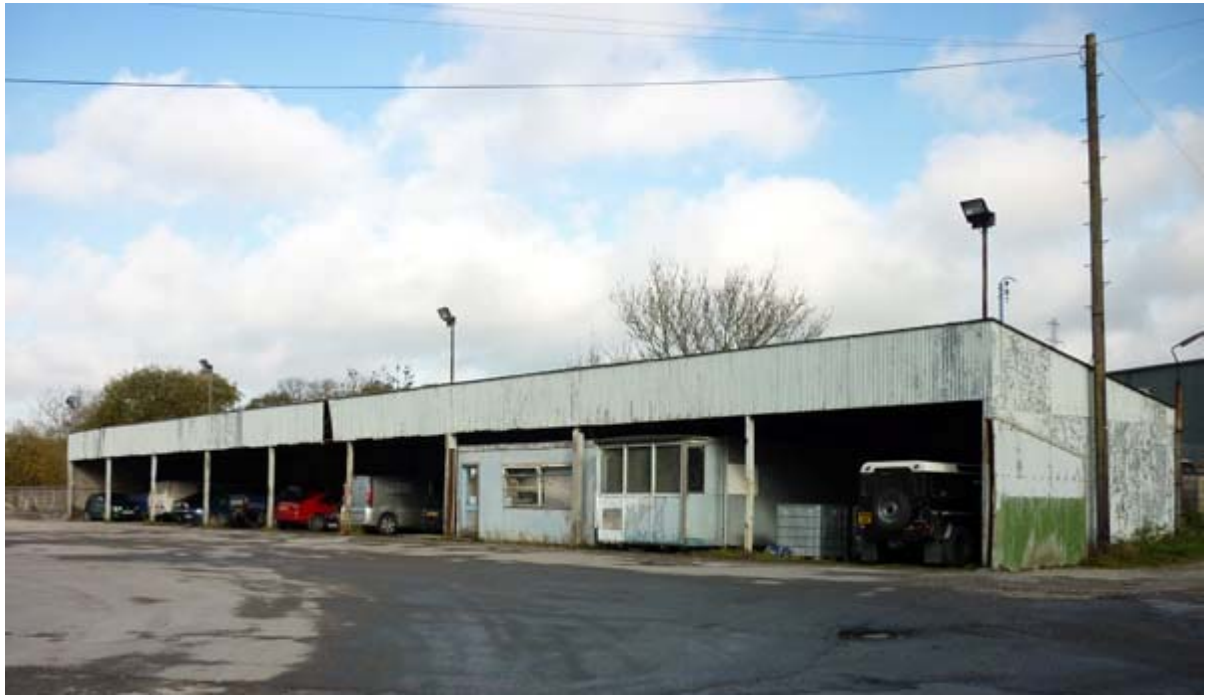
Photograph 1: Building B1 viewed from the south-east

Building	Description	Roost Potential
B1	B1 is a single-storey outbuilding constructed from corrugated metal (sides and a supporting sloping corrugated metal roof). B1 is open to the front apart from a short fascia on the front. Internally it is separated into nine bays, two of which are occupied by portable offices. The walls and roof are without cover or insulation and some of the sheets are damaged or missing. The guttering is bracketed directly to the northern side and is incomplete in places. The portable offices are generally tight, but the fascia has slightly warped away from southern side.	Low potential: A loft space is absent and the building is constructed of corrugated metal with no internal layering resulting in crevices being absent. The building is open fronted and will be subject to drafts, it is considered to offer low potential for roosting bats. The internal portable office contained a gap at the fascia, which was inspected with the use of an endoscope and no evidence of use by bats was found. Old birds' nests were evident.

- 6.6 The inspection and assessment survey of buildings (B1 and B2) found them to contain low potential to support roosting bats and no signs of bats were found. Therefore, there are no apparent implications with regards to roosting bats and Buildings 1 and 2. However it should be borne in mind that bats are occasionally found in the most unexpected places. If at any time bats are observed or suspected during the works, then all works must stop immediately and advice should be sought from the acting Consultant or Natural England.

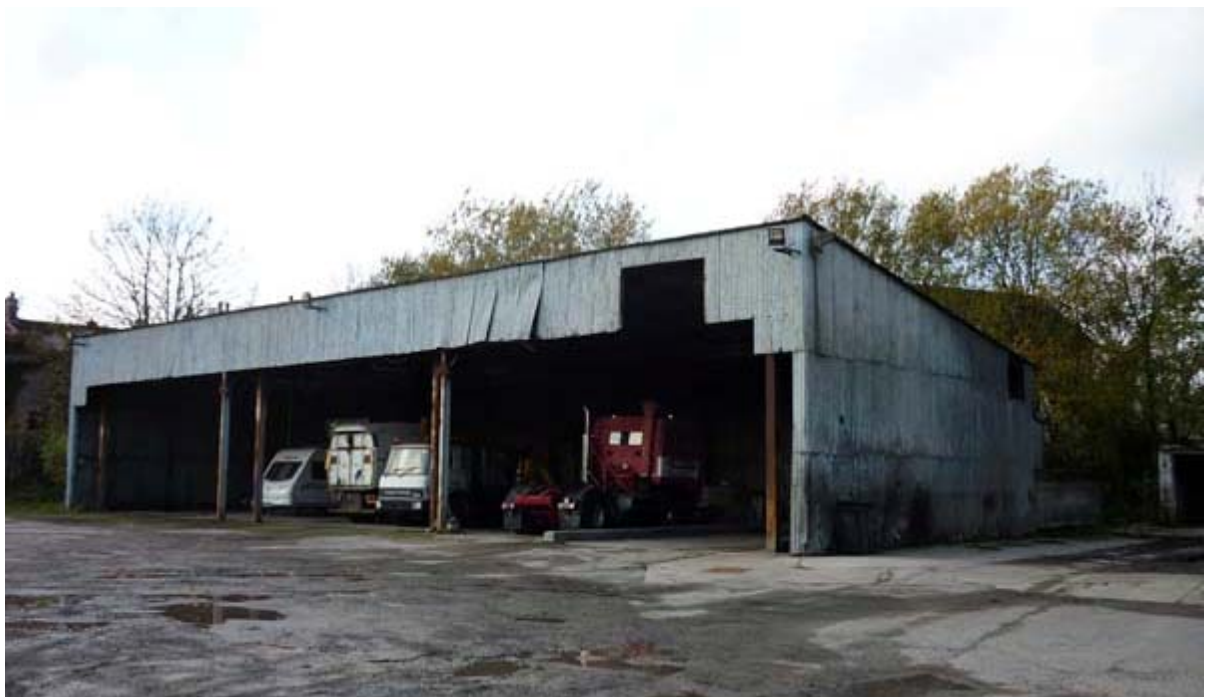
Photograph 2: Building B2 viewed from the north-east

B2	B2 is a single-storey outbuilding constructed from corrugated metal (sides and a supporting sloping, corrugated metal roof). B2 is open to the front apart from a short fascia. Internally it is separated into three bays. The walls and roof are without cover or insulation and some sheets are damaged or missing. The guttering is bracketed directly to western side. There is a breeze block extension attached to the western	Low potential: A loft space is absent and the building is constructed from corrugated metal with no internal layering resulting in crevices being absent. The wooden fascias carrying the guttering are tight fitting and the breeze block extension has folded barge boards on

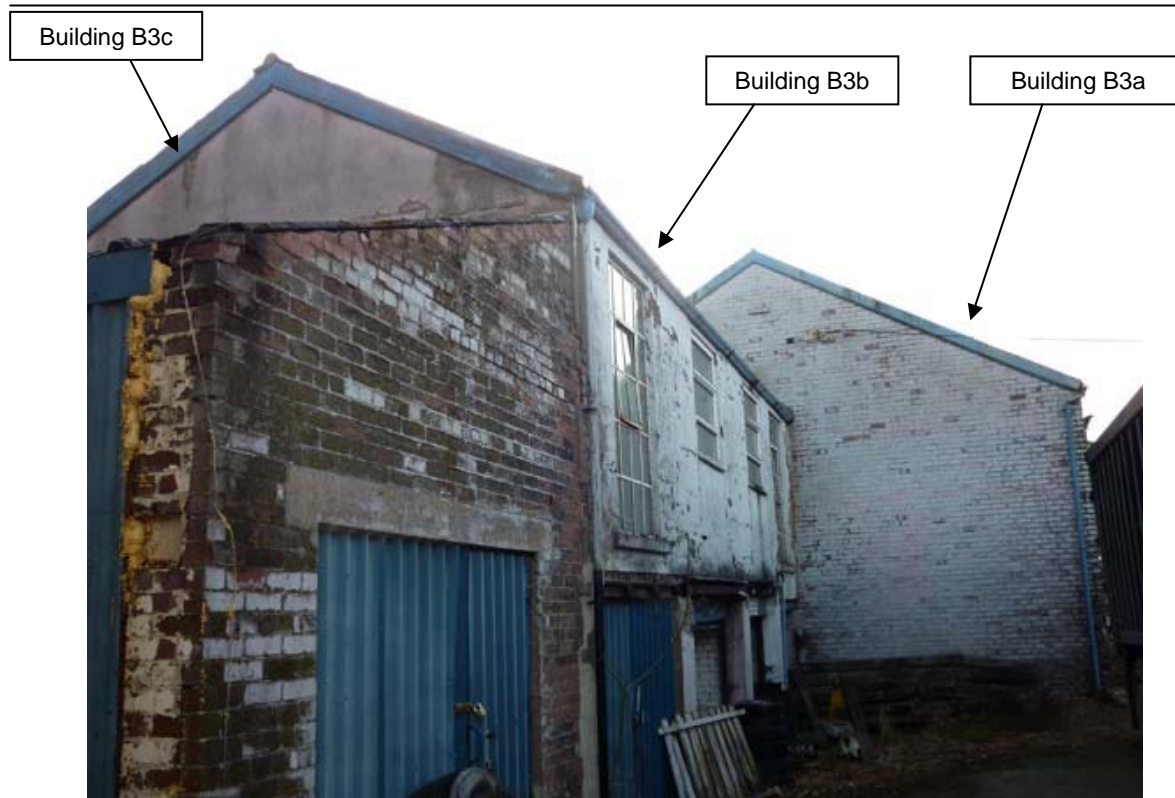
Photograph 3: Building B3 viewed from the north

side of B2 which has a sloping corrugated metal roof. Guttering is mounted on a wooden fascia which is tight fitting. There are folded metal barge boards over northern and southern sides which are very loosely fitting resulting in a large gap with no suitable crevices.	northern and southern aspects, neither contains suitable crevices for bats. No evidence of use by bats was found.
B3	<p>B3 is comprised of three attached buildings. This building was not able to be accessed internally during the survey.</p> <p>B3a is the largest and southernmost part of B3. It is constructed from brick which supports a corrugated cement fibre pitched roof. There are wooden barge boards overlaid with folded metal on northern gable and wooden barge boards on southern gable. The guttering is bracketed directly to the western side and to a wooden fascia on the eastern side of the building. There is a mixture of metal and wooden door frames.</p> <p>B3b is a two storey building with cement rendered brick walls and a supporting corrugated cement fibre pitched roof. Barge boards are present on the northern gable, which are damaged. The guttering is bracketed directly onto the western side of the building and fixed to a wooden fascia on the eastern side. There is a mixture of metal and wooden windows and door frames. Storage areas on the ground floor are mainly open on the western side, with no doors or shutters.</p> <p>B3c is a lean-to attached to the northern side of B3b. It has brick walls on the eastern and western sides, and a corrugated metal wall on the northern side. The roof is of corrugated cement fibre. The barge board is absent from the western wall and incomplete on the eastern wall.</p>	<p>All B3 (a/b/c) contain medium potential:</p> <p>B3a has an almost continuous gap between the southern gable barge board and the eastern pitch that may be accessed by crevice-seeking bats. There is space beneath folded metal covering on the northern barge board (unable to properly assess from the ground). The wooden fascia on eastern side is warped in places which also created gaps that could be accessed by crevice-seeking bats.</p> <p>B3b has numerous ingress points where the northern barge board is broken and ill-fitting. The ridge tile is damaged at the apex and has created a gap. Fascias are tight to the walls and windows and door fittings are generally tight.</p> <p>B3c has numerous gaps between the roof and brickwork where the barge boards are either absent or damaged and which may be suitable for crevice seeking bats.</p> <p>No evidence was recorded of use by bats in any of B3's buildings.</p>

- 6.1 The bat investigation and assessment survey identified features at the site that may provide suitable bat roosting habitat, within buildings B3, B4, B5, B6 and B7. Therefore, it is recommended that further activity surveys should be undertaken on all buildings that contain medium potential to further assist in determining the presence/absence of roosting bats.
- 6.2 It is recommended that an internal inspection of building B3 be carried out which could be achieved immediately prior to the activity surveys proposed for buildings B3, B4, B5, B6 and B7.
- 6.3 The activity surveys will need to be undertaken during the breeding season of bats i.e. between May and August. Generally three activity surveys are required over that

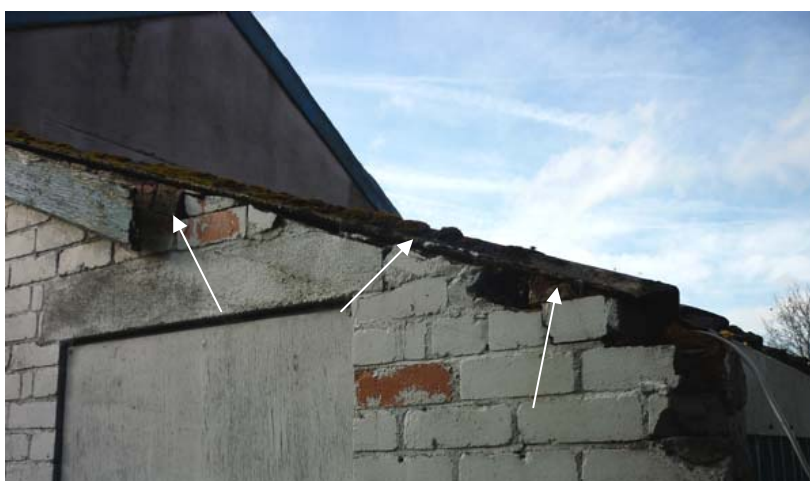
- The crevices apparent between the roof and brickwork where barge boards are absent and the frequent gaps between the wooden fascias and barge boards and the brickwork of building B3;

Photograph 4: Building B3c with roost opportunities

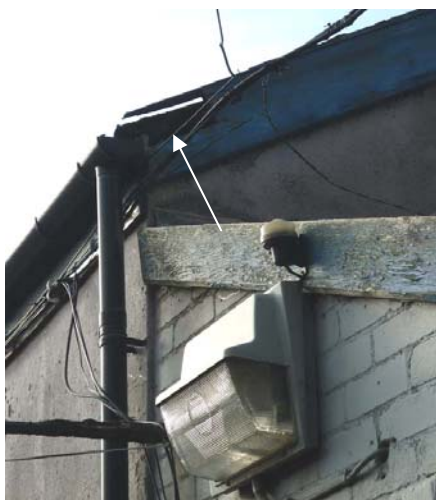
Photograph 5: Building B3b with roost opportunities

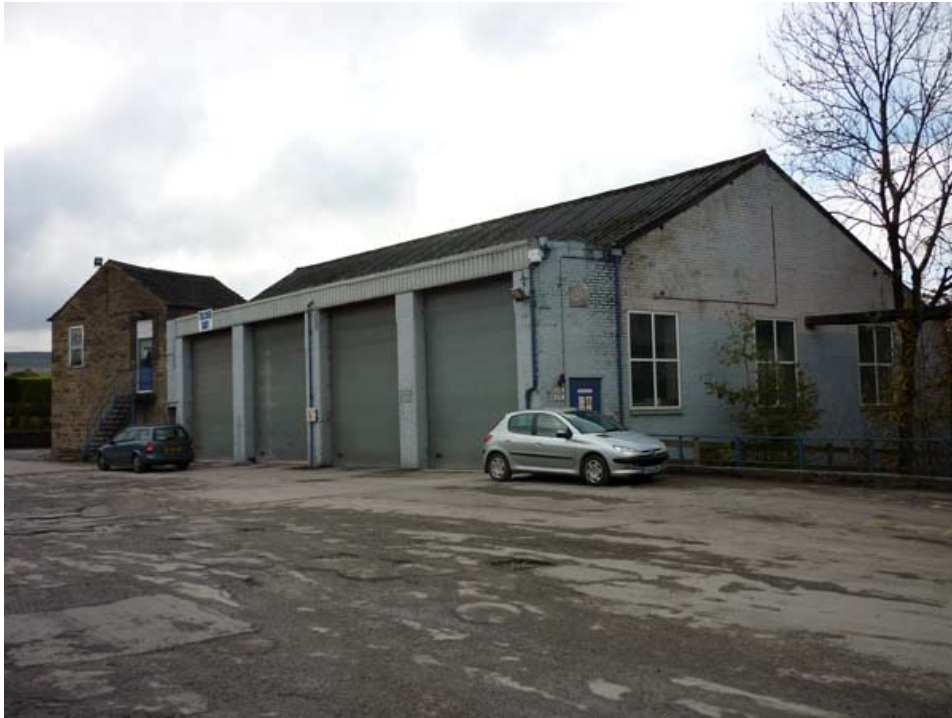
Photograph 6: Building B4 viewed from the north-east

B4	Building B4 has brick walls supporting an unequally pitched roof of corrugated cement fibre, with a double pitch to the eastern side of the roof. The double pitch to the eastern side is hidden from view from the ground by a corrugated metal fascia. The building is divided into four bays covered by metal roller shutter doors housed within a wooden framework. There are cement fibre barge boards on the northern gable end. The door	<p>Medium potential:</p> <p>The building is of relatively sound construction but the cement fibre barge boards on northern gable contain continuous gaps that could be accessed by bats to gain entry into the space between the fibre insulation boards and the roof. Windows and door frames tight.</p>

- The numerous gaps between the cement fibre barge boards and the northern gable of building B4;
 - The extensive gaps between the barge boards and gables of building B5;

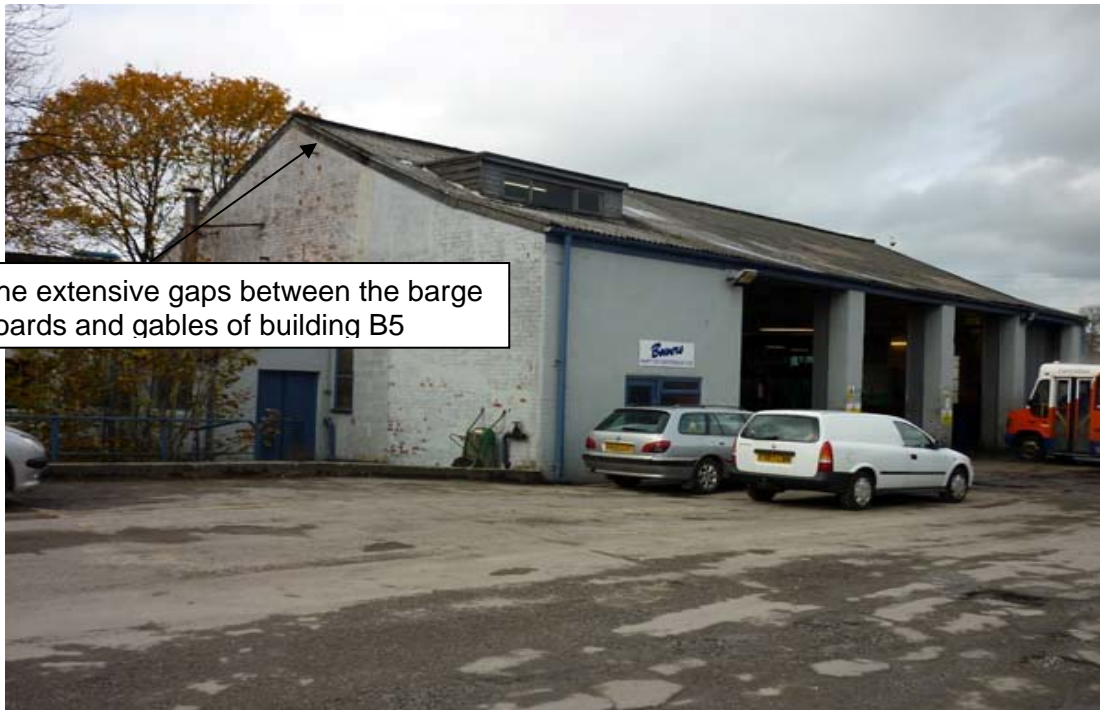
Photograph 7: Building B5 viewed from the south-east

and framework is wooden with recently refurbished uPVC windows. There is fibre board insulation that is complete in some bays and sealed with tape.	No evidence was recorded in the building of use by bats.
B5	Building B5 has brick walls supporting an unequally pitched roof of corrugated cement fibre, with a double pitch to the eastern side of the roof. There is a wooden dormer window in the eastern pitch. The ridge fitting is made of cement fibre. There are cement fibre barge boards on the northern and southern gable ends. The building is divided into four bays covered by metal roller shutter doors housed within a wooden framework, with a fifth section used as an office and storage. The window and door frames are wooden. There is a corrugated metal extension along the majority of the western side and extending to the northern gable end. Internally, the roof is partially insulated by fibre boards.	<p>Medium potential: The building is not as well maintained as B4, but it is of a similar design. There are gaps apparent between the roller shutter wooden framework and there are gaps in the brickwork that bats could access. There are extensive gaps between barge boards and the gable ends that bats could use to gain access to the space between the fibre board insulation and the roof. Some of the fibre board insulation is incomplete but there is still extensive coverage sealed by tape.</p> <p>No evidence was recorded in the building of use by bats.</p>

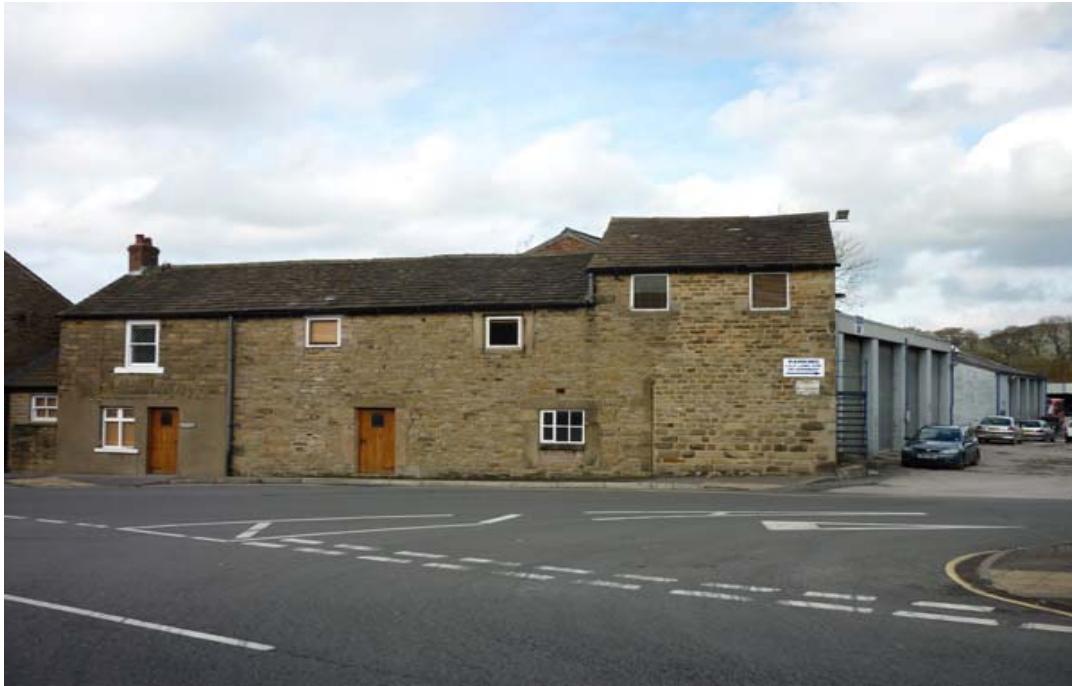
Photograph 8: Building B6 viewed from the south-east

B6	Building B6 comprises three separate houses converted into one and used as offices. B6 is constructed of stone walls with a grey slate covered pitched roof with clay ridge tiles. There are no barge boards on either gable end. The guttering is bracketed directly to the northern and southern elevations. There are wooden windows and door frames. The roof felt is not entire. Relatively recent loft work has involved the installing of a partial false ceiling but access was still available. Loft height varied between approximately 1.5 – 2m high. The building interconnects internally with building B7.	<p>Medium potential: Roof slates have become dislodged in places creating gaps that would allow ingress by bats between the slates and the roofing felt. Gaps are also apparent that would allow ingress by bats against some ridge tiles and where mortar is displaced on both gables between the stonework and slates. Light was seen to be penetrating into the loft at the gable ends between the stonework and the roof and through the dislodged slates.</p> <p>No evidence of use of the building by bats was recorded.</p>

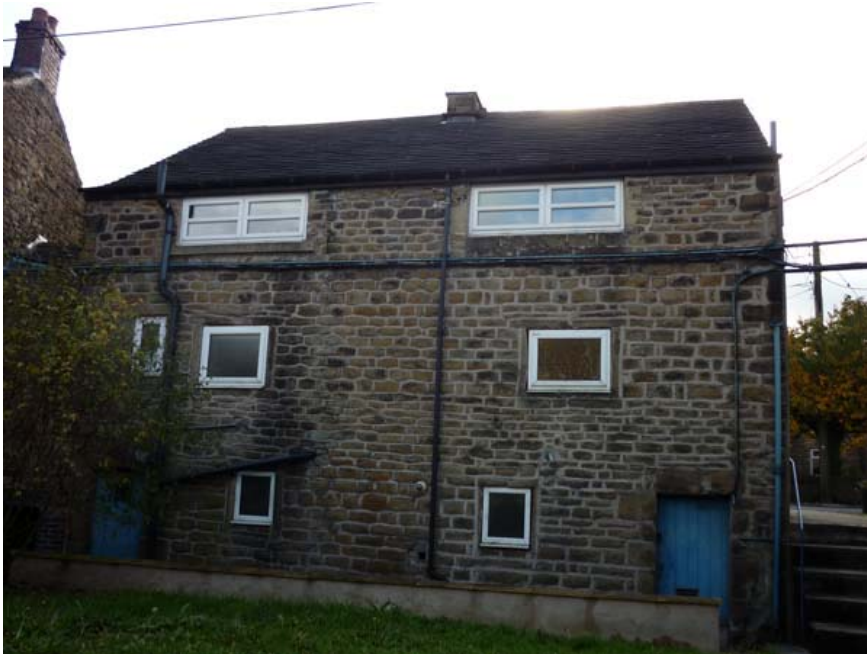
Photograph 10: Building B7 viewed from the north

B7	Building B7 comprises of two separate houses converted into one and used as offices. It has stone walls and a tiled roof pitched roof with clay ridge tiles. There are no barge boards on either gable end. The guttering is bracketed directly to the southern side of the building and fixed to a wooden fascia on the northern side. The window frames are uPVC and the door frames are wooden and generally tight. The roof felt is entire and the loft height varies between approximately 1.5 – 2m high. The building interconnects internally with building B6.	<p>Medium potential: There are numerous gaps between the wooden fascia carrying northern side guttering and the stonework that could be accessed by crevice-seeking bats. Some roof tiles are lifting, particularly on the northern pitch creating gaps that could allow ingress by bats. The gable ends have been relatively recently pointed up between the roof tiles and stonework.</p> <p>No evidence of use of the building by bats was recorded.</p>

- The frequent spaces apparent on the roof of B6 through dislodged tiles, displaced mortar against slates and gaps against ridge tiles;
 - The gaps created by lifting roof tiles and the spaces between the wooden fascia and stonework of building B7.
