BAT SURVEY & REPORT
at
St Christopher Trust
Redcourt/Hollin Cross Lane
Glossop
Derbyshire
SK13 8JH

10626/B/CS

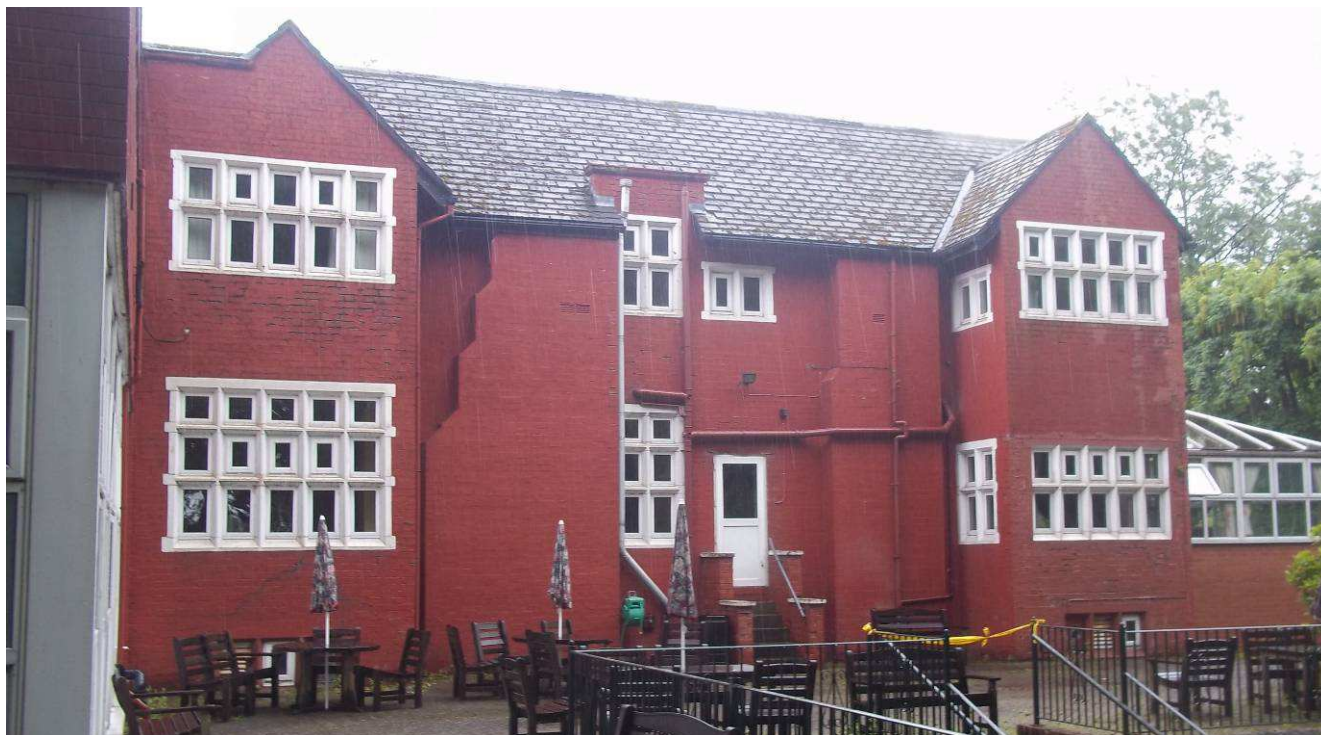
Building 1: This appears to be the oldest building on site. It is a two storey red brick building, with a pitched slate tile roof. A conservatory is attached to the south-western corner and a large two storey brick extension, with a flat roof, is attached to the north-western corner. Overall the external walls are in an excellent state of repair, however, a small amount of damage was noted on a section of the west facing wall (Target note 8). Here, large areas of mortar had fallen away from between the brickwork, creating a series of shallow gaps. After closer inspection, all of this damage appeared to be superficial, with none of the gaps seeming to lead into the cavity wall space. The buildings roof extended over the eaves by around 30cm and had wooden boarding fixed along the ends. Gaps were present under most of the eaves, however it was unclear whether these gaps lead into the loft space or cavity walls. The mortar running along the apex of the gable end walls were all in an excellent state of repair with no gaps being noted. The roof was similarly in a good state of repair, with no missing, lifted or slipping tiles, or missing mortar being noted. The roof was also sparsely covered in moss. A small wooden porch was located along the southern wall. Where this porch connected to the building, a gap was present (roughly 5cm wide) which extended vertically up into the roof (Target note 9). It is possible that this gaps leads to a small space between the roof and ceiling of the porch. The ground directly underneath this gap is shelter from the weather and is left largely undisturbed. The entire porch was carefully searched for signs of bat activity but none were found.

The building has a single large loft space and both the floor and ceiling are insulated. The loft appeared unused and was therefore in a very dirty condition, with large amounts of cobwebs covering the ceiling and rafters. The roof was supported by a mix of small rafters and large steel beams. A series of brick walls were present throughout the loft, which were around half the height of the loft. Around 4 chimney stacks were noted within the loft. These had all been partially dismantled, meaning the chimneys had been removed from the roof and the roof sealed over, but the open chimney stack was still present within the loft. Two windows were present towards the southern end of the loft, one of which had a small gap (roughly 3cm) running along the lintel (Target note 4). There is therefore the potential for bats to enter the loft via this gap. The windows and surfaces surrounding this gap were carefully searched but no signs of bat activity were found. A large wasp nest was present to the northeast (Target note 5). A small number of old bat droppings were found to the north of the loft under a gap in the roof insulation (Target note 6). This suggests that a single or small number of bats could have roosted in this part of the oft in the recent past.

Overall this building has been deemed to have a **moderate** bat roost potential.

Photo 1: A view of building 1 from the west.

- 5.1 Building 1 and 3 have been deemed to have a **moderate** and **high** bat roost potential, respectively. Bat droppings were noted within the lofts of both of these building. Due to building 6's close proximity to the woodland edge and stream and its current condition, this building has been deemed to have a **low to moderate** potential for roosting bats, even though no evidence of bat activity were found. It is therefore recommended that further bat surveys are undertaken on Buildings 1, 3 and 6.

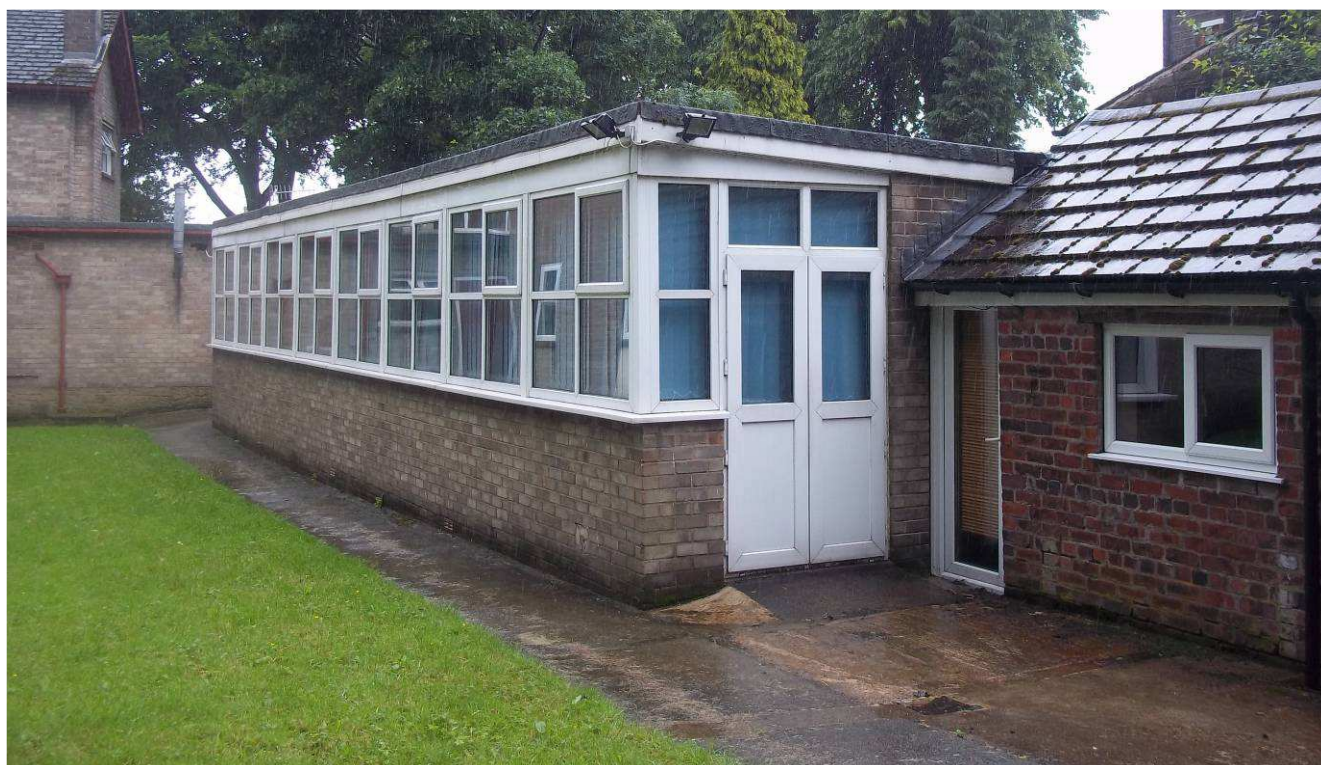
Building 2: This building could be divided into two distinct halves. The western half was a single storey brick building, with a flat felted roof. The bottom half of the external walls are constructed of brick and the top half fitted with windows. Wooden boarding is present along the eaves and is fitted tight to the wall leaving no gap. The eastern half of the building appeared to be much older. This was again single story and constructed of brick. The roof was pitched and covered in large slate tiles. Wooden boarding ran under the eaves and again fixed tight to the walls. The gable end wall was completely rendered and overall the external structure was in a good state of repair. We were informed that this building had no loft space.

Overall this building has been deemed to have a **low** to **very low** bat roost potential.

Photo 2: A view of building 2 from the southeast.

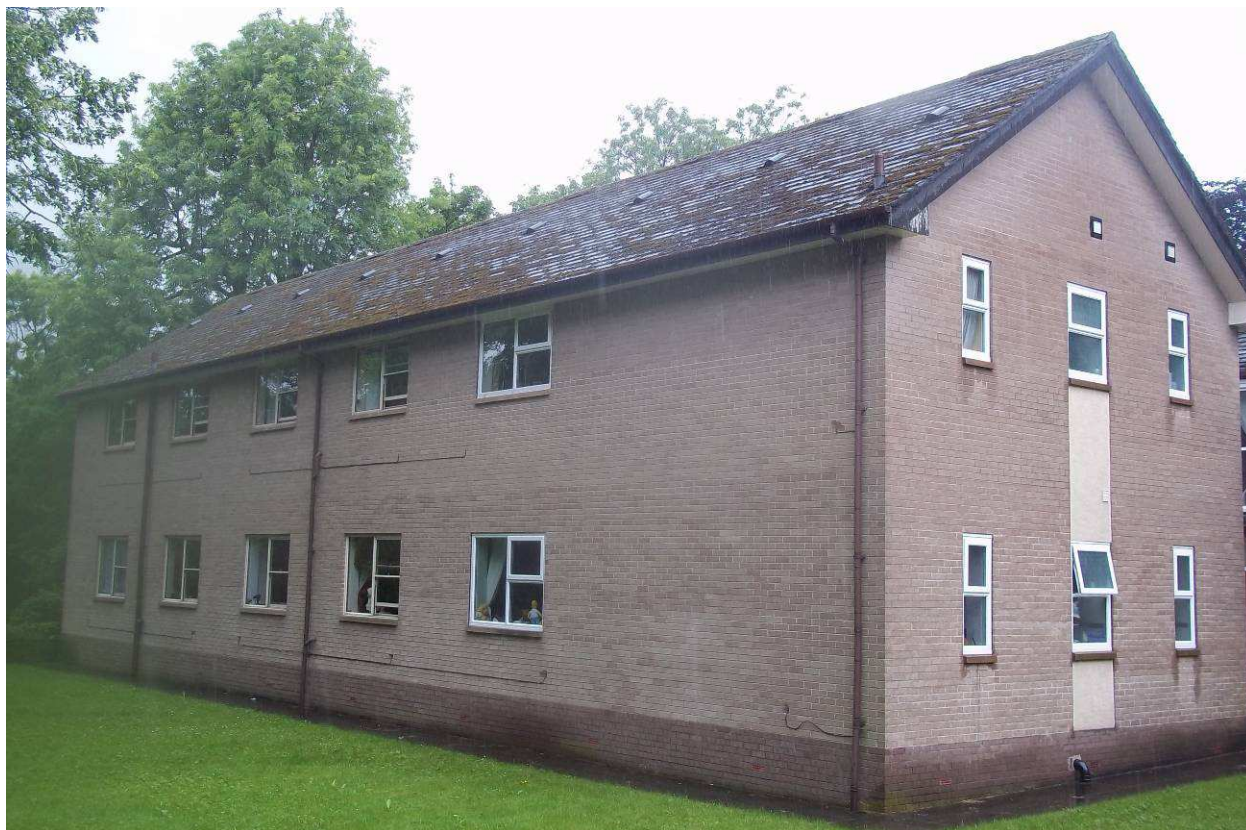
Building 3: Building 3 and 4 were connected by two walkways. This building was two stories high with a pitched slate tile roof. The roof and external walls appeared to be in an excellent state of repair, with no obvious defects noted. White wooden soffit boxing was present under the eaves and was in a similarly good state of repair. This boxing was not fixed tight to the wall, meaning a small gap (around 1-2cm) was present between the soffits and wall. This gap was present around the entire building. No signs of bat activity were noted around any of these gaps.

The loft had previously been one single large space. However within the recent past, a series of plaster board walls had been erected, effectively dividing the loft into 7 individual loft spaces with a small walkway running along the centre. The 7 lofts were of differing sizes and could be accessed via the walkway by small hatches in the walls. The loft spaces appeared to be completely separate, with no potential access for bats between them. The roof and floors were all insulated and the lofts were in a clean condition. What looked like a small pile of old disintegrated bat droppings were found within the far southern loft (Target note 1). A single bat dropping was found in one of the lofts to the east (Target note 2). A large number of fresh droppings were found on the floor, along the western wall of one of the lofts (Target note 3). This indicated that up to 3 bat roosts may be present within this building.

Overall this building has been deemed to have a **high** bat roost potential.

Photo 3: A view of building 3 from the east.

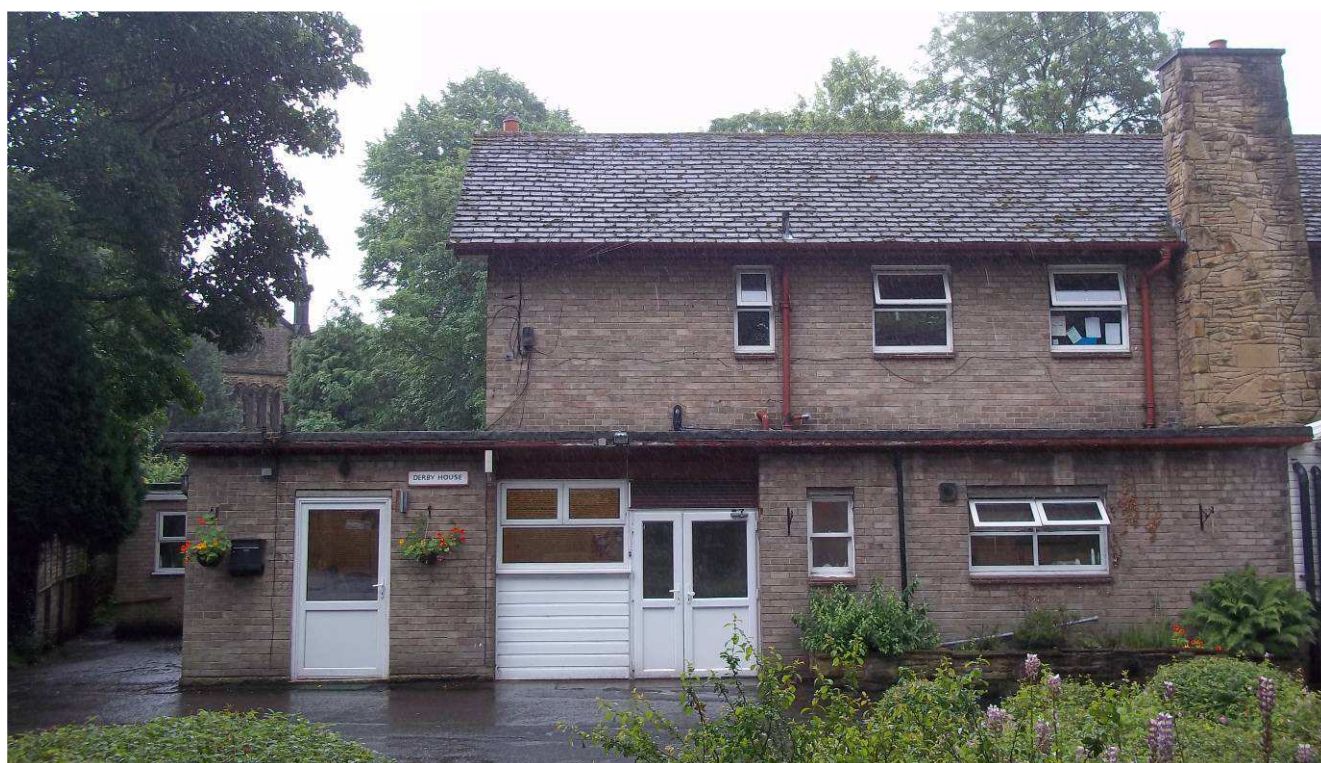
Building 4: This building was of similar age and design to building 3. The building was again two stories with a pitched slate tile roof. The roof and external walls were in an excellent state of repair, with no obvious defects noted. Red wooden soffit boxing was present under the eaves, and was in a similarly good state of repair. Again the boxing was not fixed tight to the wall, meaning a small gap (around 1-2cm) was present between the soffits and wall. This gap was present around the entire building. No signs of bat activity were noted around any of these gaps. We were informed that this building had no loft space. A single storey brick extension, with a flat felted roof, was present around the northern half of this building. No gaps were noted under the eaves. A glass conservatory was present along the southern half of the west facing wall.

Overall this building has been deemed to have a **low** bat roost potential.

Photo 4: A view of building 4 from the west.

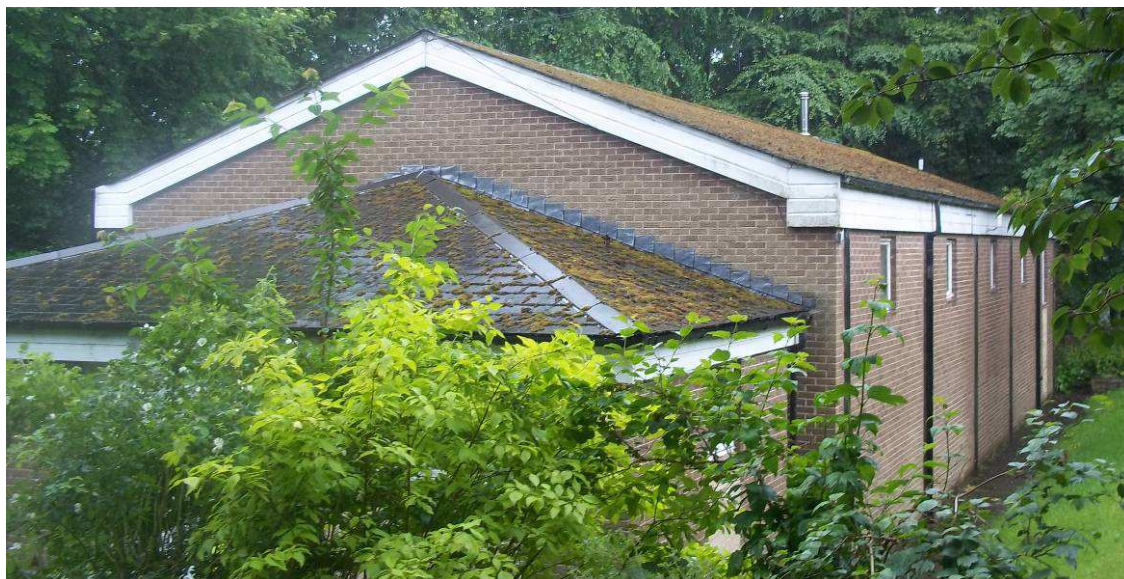
Building 5: This was a single storey brick building of similar age to buildings 3 & 4. The building had a pitched tile roof, densely covered in moss. A small pitched roof extension was present along the eastern wall. The roof and external walls were in an excellent state of repair. White wooden boarding was present under the eaves and a gap was present between this boarding and the walls. The building is currently used as a gymnasium and we were informed that it contains no loft space.

Overall this building has been deemed to have a **low** bat roost potential.

Photo 5: A view of building 5 from the east.

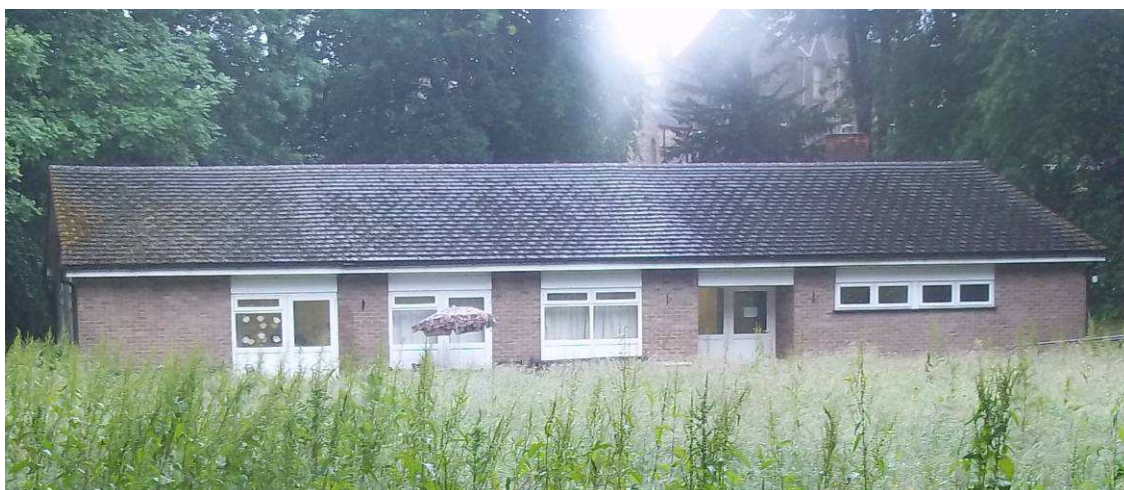
Building 6: This building was of similar age and design to building 5. The building had a pitched tile roof, which was sparsely covered in moss. The roof and external walls were again in an excellent state of repair. White wooden soffit boxing is present under the eaves and a small gap is present between this boxing and the walls. The building has a single large loft space which is only occasionally used for storage. The roof and floor is insulated and the centre of the loft had been boxed off with plaster board. The roof is supported by a series of small wooden beams and rafters. The loft was carefully searched, but no signs of current or historic roosting found.

Overall this building has been deemed to have a **low to moderate** bat roost potential.

Photo 6: A view of building 6 from the east.

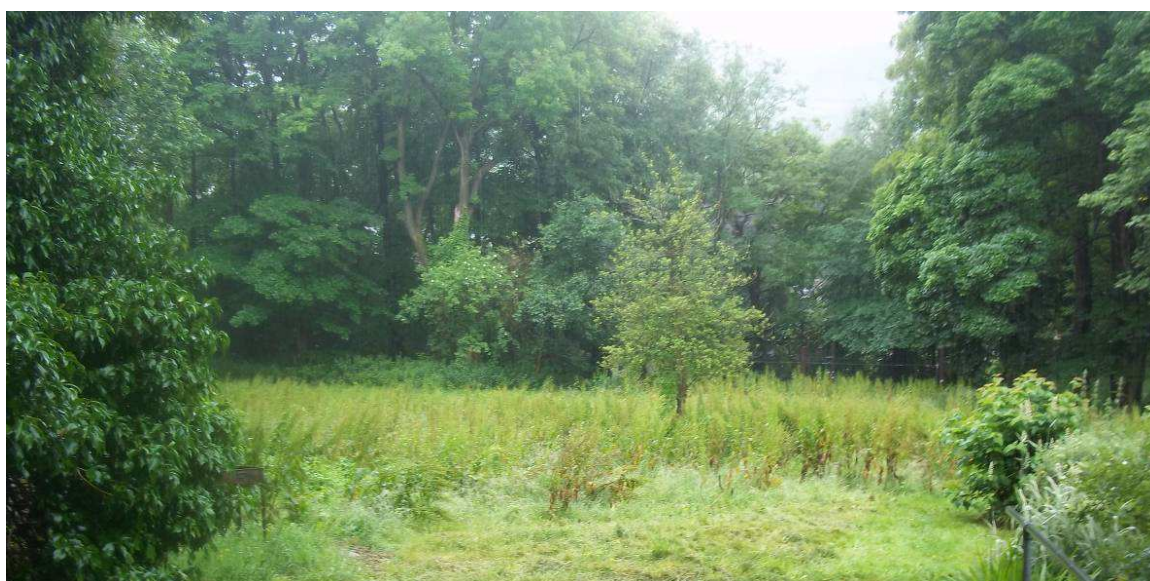
The site contained a mix of amenity and improved grassland, introduced shrubs, scattered mixed trees, tall ruderal, dense scrub and broadleaved woodland. A small stream also passed by the site, situated on adjacent land, bordering the south-western boundary. This stream had steep rocky banks, supporting a mix of tall ruderal and scrub vegetation. The banks also supported a large number of mature broadleaved trees.

The mix of habitats on site is likely to support a wide range of insect species throughout the year, and thus attract foraging bats. Bats will especially be attracted to the tree lines, woodland edges and running water, as these features often support the greatest insect numbers. The woodland and stream also form part of a strong linear feature (green corridor), which has the potential to be used by commuting bats.

Photo 8: A view of the improved grassland and woodland present within the south-western half of the site.
