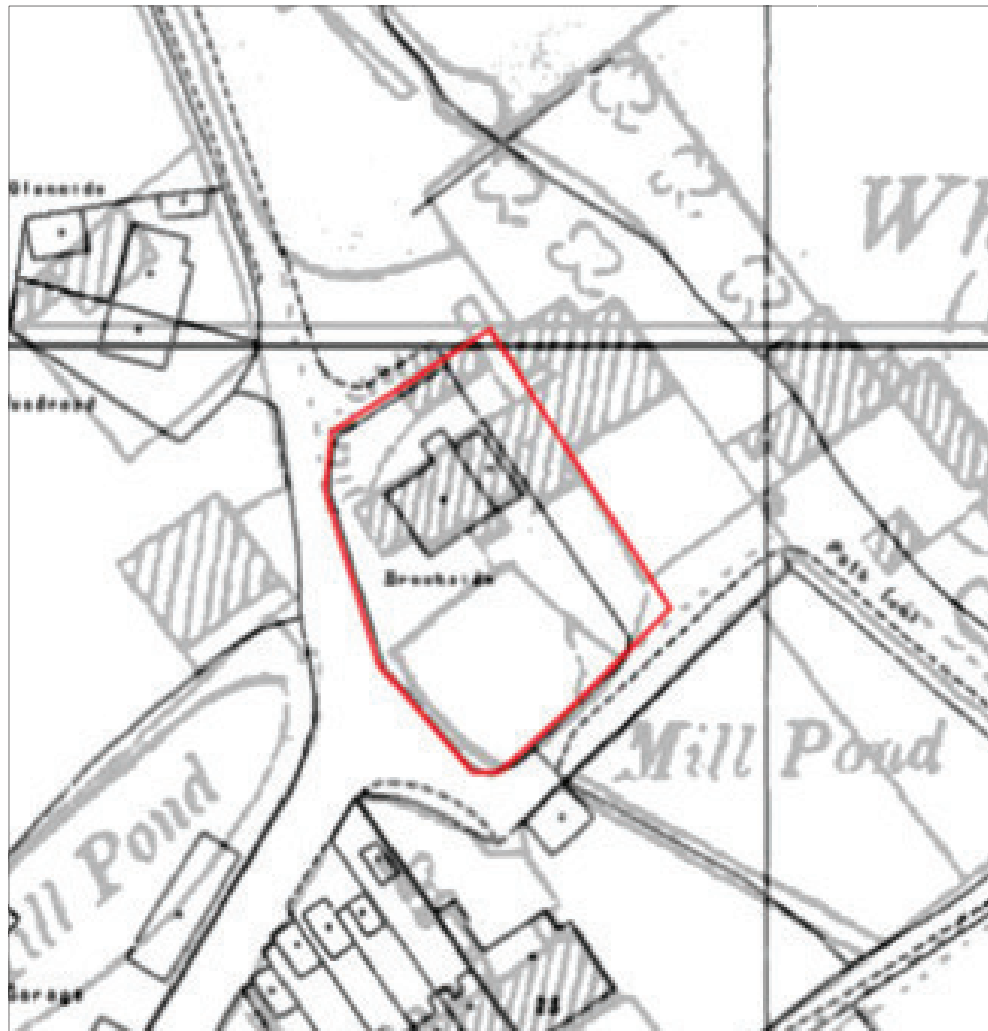
Figure 8: Overlay of 1992 and 1898 Ordnance Survey maps, showing location of Brookside bungalow in relation to White Mill

the majority of these features remained extant in 1910 but had been demolished by 1921. Brookside bungalow had been constructed by that date. Comparisons between the mill buildings that were depicted on the 1898 Ordnance Survey map and the position of the bungalow on the 1992 Ordnance Survey map suggest that Brookside was constructed directly over part of the former mill (Figure 8). The building appears to occupy the site of the loading and unloading bay that was shown at the west of the mill on the 1810 engraving (Plate 1).

It is not clear to what extent the mill was demolished or if the bungalow incorporated any elements of the earlier structure. No obvious evidence of the former mill buildings were visible within the fabric of the bungalow during the site visit, although it is possible that parts of sub-surface features such as foundations or basement levels may be present. It is also possible that basement levels were infilled and the ground levelled-up to form a surface on which to construct the bungalow. In that case, sub-surface features relating to the cotton mill may survive beneath the present building. This may include the goit that channelled water to the mill from the pond at the south of the site; the goit was not visible on historic maps, which suggests that it was a sub-surface feature that ran beneath the mill. Within the footprint of
