Coal Mining Risk Assessment

Carr Brook Works

Whaley Bridge

Report No. A0442/G/1

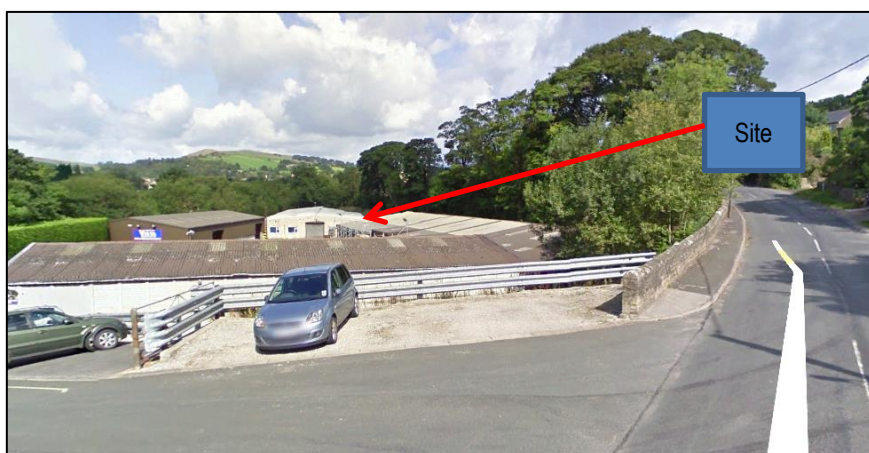
Figure 3 View of Site Frontage

- 2.3 Figure 3 (below) provides a photograph showing the site frontage.
- 2.4 The site is centred at Ordnance Survey National Grid Reference SK01450 80351, postcode SK23 7JN.
- 2.5 The two development areas lie at an elevation of approximately 181mAOD to 184mAOD.
