Bat Survey for Glossop Central Methodist Church, Chapel Street, Glossop

23 July 2014

MAMPAM CONSERVATION

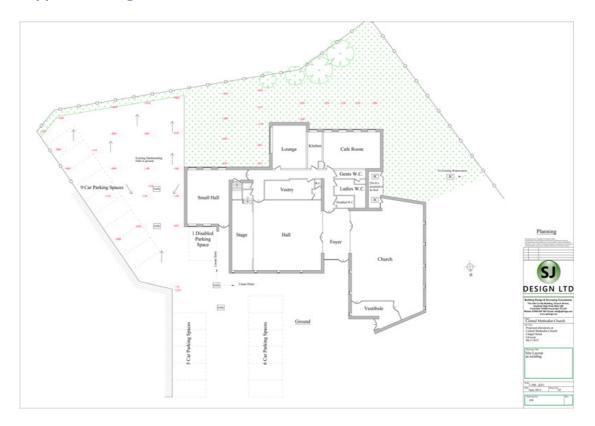
Figure 1: Plan of site.

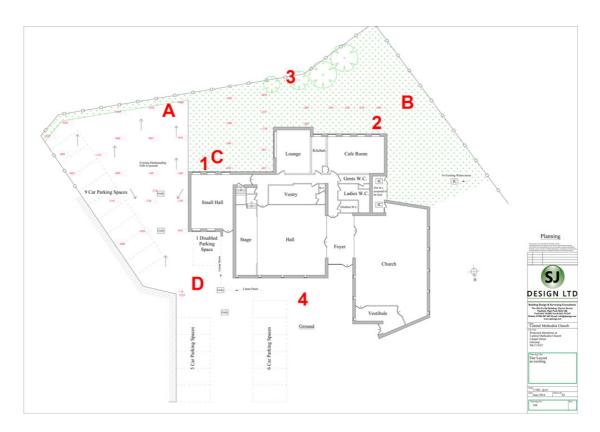
The small size of the site made transects for activity surveys unnecessary. The surveyor walked around the site and made observations on bats using ultrasound recorders, bat detectors and, where necessary, torches with red filters. Positions of ultrasound recorders is given in Figure 2. The surveyor recorded flight paths and used clues from bat detectors and biological intuition to interpret activity as foraging, commuting or social activity.

Figure 2. Position of ultrasound detectors (numbers) and night vision equipment (letters) during the survey.

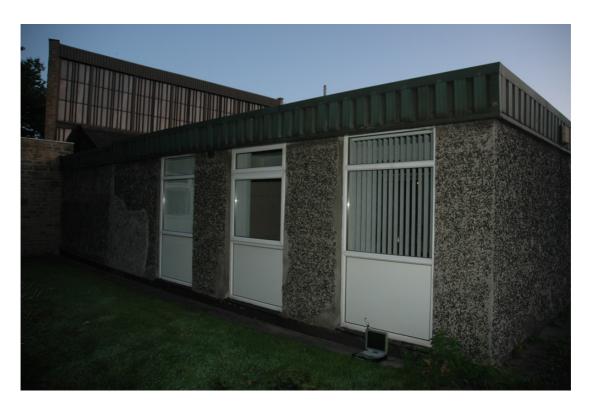
In May 2014 staff at the church had contacted pest controllers after finding what they thought were rodent droppings around a window in the southeast of the building. The pest controller told them they were bats droppings and subsequently the area was thoroughly cleaned. No bats droppings were found in this area during the survey, despite intensive searches.

Figure 4. Southeast wing of Central Methodist Church.

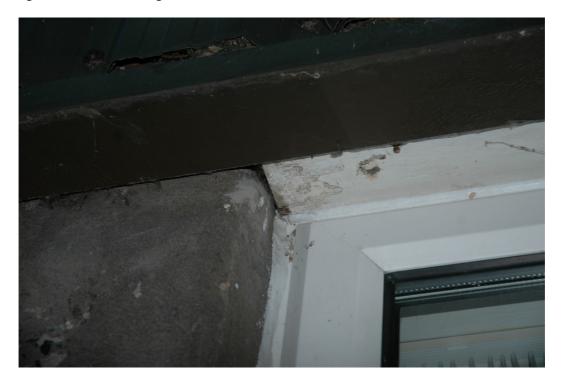
No evidence of bats was on or around the exterior of the building and no obvious access points to the interior of the buildings were identified. Roosting opportunities were limited to crevices between concrete panels and window frames, roof lips and soffit boards.

Figure 5. Details of crevice above window frame – left side

- 1. Fecal survey: Plastic sheeting placed below the roost will enable any droppings to be easily detected. The sheeting should be inspected weekly.
- 2. Roost watch. The roost should be monitored visually and with a heterodyne bat recorder at least once per month between February and November for one hour after sunset or for one hour before sunrise. The time of the earliest/latest bat calls detected should be recorded.

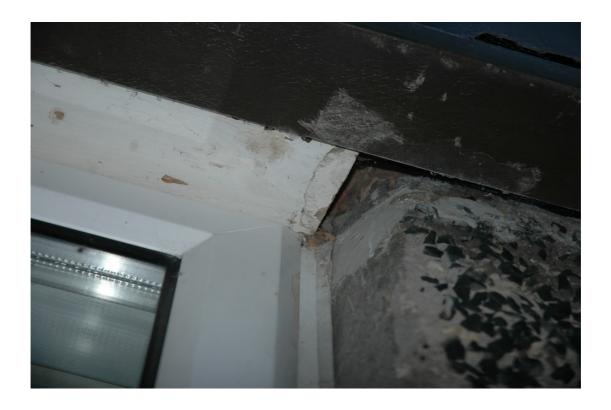
Figure 6. Details of crevice above window frame – right side
