DAYTIME BAT SURVEY AT BOWER COTTAGE, WHITLE FOLD, NEW MILLS, DERBYSHIRE

2014

RACHEL HACKING ECOLOGY

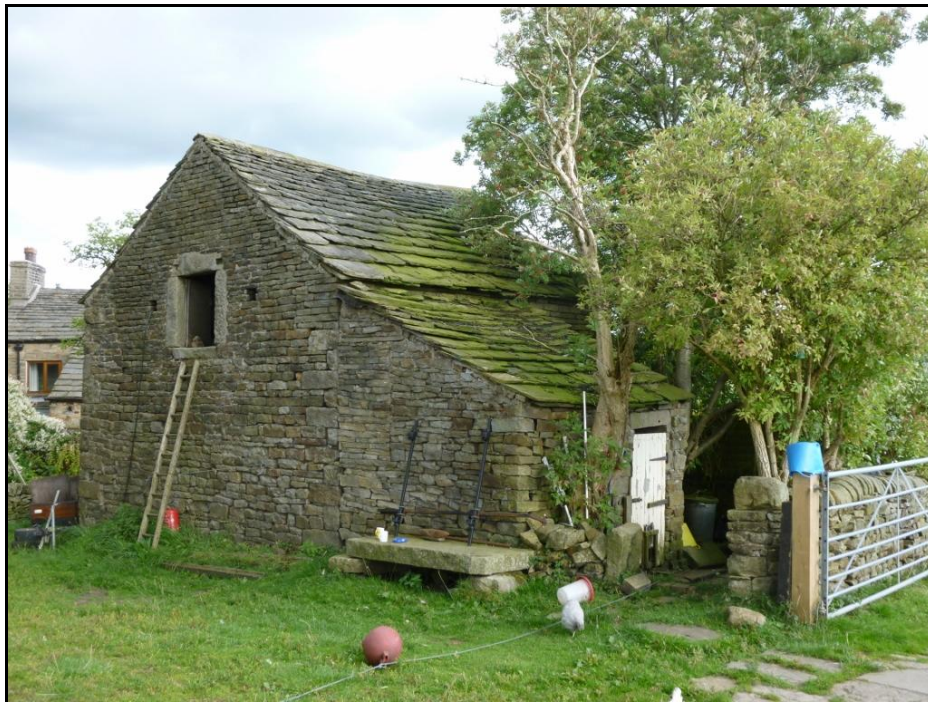
- 3.1 The barn at Bower Cottage is constructed of stone, with a pitched stone tile roof. The majority of the barn is two-storey in height. Two small one-storey extensions to the barn exist. To the north of the barn, is a one-storey extension with a corrugated metal roof. On the south side of the barn is a one-storey self-contained chicken coup, also constructed of stone with a stone tile roof (see Photograph 1).

Photograph 1 showing the south side of the barn

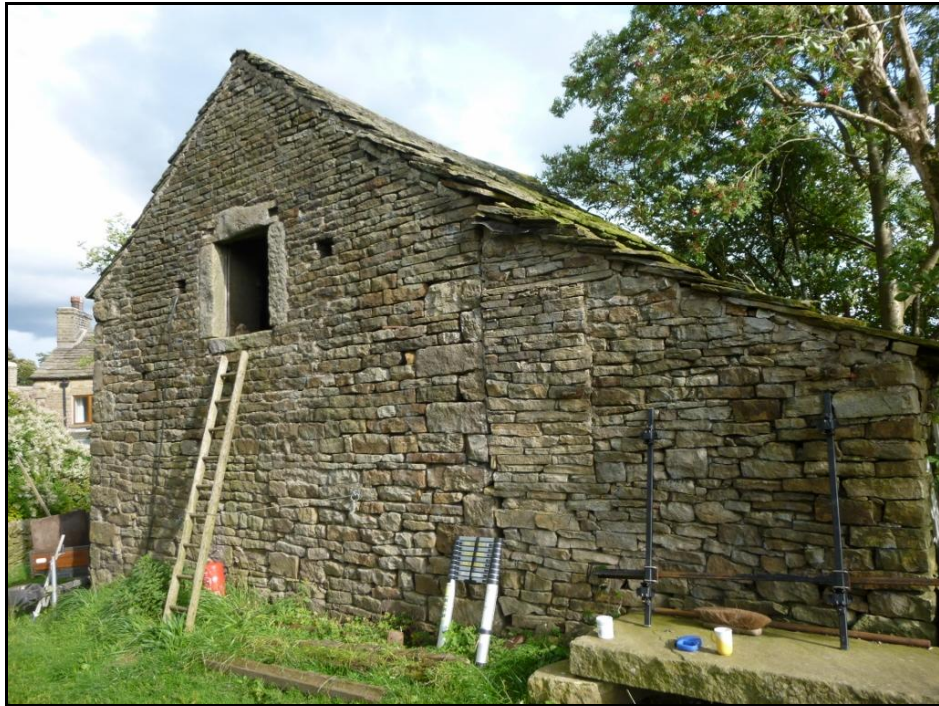
- 3.2 The barn was easy to survey externally. Many potential bat access holes were located. Gaps exist between the stonework, where the roof tiles meet the walls and through gaps in window shutters and doors, particularly on the western gable end (see Photograph 2). The majority of the gaps were covered in cobwebs.

Photograph 2 showing the gaps in the stonework

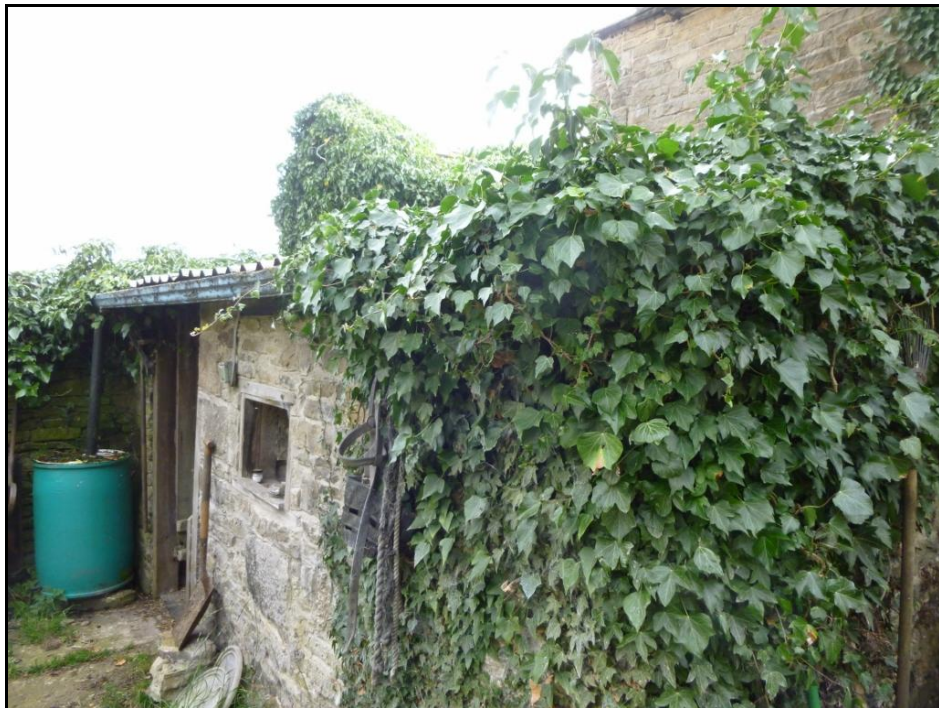
- 3.3 The small extension with a metal corrugated roof also exhibits gaps. This section of the barn is partly covered in Ivy *Hedera helix* (see Photograph 3). This was thoroughly inspected and no evidence of bat activity could be located.

Photograph 3 showing the one-storey extension to the barn

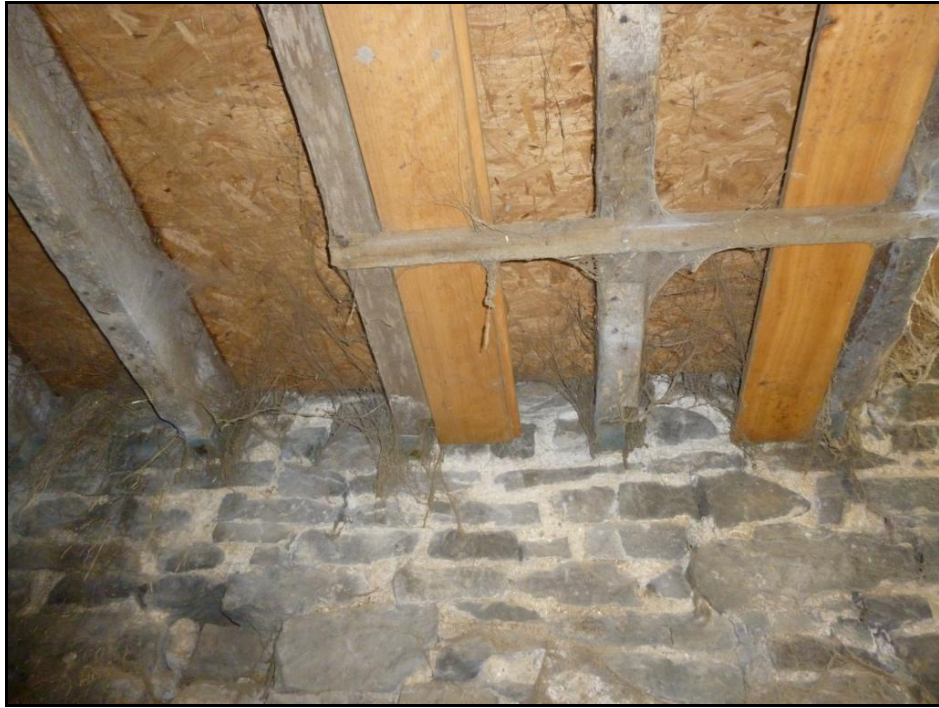
- 3.5 The whole barn could be surveyed internally. The ground floor areas are used for storage and as a stable. The barn is well-lit throughout and in constant use. Thick cobwebs were evident throughout the barn (see Photograph 4), on walls, wooden beams and beneath the stone tile roof.

Photograph 4 showing the cobwebs evident on all woodwork and walls

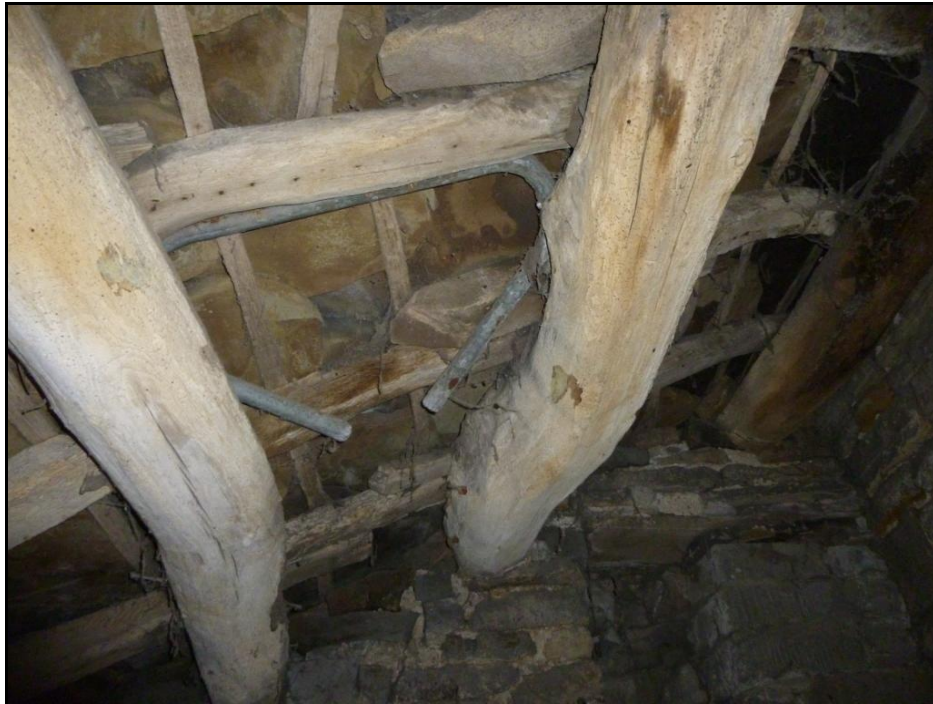
- 3.6 The first floor of the barn is used for storage. The walls are partly rendered and easy to inspect. The roof is in a good state of repair. No gaps were evident within the wooden beams. The roof tiles were easy to inspect internally (see Photograph 5). All were covered in cobwebs and few gaps existed between the roof tiles.

Photograph 5 showing the internal roof tiles and beams

- 4.3 It should be noted that bat absence is very difficult to prove definitively due to their mobility and size, and single or small numbers of bats are able to roost in extremely small spaces, such as between roofing tiles. Therefore it is recommended that all removal of roof tiles and ridge tiles is to be undertaken with care.

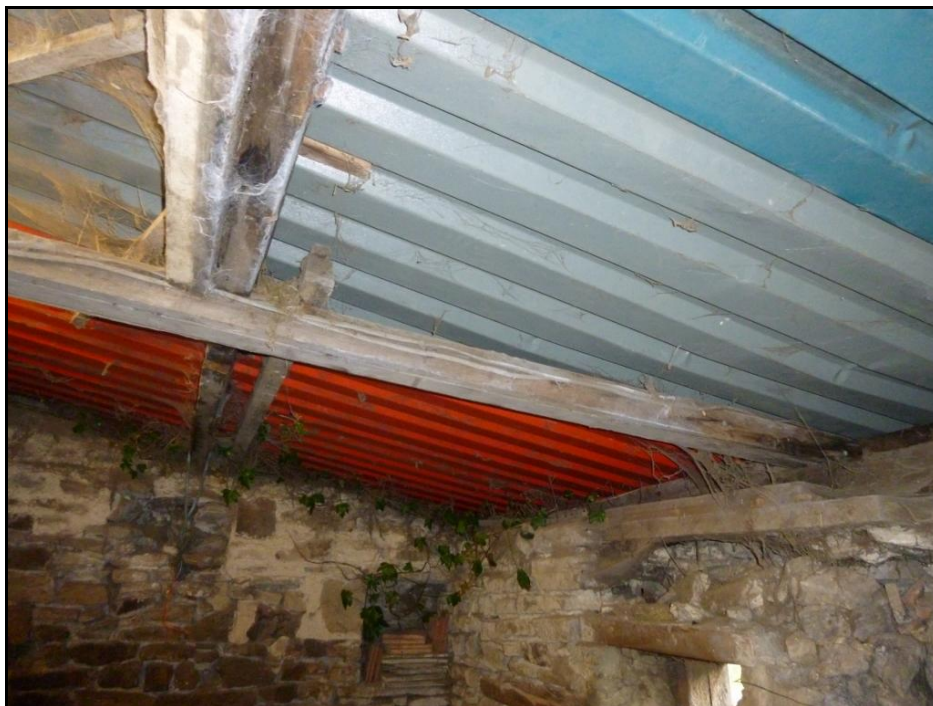
- 3.7 The single-storey extension with the corrugated metal roof offers little opportunity for roosting bats. Internally, the roof is covered with cobwebs.

Photograph 6 showing the internal corrugated metal roof
