Heath Street, Buxton

Protected Species Survey Report

May 2015

Project No: NLG515

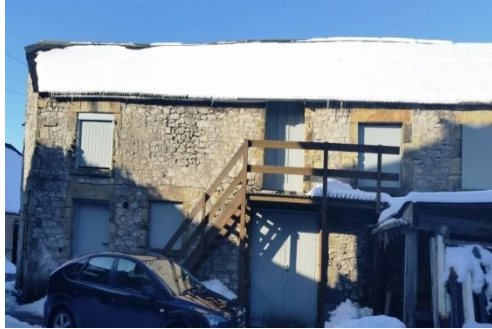
Plate 1 – Building exterior from the south side

- 3.2.1 The building is a large traditional stone barn building that is used as a joiner's workshop (Photographic plate 1). It has a single skin corrugated asbestos roof and ridge paneling. A single story open lean-to is present on the southeast side (Photographic plate 2) with a flat corrugated asbestos roof. The main roof had a covering of snow during the inspection. However, it is considered that the roof is structurally sub-optimal for bat roosting being constructed of single skin asbestos cement paneling.

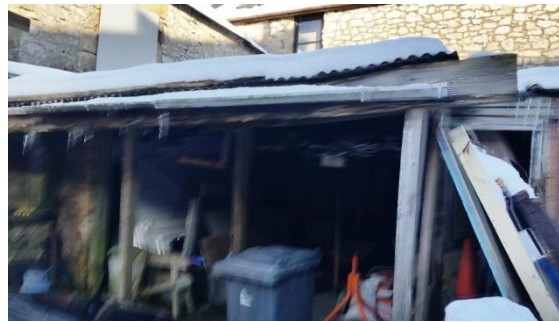
Plate 2 – External view of lean to section

- 3.3.3 The single story lean-to is open for flight access throughout with a corrugated asbestos roof. Internal access was restricted somewhat by stored items. However, the majority of the interior could be inspected and no evidence was found throughout. Dust and debris as well as occasional water seepage was also present.

- 4.1.4 No evidence of nesting birds was observed during the survey. However, the lean-to extension has open flight access through which birds may commence nest building. Should bird nesting be subsequently discovered, work should stop until the young have fledged and any nests left undisturbed until such a time.

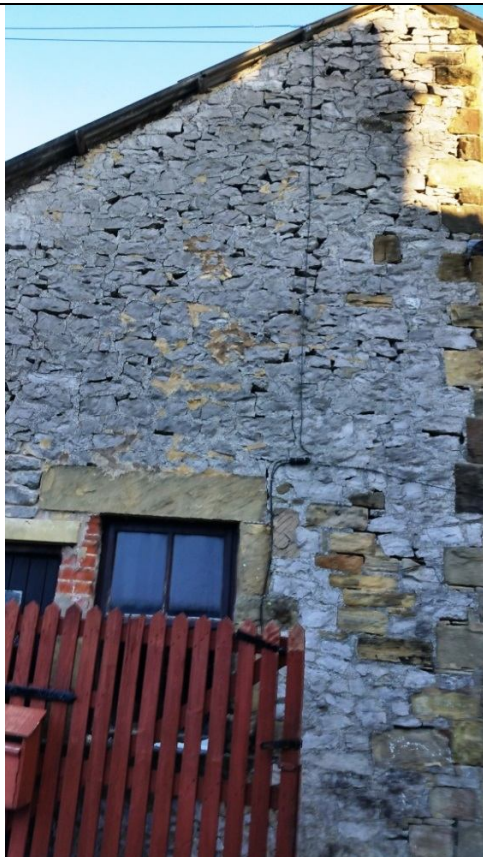
Plate 3 – View of far west side of building with extending gaps in stonework

- 3.2.2 The main external stonework on the external walls is in variable condition with many superficial gaps and cracks noted on the southeast side elevation. These gaps were found to be shallow, and none extending with just small recesses resulting from the shallow mortar loss. On the west side there are again superficial gaps. However, on the far western section (Photographic plate 3 and 4) there are several extending gaps between stonework that extend in significantly within the wall structure. Many of these holes could be viewed with ladder access and no evidence of bats was found throughout. However, due to the heights of some of the holes and the depths and angles that the holes extended into, not all sections could be viewed at close quarters. It is also possible that bat evidence may well have been blown or washed away through the winter months. The north side elevation also has several opportunities in stonework which is evident at the southwest end of the northern elevation where access was possible. Here, deep extending cracks were again noted. Because of the close-by building to the northwest, almost all of the northwest elevation could not be assessed or viewed in terms of gaps and opportunities available due to a lack of vantage points, deep snow between the buildings, and no ladder access possible (Photographic plate 5). There may therefore be more opportunities for roosting bats that could not be established by undertaking the inspection method alone. Towards the west side of the building there is a window and a door. These both have extending gaps and cavities above them. On the southeast side elevation there are also gaps above the main double door beneath the stairs which extend upwards, as well as above a small broken ground floor window adjacent to the lean-to extension.

- 4.1.1 No evidence was found of bats using the interior or exterior of the buildings as a roost site. However, there are many cracks and gaps on the far west end of the building exterior stone wall. These were observed at close quarters where possible and no evidence of bats was found. However, many of the gaps extend far back into cavities and therefore present suitable roosting opportunities that couldn't be discounted by a single winter inspection visit alone. In addition the north side elevation could not be checked at close quarters, and due to the condition of the stonework at that location it is likely that there are further extending gaps in stonework that may provide roosting opportunities. The general surroundings are well built up with surrounding buildings on all sides with a general lack of close-by tree and vegetation cover. However, in the wider area there are areas of tree cover surrounding the church c. 40m north to and a large amenity sports field c. 40m to the south that is surrounded by trees and may link bats to the wider landscape. By taking to account the lack of direct habitat connectivity, it was considered that the building exhibits low potential in light of the extending suitable gaps in stonework.

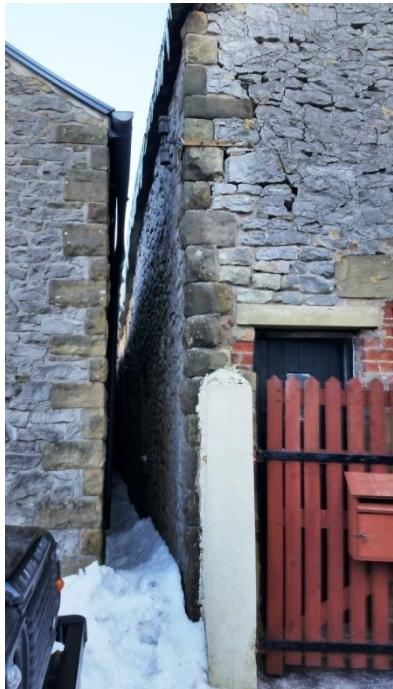
Plate 5 – North side elevation with unknown bat potential

- 2.7.1 During the inspection, access was occasionally restricted around the exterior of the building particularly along the north side elevation due to a close-by building and deep snow. However, the building was assessed as far as possible using binoculars and strong torchlight, and ladders where safe and accessible. Snow was present on the roof of the building which obscured the view of the roof during the inspection. However, the roof is considered to have a sub-optimal structure type for bat roosting, being corrugated asbestos cement sheeting. No snow or such limitations were present during the further emergence survey. Dust and debris was occasionally present within the upper floors, and stored items occasionally restricted internal access. However, a representative and thorough internal inspection could still be undertaken.

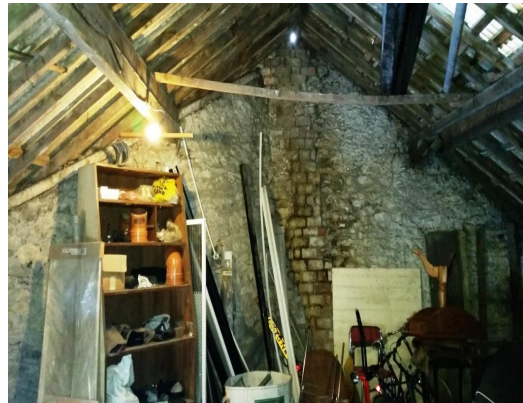
Plate 6 – Internal view of west main upper section

- 3.3.1 The upper floor interior is separated into three main compartments (Photographic plates 6, 7 and 8) with the west and central sections accessed from external steps on the southeast side elevation of the building and the east side is accessed from internal steps. The far west upper floor area is a large upper floor room with bare timbers including purlins, rafters and ridge board present with brick and stone inner walls that are in good condition far the most part. There is an influx of light at the ridge and throughout due to skylights that will likely restrict potential bat use to crevice dwelling. A crack is present on the west wall that does not appear to extend in far enough for roosting, and the light filled ridge is considered suboptimal. There are occasional gaps at the eaves where the asbestos roof meets the walls, and occasionally where the purlins meet the walls. However, no bat evidence was found throughout. Many stored items are present but the space was easily accessed and inspected.

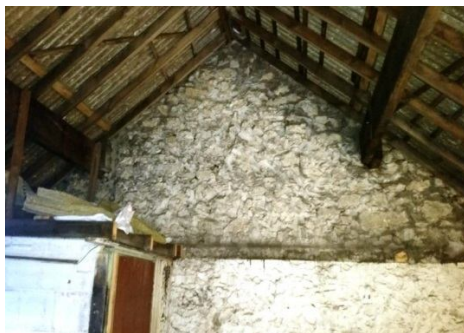
Plate 7-Internal view of main central upper section

- 3.3.2 The central section has the same structure as the west side and has occasional large gaps in brickwork. This section is again light filled and no evidence was found throughout. The final east section is also the same with stored wood on the floor, and is again well lit with light protrusion at the ridge and skylights. The internal stonework is in general good condition with c. 3 extending gaps in the gable wall. However, no evidence was found throughout. The ground floor was also inspected with no bat evidence found.

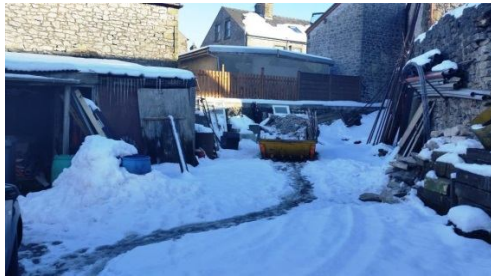
Plate 9- View of hard standing yard area

- 3.8.1 The building is surrounded by hard standing and therefore lacks ecological constraints.
