Bat Roost & Breeding Bird Survey

**Banksfields Farm, Boggard Lane,
Charlesworth, SK13 5HI**

27th July 2015

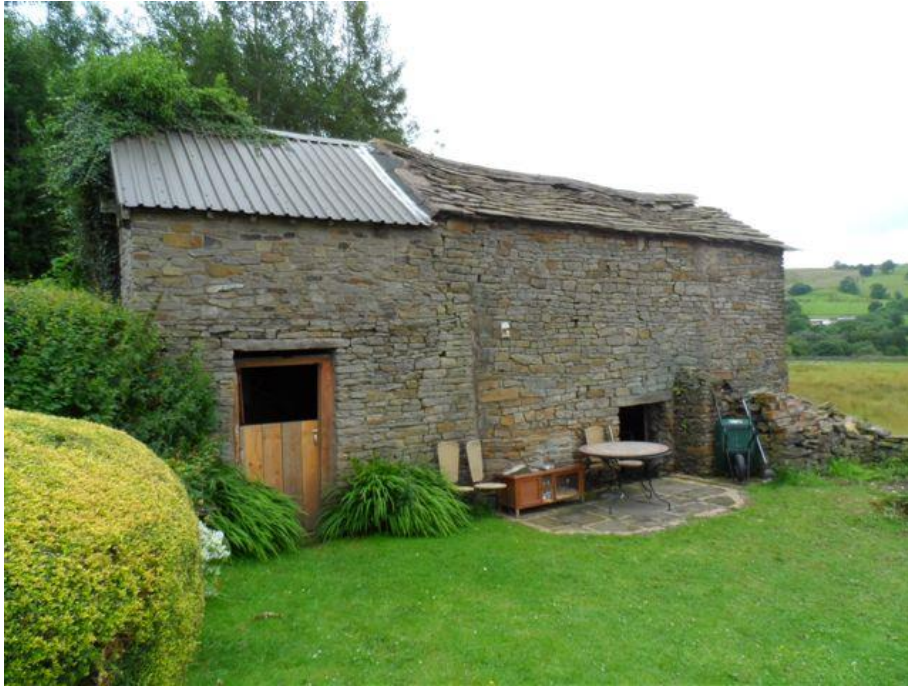
- 1.1.1 The Site is located in a rural area in Glossop and is bordered entirely by open countryside and agricultural land. The Site comprises of an old brick built barn (building B in a very poor state of repair with open aspects caused by missing walls and roofs, since the survey of 2011 the building has suffered much damage due to winter storms and is almost fully open to the elements.
- 1.1.2 For site location and see original EBS report 2011.
- 1.1.3 For full buildings condition and layout see Appendix 1, Site photos.

External old barn

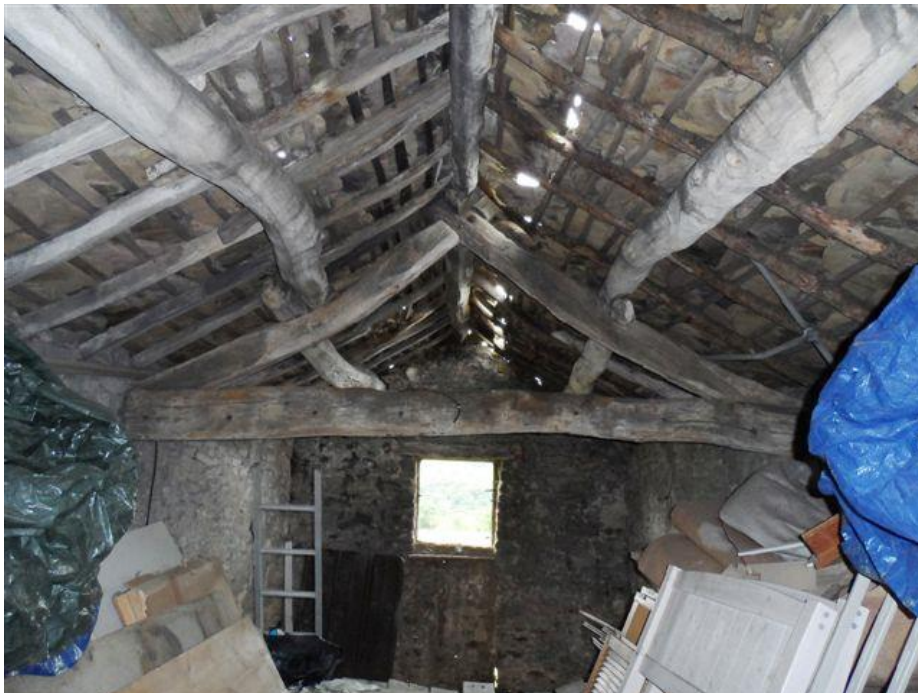
Internal barn showing open roof
