Bat Scoping and Presence/Absence Survey

BE248.3

Rose House, Tunstead Milton

Report title	Bat Scoping and Presence Absence Survey
Report reference	BE-248.3
Site address	Rose House, Manchester Road, Tunstead Milton, High Peak, Derbyshire SK23 7ER
Grid reference	SK 03261 80106
Report compiled by	David Watts BSc (Hons) FdSc
Client	David Shelmerdine
Date	24 th April 2015

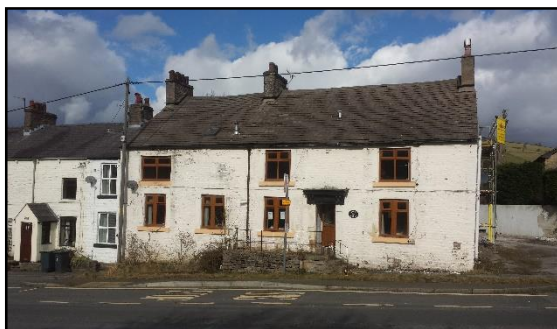
Figure 4.1 Southern aspect of building

- 4.4. The building is an end terraced property with a pitched English tile roof and three chimneys. The gable end is located on the eastern aspect of the building and the western aspect is connected to the adjacent property.
- 4.5. An inspection of the exterior of the property found the roof to be in poor condition. There is damage and visible gaps to the ridge tiles, and gaps in several of the roof tiles on the building's southern aspect. No soffits are present, and there are gaps under the eaves. The brickwork to the southern aspect of the building is in good condition, although there are gaps in the brickwork to the building's northern aspect.

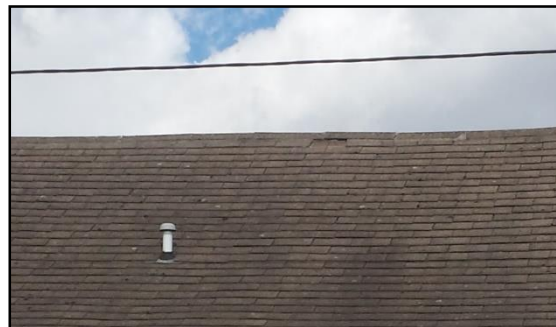
Figure 4.4 Damage to ridge tiles

- 4.9. No access points into the loft area were identified, but it is anticipated that a solitary bat may have previously entered the roof void through gaps in the felt lining, which may lead to gaps in the ridge tiles and/or roof tiles on the exterior of the building.

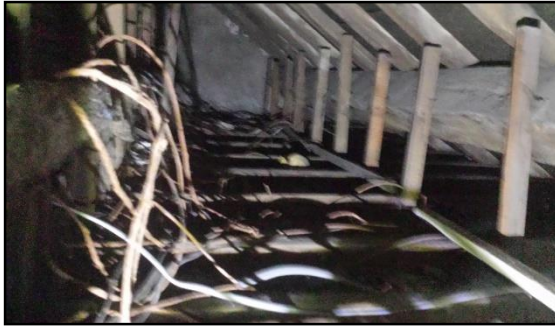
- 4.7. The western section of the loft space is a well lit loft conversion, with a skylight on the northern aspect of the roof. There is a hole in the floor of this section, leading to the first floor of the building below. A fake wall was previously present, which has since been removed. Behind this, nine bat droppings were found on the floor, amongst mouse droppings. The bat droppings were between 2-4mm in size, and did not appear to be fresh.

Figure 4.5 Western section of roof void

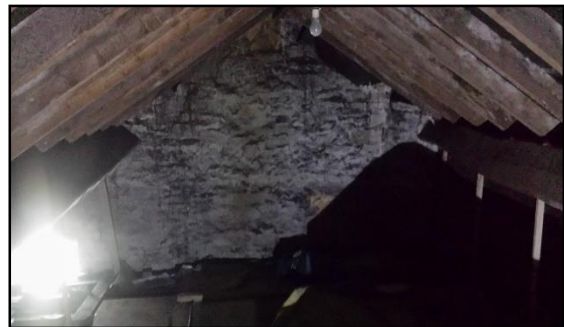
- 4.8. The eastern section of the loft space is also well lit, with a window on the eastern aspect. Three bat droppings were found, of similar size and age to those found in the western section. No further signs of bats such as feeding remains were identified.

Figure 4.6 Eastern section of roof void

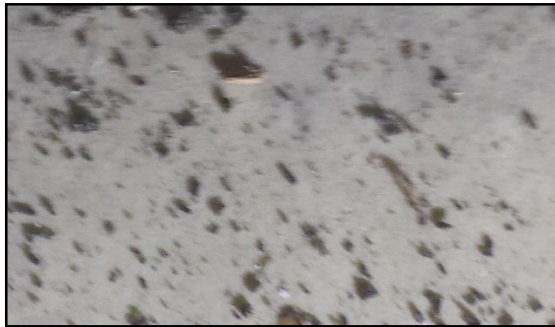
Figure 4.7 Bat and mouse droppings

- 5.2.** Bat droppings were found in the roof void; however, as only a small number of bat droppings were found, and the roof void is well lit, it is anticipated that the building has been used as a transitional roost or as a night roost by a solitary male or non-breeding female. It was not possible to determine the age of the droppings.
- 5.3.** The exterior of the building exhibits features indicative of roosting bats, including damaged ridge tiles and roof tiles, gaps in the brickwork and gaps under the eaves. The surrounding area is highly suitable for bat habitats, with good habitat connectivity to the site, and the ecological data search found a number of bat records and designated habitats in the surrounding area.

- 6.1.** As it is concluded that there are no roosting bats in the building, the proposed demolition works may be carried out with no further considerations in regard to bats.
- 6.2.** In the unlikely event that a bat is discovered during any construction or demolition works, all works should cease and a licensed bat worker should be contacted immediately.
- 6.3.** In accordance with the National Planning Policy Framework, the proposed development should include ecological enhancement measures to improve the biodiversity value of the site and the wider surrounding area. It is recommended that one bat box is incorporated into the proposed development. This should be of type Schwegler 1WI and should be situated on the wall of the proposed building, at a minimum height of 4m and as close to any gable apex as possible.
