HERITAGE STATEMENT

TO ACCOMPANY APPLICATION FOR LISTED BUILDING CONSENT FOR:

Refurbishment of floor 0 in the main cotton mill.

Torr Vale Mills, Torr Vale Road, New Mills, High Peak, SK22 3HS

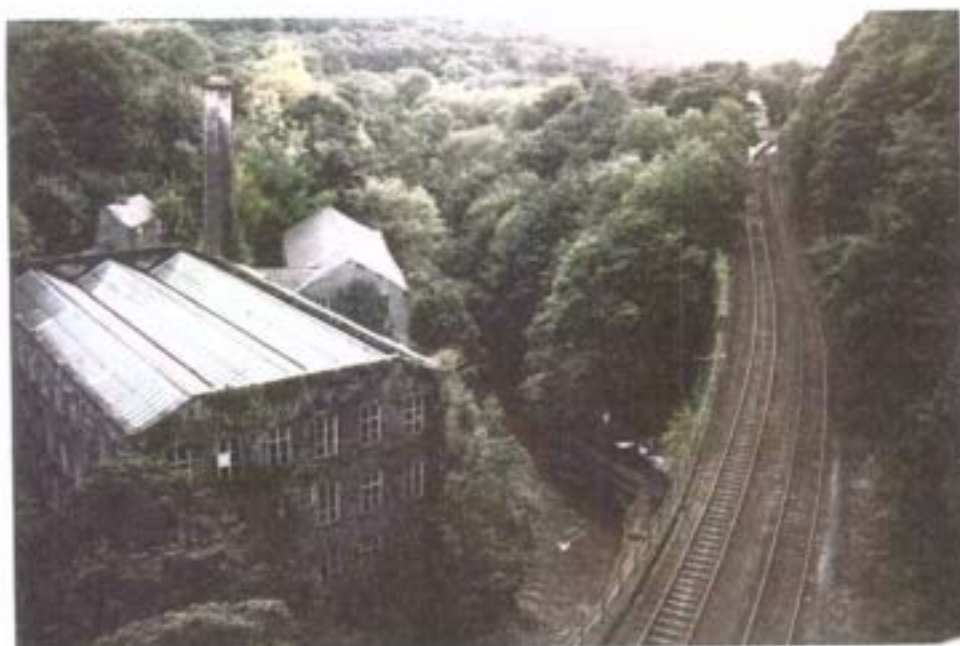
View from the North

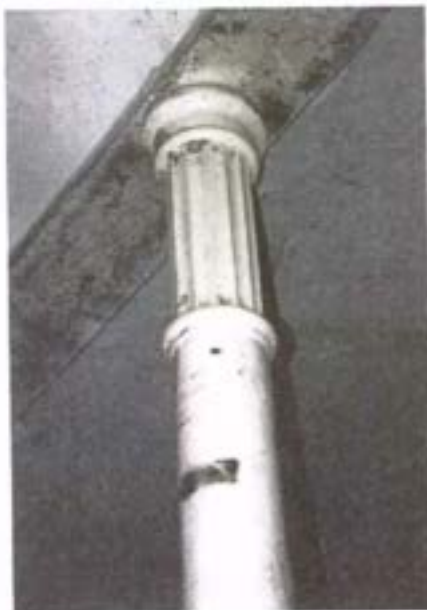
Fluted capital of cast-iron column

Ceiling	Level 2 suspended panels Levels-2 to 1: shallow brick arches supported on cast iron beams
Walls	Plaster
Floors	Stone flags, black quarry tiles, linoleum and screed
Cast Iron Columns	Two rows of ten cast iron columns with fluted capitals support cast iron beams which carry the eleven brick vaults. The cast iron columns act as down pipes for the internal roof valleys.
Fixtures/ Machinery	The steam engine was installed in the basement in 1856. The engine was a single cylinder beam engine and was coupled to the two waterwheels. The line shafting was located along the centre of the north wall, as evidenced by the tie plates and ashlar stone blocks on the exterior.
Decorative Scheme	Mostly gloss paint, earliest layers are cobalt blue distemper

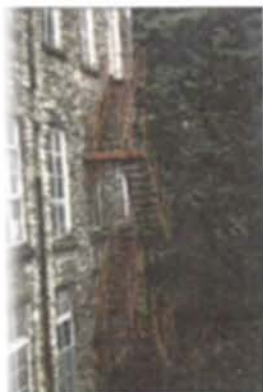
Southeast wall and fire escape

The suspended ceilings should be removed from the top floor. At least some area should retain the open volume of space, the historic floor materials and historically correct paint colour. Remnants of shafting should remain. The two wheel pits in the basement should be re-opened to allow water to flow through. The fire escape should be retained. All brackets, floor traps and evidence of shafting should be retained.

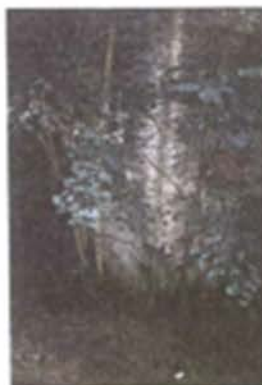
East corner of earlier cotton mill

The mill was built in 1856 - 7. The tailrace tunnel and northeast corner base of the current mill are the only visible remnants of the earlier mill on the site. Presumably, the floor of the basement, which contained the waterwheels, and the two internal walls also date from this earlier building.

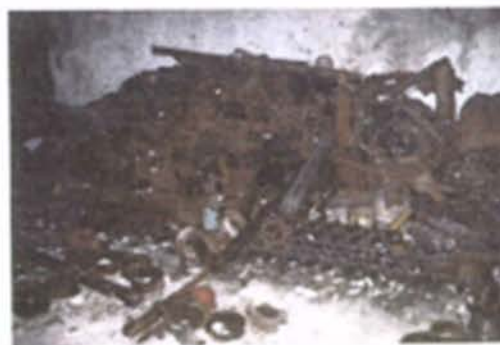
Machinery parts in basement
