METHOD STATEMENT IN RESPECT OF COMMON PIPISTRELLE AND BROWN LONG EARED BATS, AT THE COACH HOUSE, WYE HOUSE, CORBAR ROAD, BUXTON, DERBYSHIRE.

Summary of the proposed mitigation strategy

1. This document relates to The Coach House, Wye house, Corbar Road, Buxton, SK 05525 74167 which is confirmed as a bat roost for two species.
2. The building is planned to be renovated into residential apartments. Renovations include works associated with turning the property into individual dwellings; these include roof works.

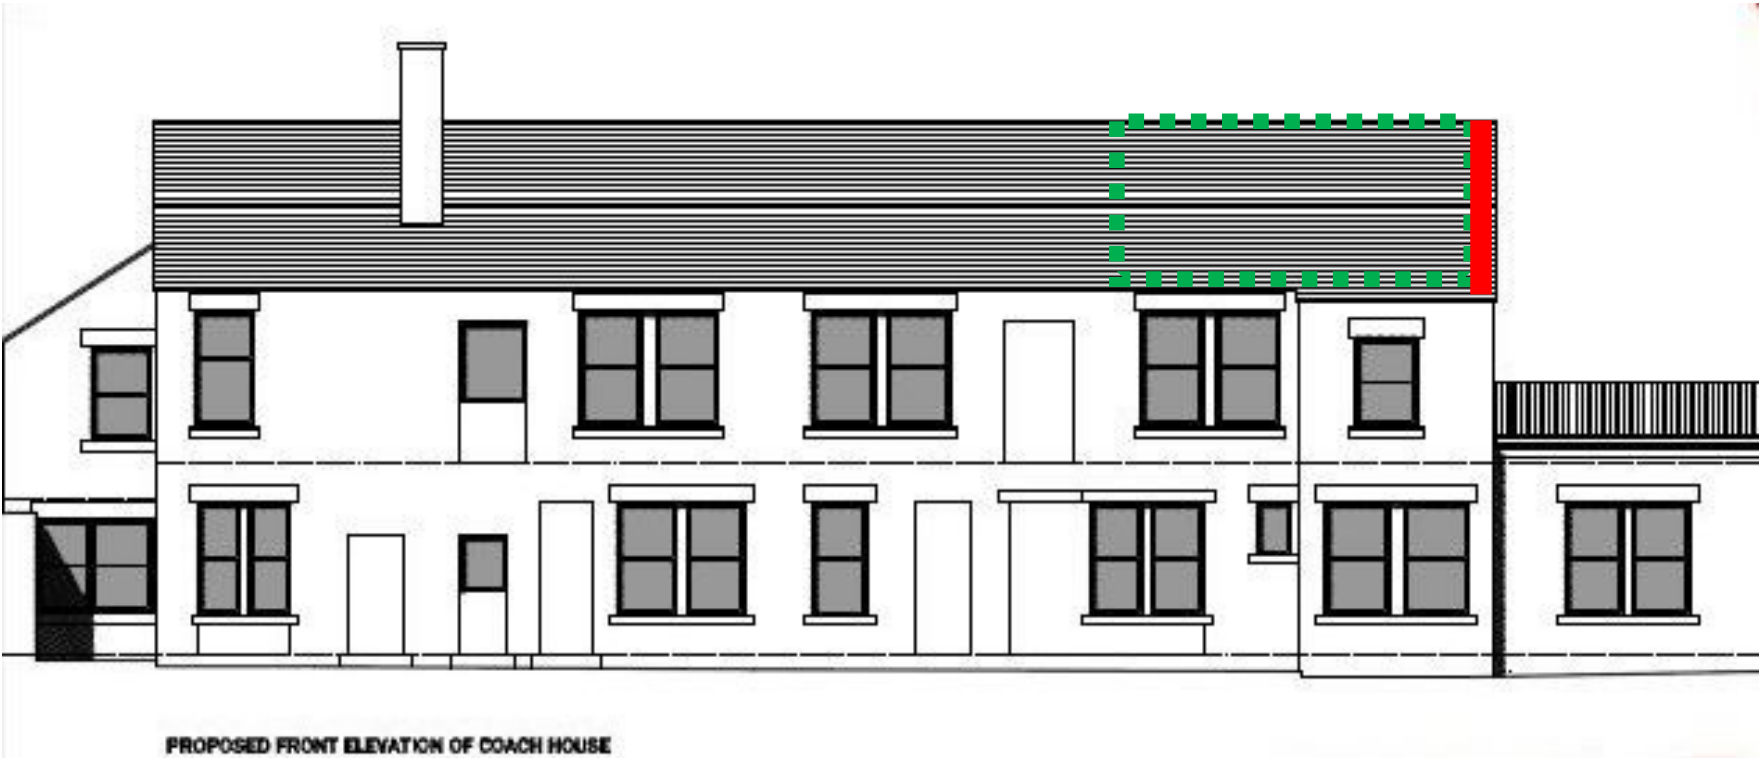
Appendix one: Location of the roost within the redeveloped property

Key	Bat access tiles	Roost location

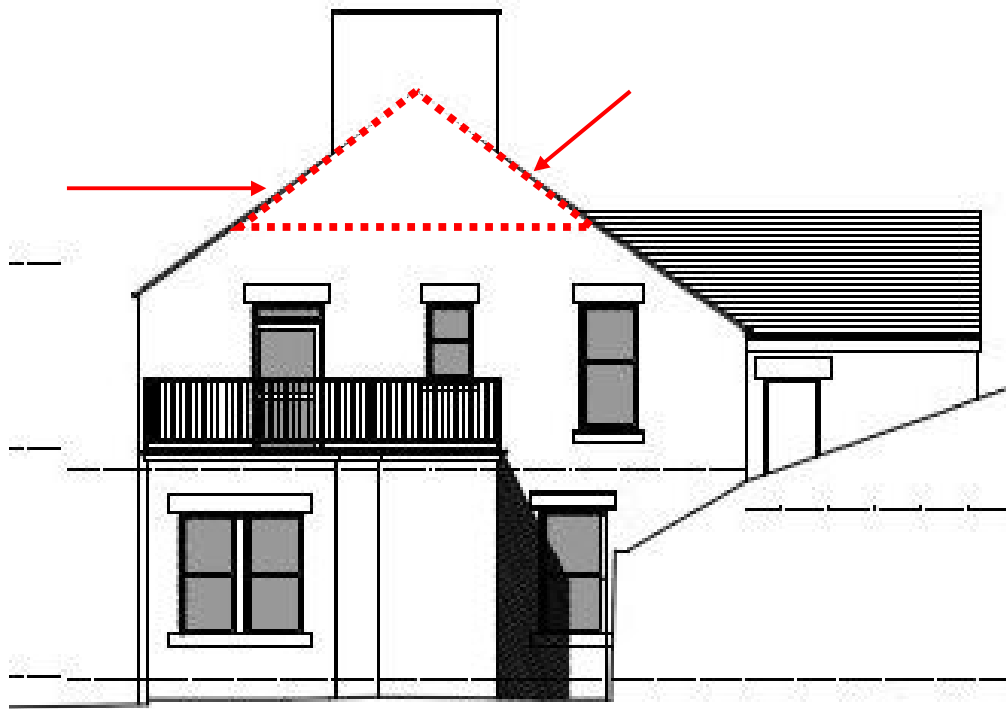
Appendix two: Cross section of bat loft and proposed new access

PROPOSED SIDE ELEVATION OF COACH HOUSE
SCALE 1:100

Proposed dimensions: 2.8m high
5m wide
5m in length

A section of the roof (south eastern elevation) under the ridge beam will be boxed out and provide an area where bats can roost. The dimensions of the roost are yet to be finalised but consultation with Natural England during the EPS licence procedure will seek conditions to be optimal for the species affected as outlined herein and within the bat mitigation guidelines 2004. Provision for Common pipistrelle bat will be provided within the bat loft via crevices between the roof beams and wall.

The boxed out area will be sealed with a boarded floor. Any insulation required in the re-developed property will be on the underside of the ceiling in order to retain the thermal properties of the boxed area.

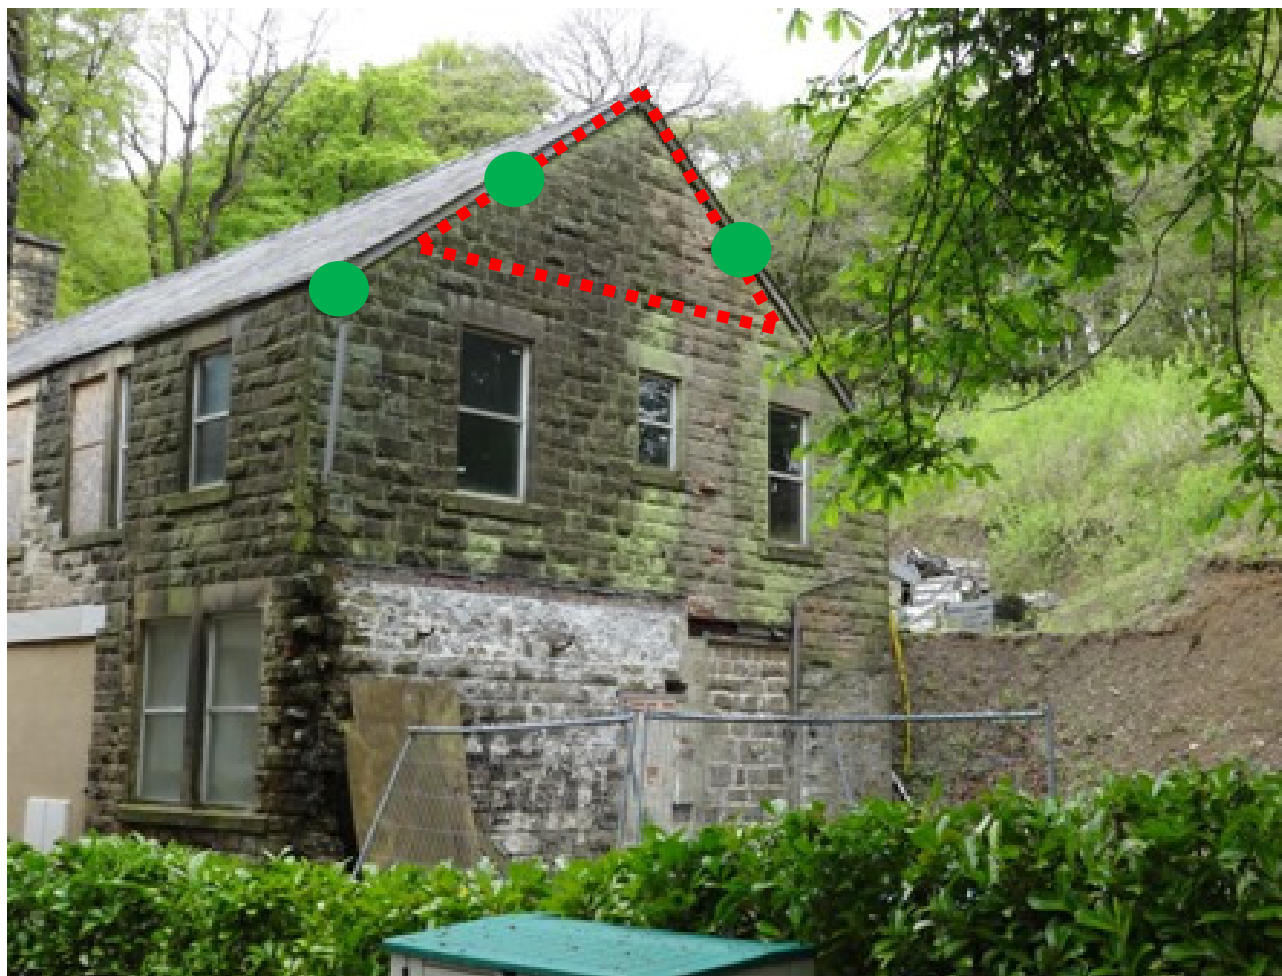
Appendix three: Roost location (hatched in red) and access points to the existing roost (green).

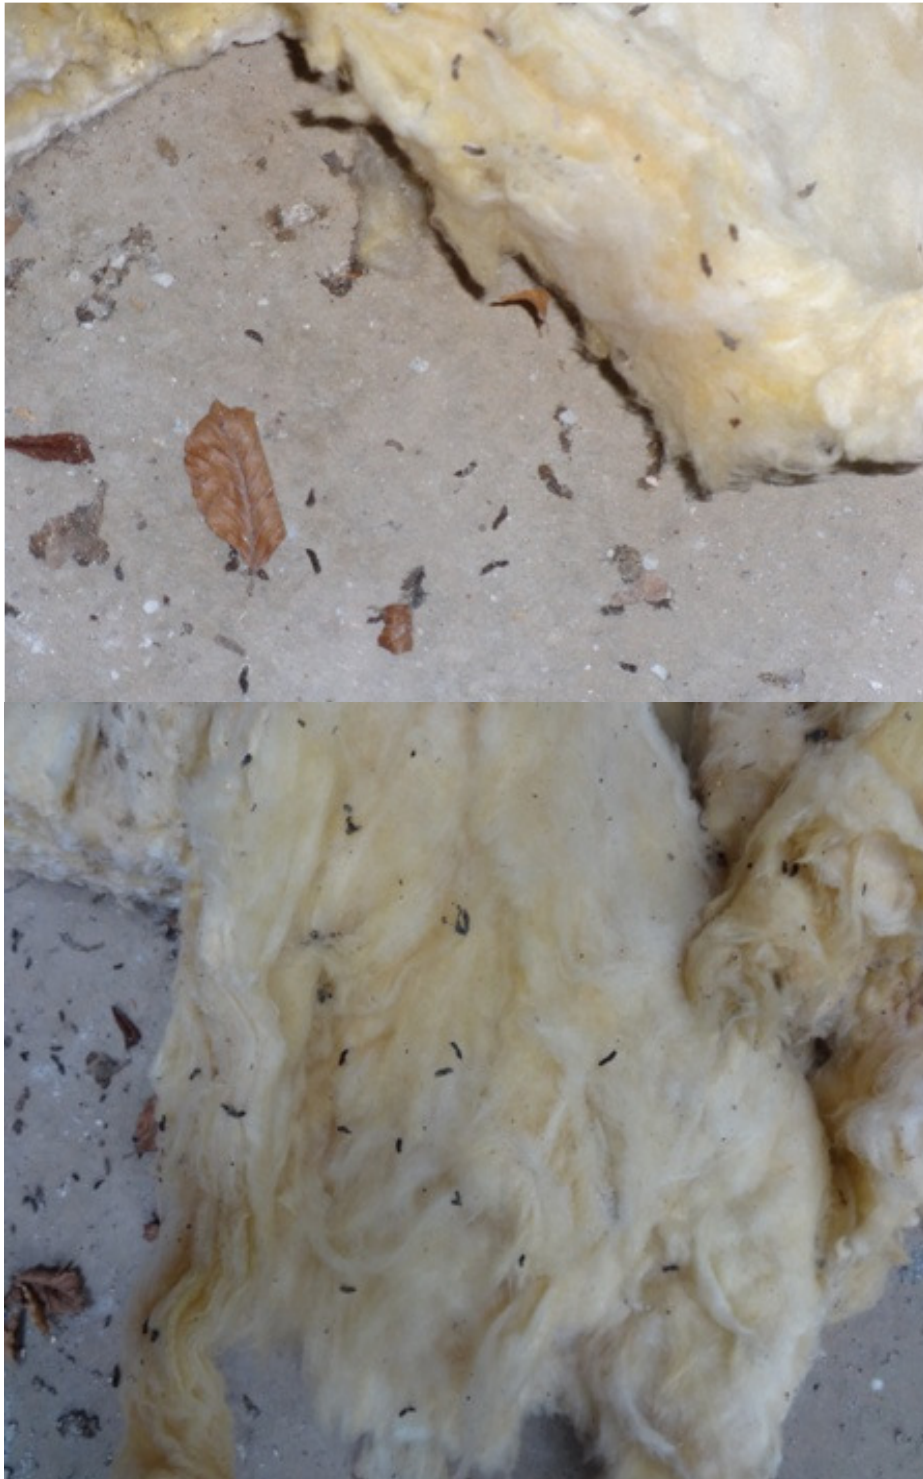
Appendix five: Bat field signs recorded at the property

Field sign evidence of Common Pipistrelle and Brown long eared bat was recorded within the building. Droppings of both species along with discarded wing cases (feeding remains) were recorded, the latter being synonymous with Brown long eared bat feeding.

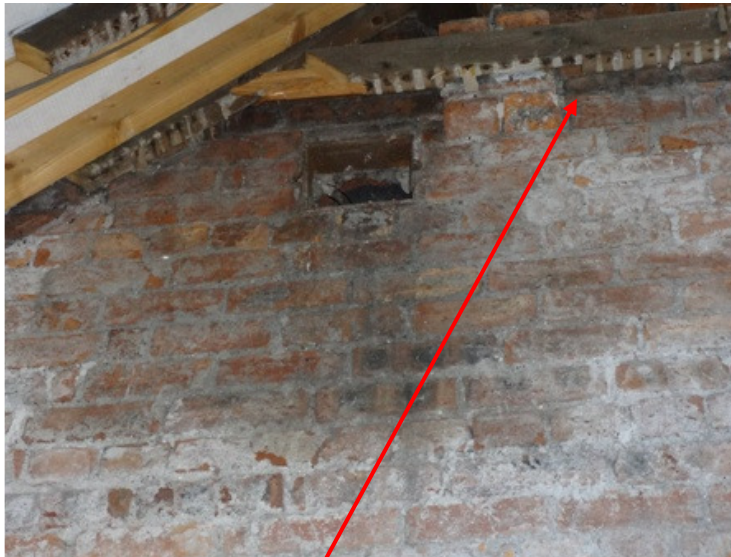
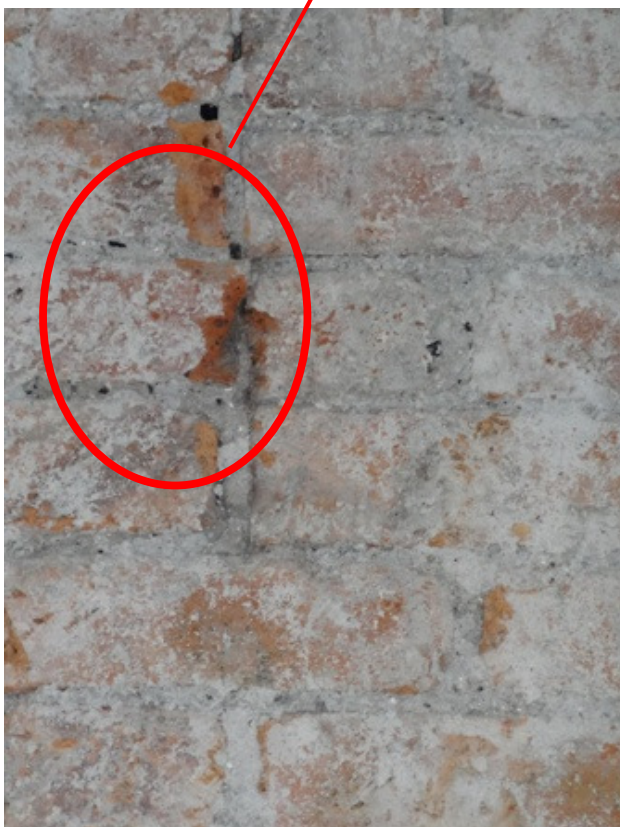
Appendix six: Roost location with field signs highlighted
