**LAND TO THE REAR OF HALLSTEADS
DOVE HOLES, BUXTON**

**PHASE 2:
GEO-ENVIRONMENTAL SITE INVESTIGATION & RISK ASSESSMENT**

MICHAEL GREEN PLANNING SERVICES LIMITED

Our Ref: RCEI43989-002 R

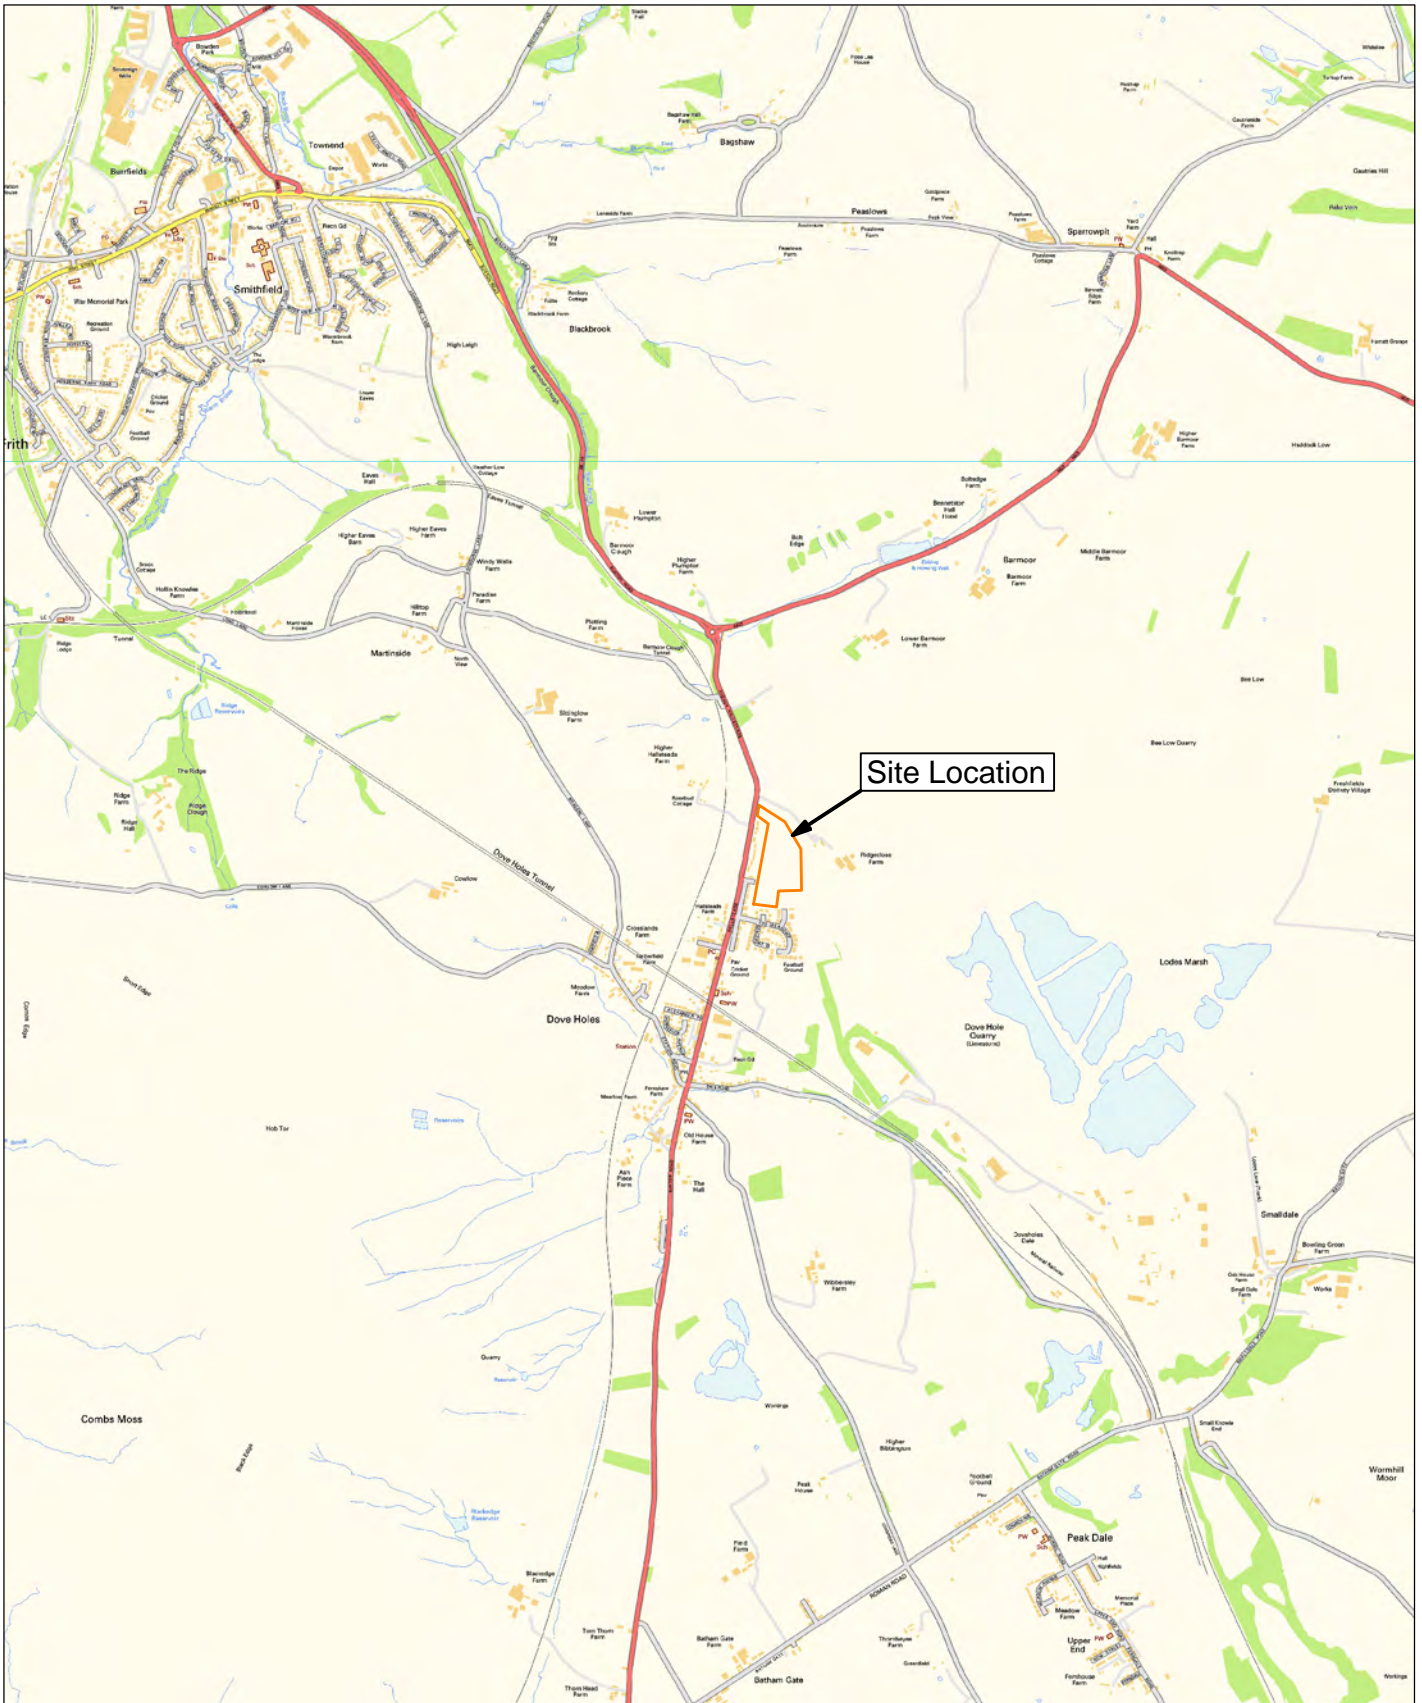
Site Location Plan

The site is located at Hallsteads, Dove Holes, Buxton. The National Grid Reference for the site is 407878, 378668. A site location plan is presented as Figure 1.
