Bat Scoping Survey: Stables at The Alders, Chinley

Client name	Poulter Architects
Project name	Stables at The Alders, Chinley
Project number	PouAr01
Report title	Bat Scoping Survey
Issue number	1
Issue date	01/08/2016
Written by	Chris Turner ACIEEM Senior Ecologist
Checked by	Sarah Stone MCIEEM Principal Ecologist
Approved by	Jessica Eades MCIEEM Principal Ecologist

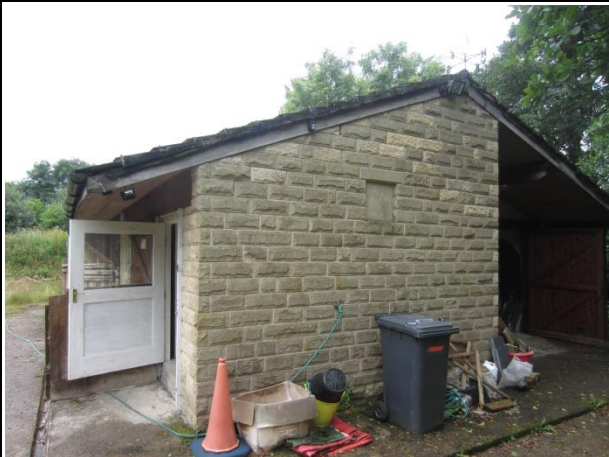
Photograph 1: North elevation showing overhang	Photograph 2: Gap in stonework on north elevation

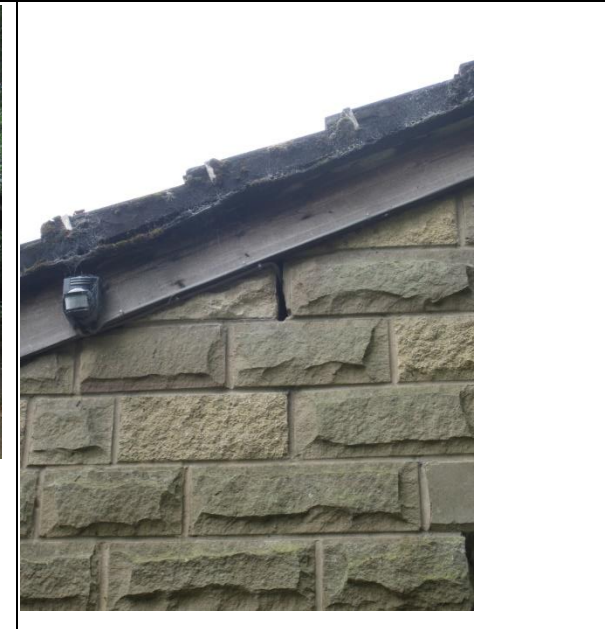
The building offered a number of potential access points for bats through gaps between stonework in the northern elevation, gaps around timber of the overhanging roof on the eastern elevation and gaps where mortar had fallen away near the apex of the southern elevation. The gaps around timber of the eastern elevation led to large, open voids behind blockwork which were considered too open to offer the sheltered conditions sought out by roosting bats.

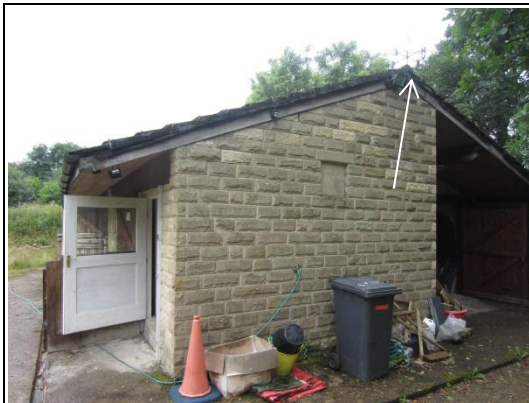
Gaps where mortar had fallen away at the apices and along the roof edges of the north and south elevations led to voids which showed evidence of use by roosting bats. Small aggregations of up to 50 bat droppings consistent with those deposited by pipistrelle bats *Pipistrellus* sp. were recorded resting on tile battens between roofing felt and roof tiles. A few larger droppings were also recorded indicating that another species may also use the building for roosting.

Photograph 3: Roost entrance – north elevation

In order to fully ascertain the use of the site by roosting bats, including number and species, further survey work is recommended.

Based on current the current guidelines issued by the Bat Conservation Trust (Collins 2016), for a building with high bat roosting potential or a confirmed roost, three bat activity surveys are recommended to fully ascertain the use of the site by bats. These surveys would be carried out at dusk or dawn and should ideally be spread at least two weeks apart, during the bat activity season which runs from May to September inclusive.

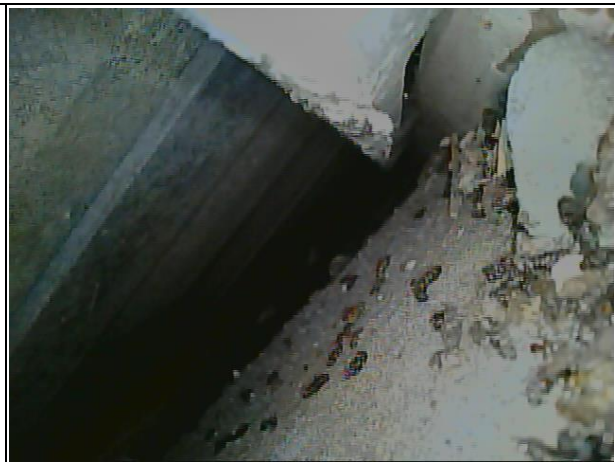
These droppings were of varying ages with some relatively dark, moist and fresh, with others being much paler and beginning to lose their form. This indicated that the roosting sites had been used over a number of years, though not extensively.

Photograph 4: Bat droppings between felt and roof tiles

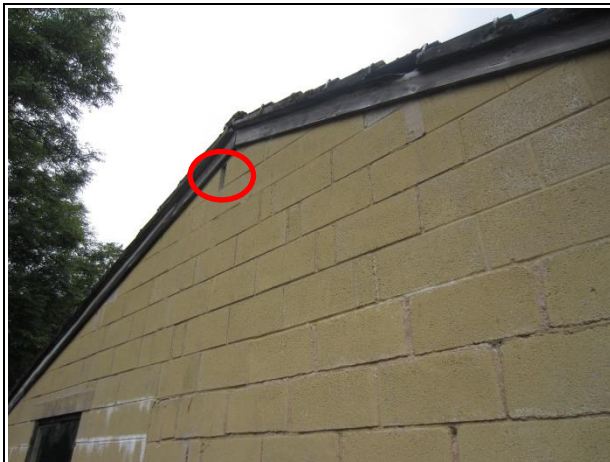
In addition to a crevice roosting site identified by bat droppings beneath the roof tiles at the southern apex, bat droppings were recorded inside the gable wall, with the most likely bat access point being the rectangular 'air vent'. Bat droppings were recorded within cobwebs in this area and a further aggregation was recorded within the building, against the gable wall.

Photograph 5: South elevation showing air vent

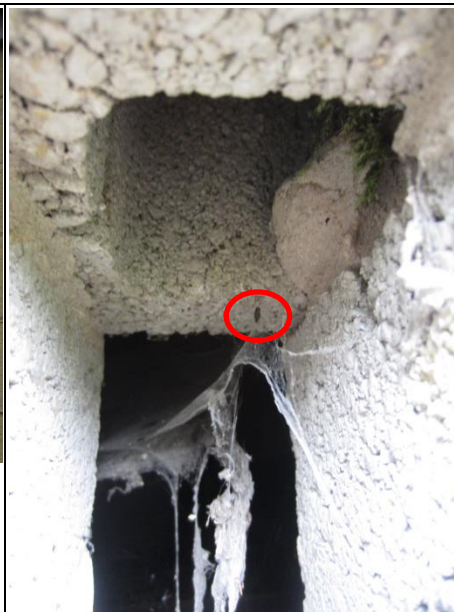
Photograph 6: Bat dropping within air vent

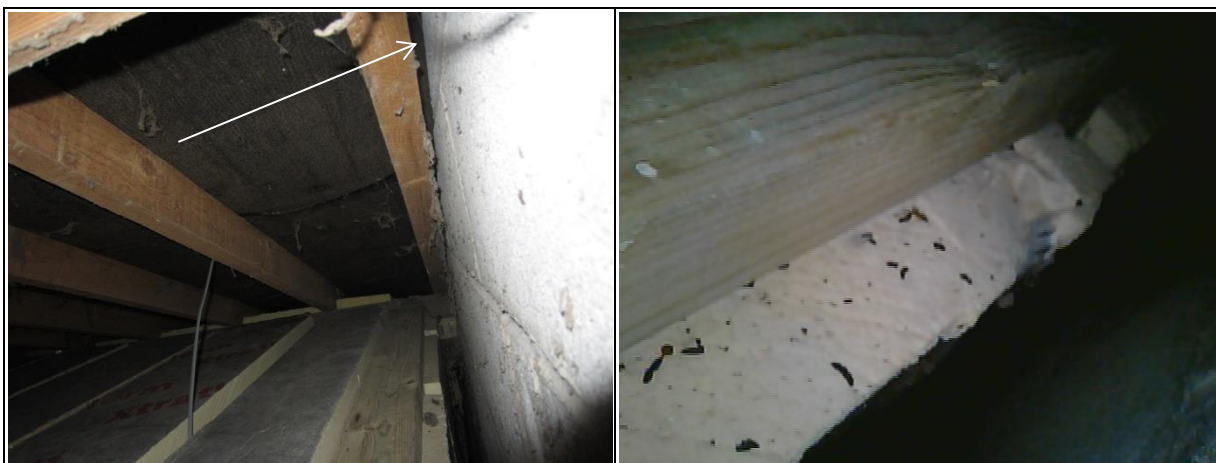
Photograph 7: View of southern gable wall. Roost site between rafter and wall – note bat dropping adhered to wall

Photograph 8: Bat droppings below roost site

The roost site, though not accessible from the interior was assessed using an endoscope and camera through the air vent. A perching point was noted within the narrow gap present between the last rafter and the internal blockwork of the gable wall. Further bat droppings were recorded within cobwebs in this area and a mixture of fresh and much older droppings were recorded, again indicating use of the site over a number of seasons. Bat droppings were probably deposited by more than one species, indicating that pipistrelles and a bigger bat, possibly brown long-eared *Plecotus auritus* have used the site for roosting.

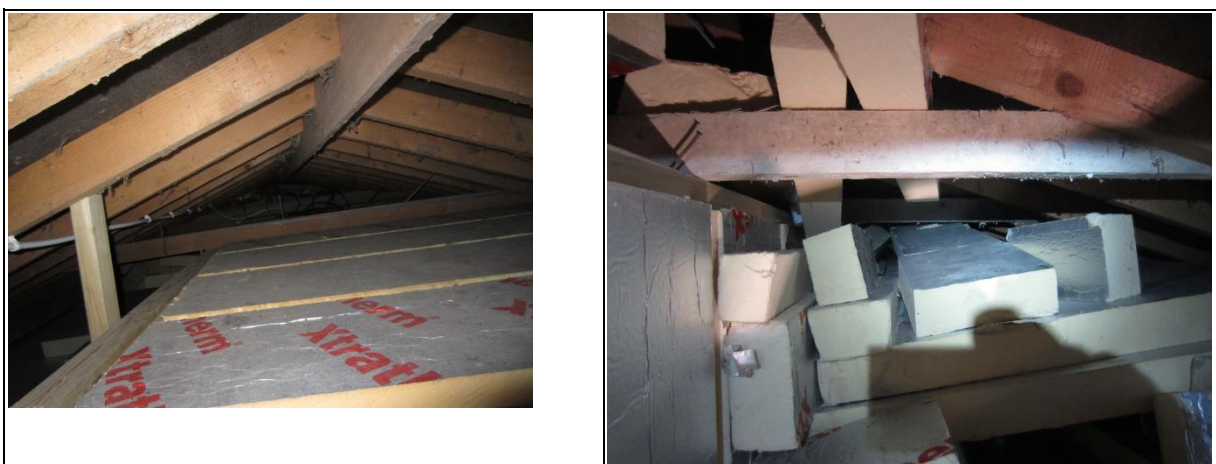
Though a small void was present which extended northward from the gable end, this was not considered suitable for loft dwelling bats as it measured less than 30cm from ridge board to insulation and was blocked by insulation boards a short way along its length.

Photograph 9: View north from southern gable end

Photograph 10: View south from northern end showing piles of insulation boards

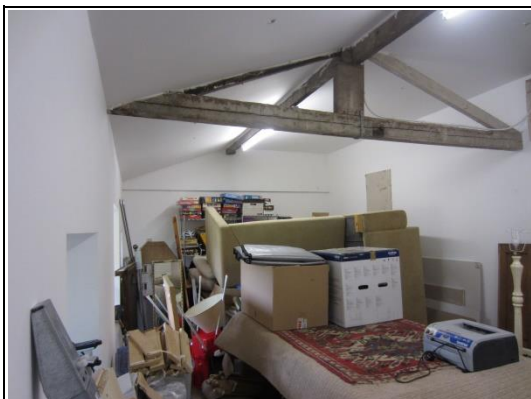
Photograph 9: Eastern room

The eastern rooms were decorated and well-sealed, offering no potential ingress points from either the exterior or from the garage and the western half (garage), though open to the rafters, contained piles of insulation boards filling the void beneath the roof pitch, thus significantly impeding access to perching points within the roof structure.

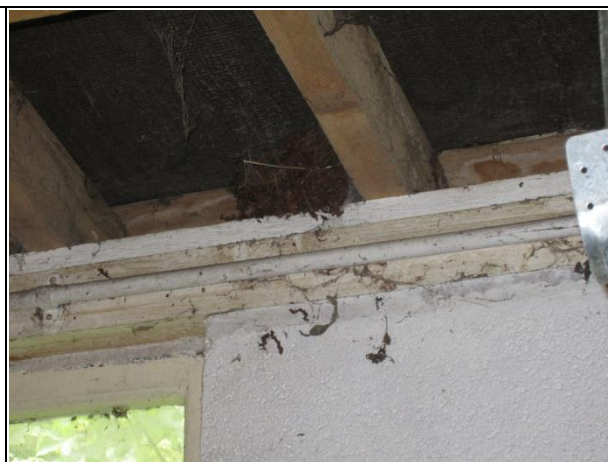
The interior of the building offered little in the way of bat roosting potential, despite good access being recorded at the eaves along the western elevation. Large gaps were present between rafters at the wall plate along the western wall, but many of these gaps contained bird nests.

Photograph 10: Access at eaves of western elevation – note bird nest

A number of old bird nests were recorded on the western wall-top with access afforded at the eaves in this area. No active nests were discovered.

As a number of old bird nests were recorded, it is recommended that works commence outside the bird nesting season which runs from March to August inclusive. Though unlikely, it is possible the birds may raise chicks outside this period and therefore a check for nesting birds must be made prior to commencement of works. This could be carried out during the supervised works regarding bats. However, if an active nest was discovered, works must pause and may not continue until all chicks had fledged.
