# ARBORICULTURAL IMPLICATIONS ASSESSMENT

PROPOSED DEVELOPMENT

BINGSWOOD ROAD  
WHALEY BRIDGE

Author: C. Salisbury  
Date: 16 May 2017  
Ref: TRE/BR/Rev A

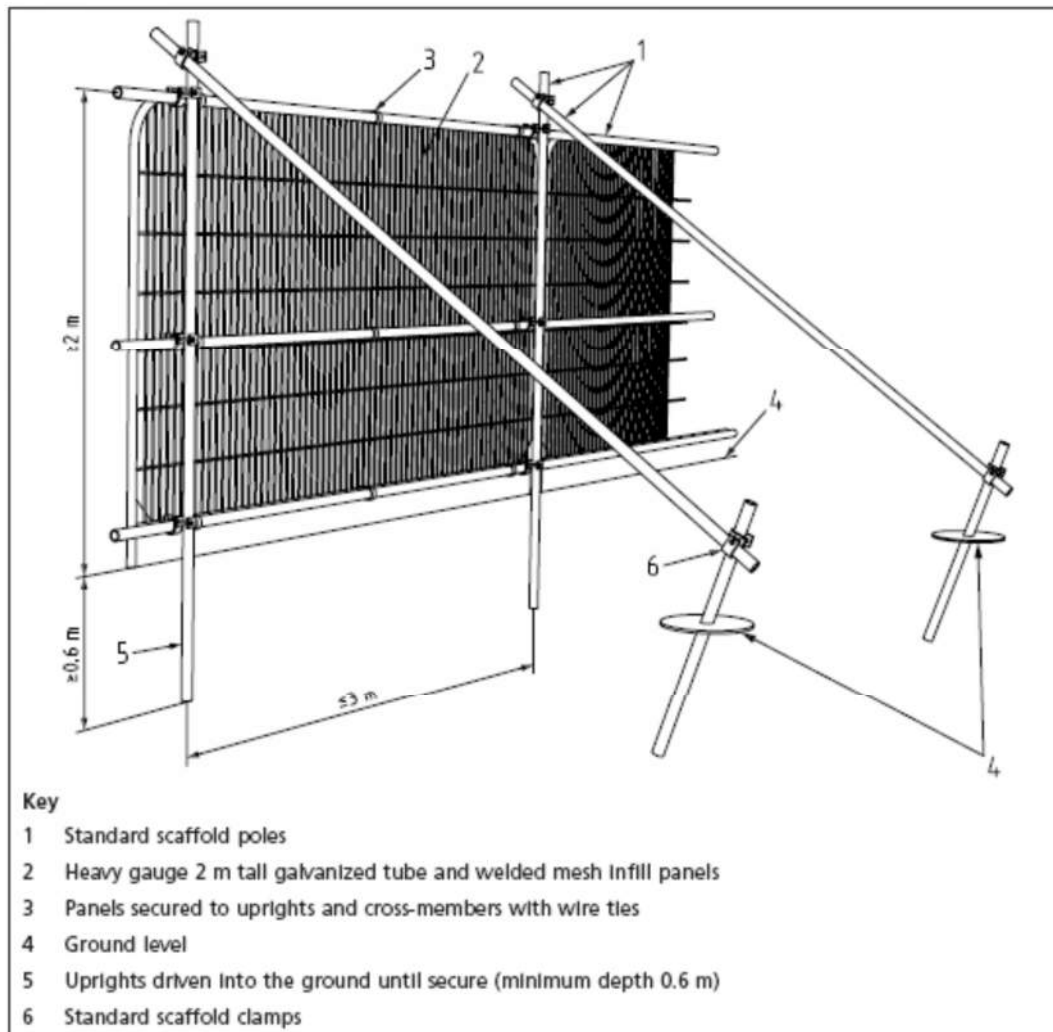
## Tree Protection Fencing (BS5837: 2012)

All fencing used on the site should fully comply with BS 5837:2012 (Trees in Relation to Construction – Recommendations).

- 2.2.1 The fencing should be strong and suitable for local conditions. It should also take into account the degree of construction activity on the site.
- 2.2.2 The fencing should be at least 2.3m in height and should be erected with both a vertical and horizontal scaffolding framework capable of withstanding impact, with vertical tubes spaced at a maximum of 3 m. This should support either weldmesh panels which should be securely fixed with wire or scaffold clamps.
- 2.2.3 Notices should also be erected on the fencing stating 'Protected Area - No operations within fenced area'.
- 2.2.4 The positioning of the protective fencing is also very important and should be erected in the proposed location identified in Appendix One. Once the fence has been erected it should never be crossed and particular care should be taken not to store any materials or soil within the protected area.
