Client:
Hallam Brothers

Preliminary Contamination Risk Assessment

GRADE A
NEW MILLS ROAD
HAYFIELD
SK22 2EU

Report Ref: 17CLR4051CW

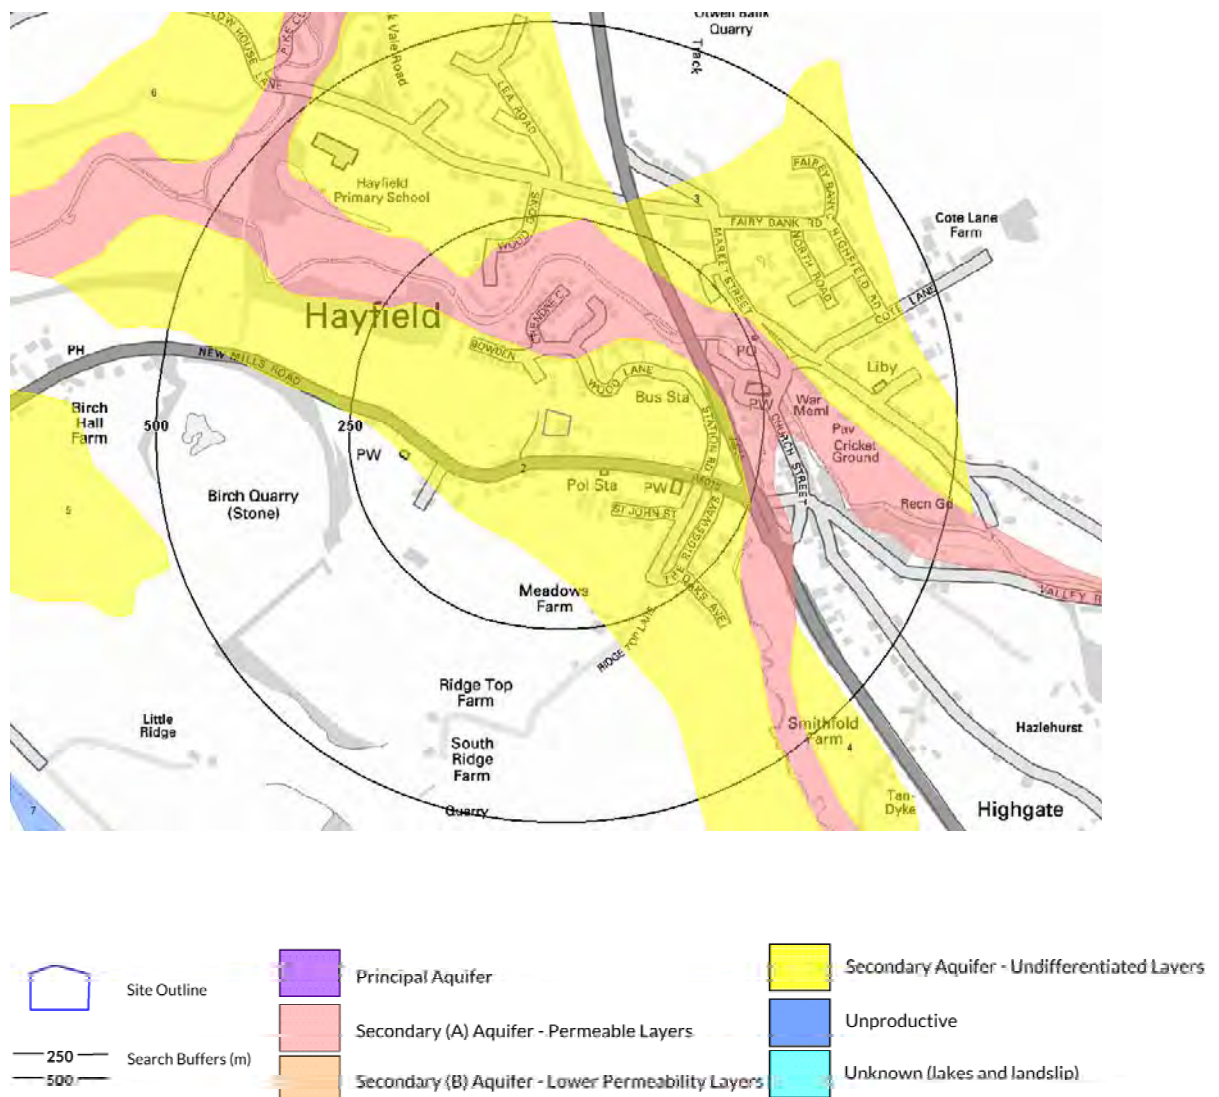
The site is shown to be located on a secondary aquifer with undifferentiated layers. This is assigned where it is not possible to attribute either a category A or B to a rock type. These are minor and non-aquifers. The soils have a low leachability which are soils in which pollutants are unlikely to penetrate the soil layer because either water movement is largely horizontal or they have the ability to attenuate diffuse pollutants.

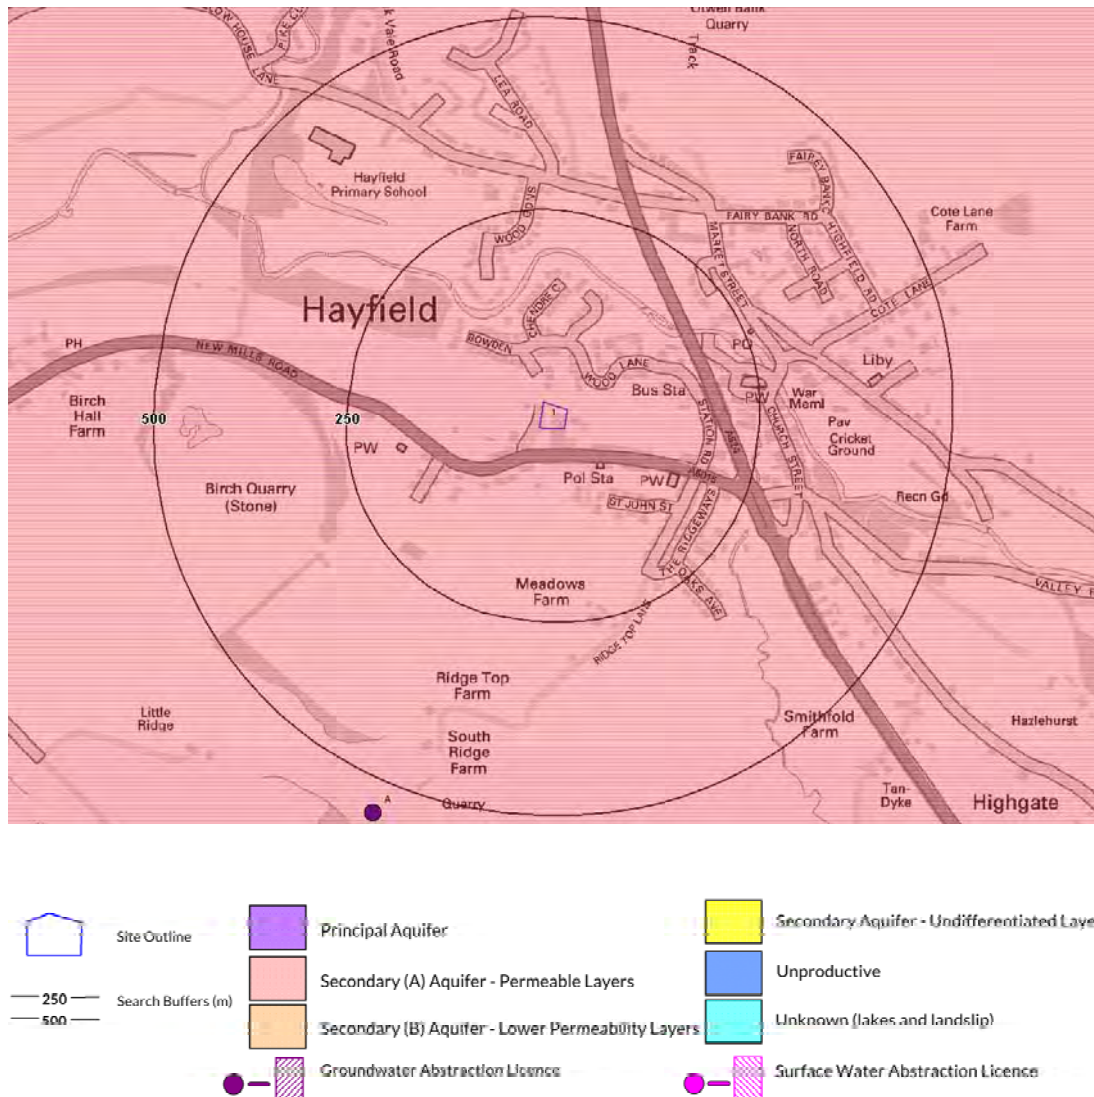
The bedrock at the site is classed as a secondary aquifer (A) which have permeable layers capable of supporting water-supplies at a local rather than a strategic scale. In some cases this forms an important source of base flow to rivers.

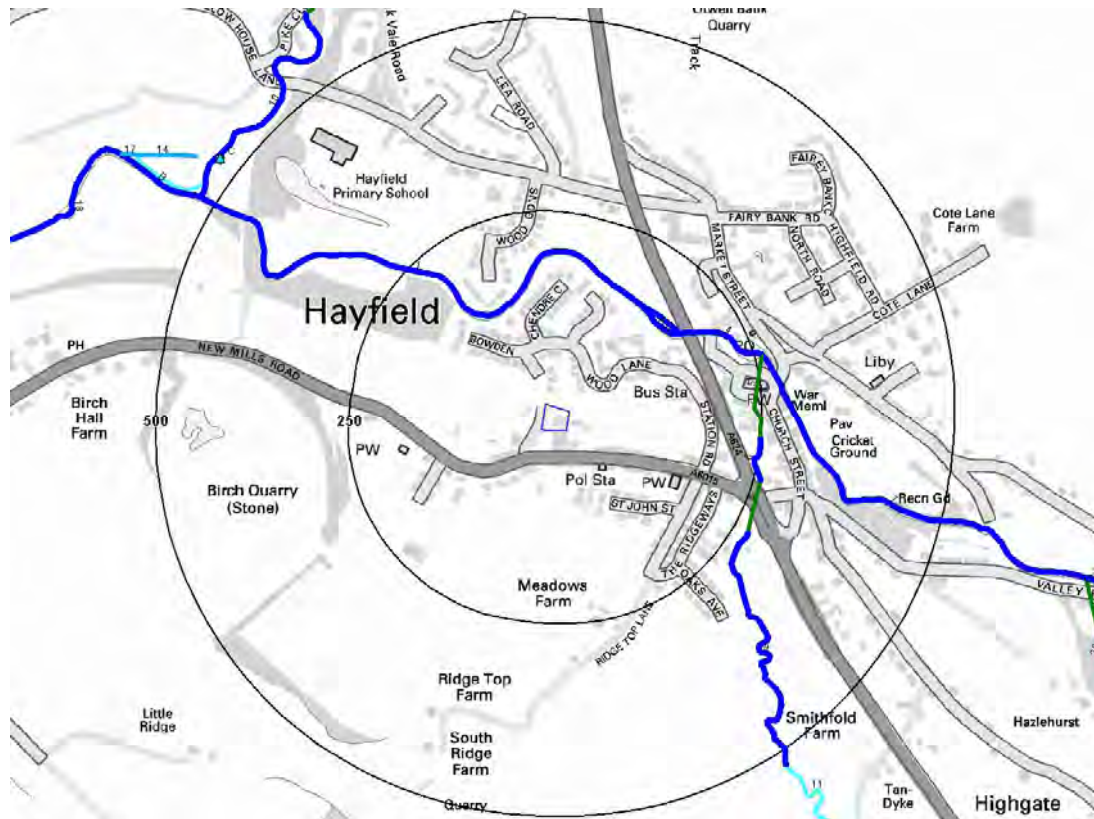
The River Sett characterised as a primary river is located 134m NW of the site.

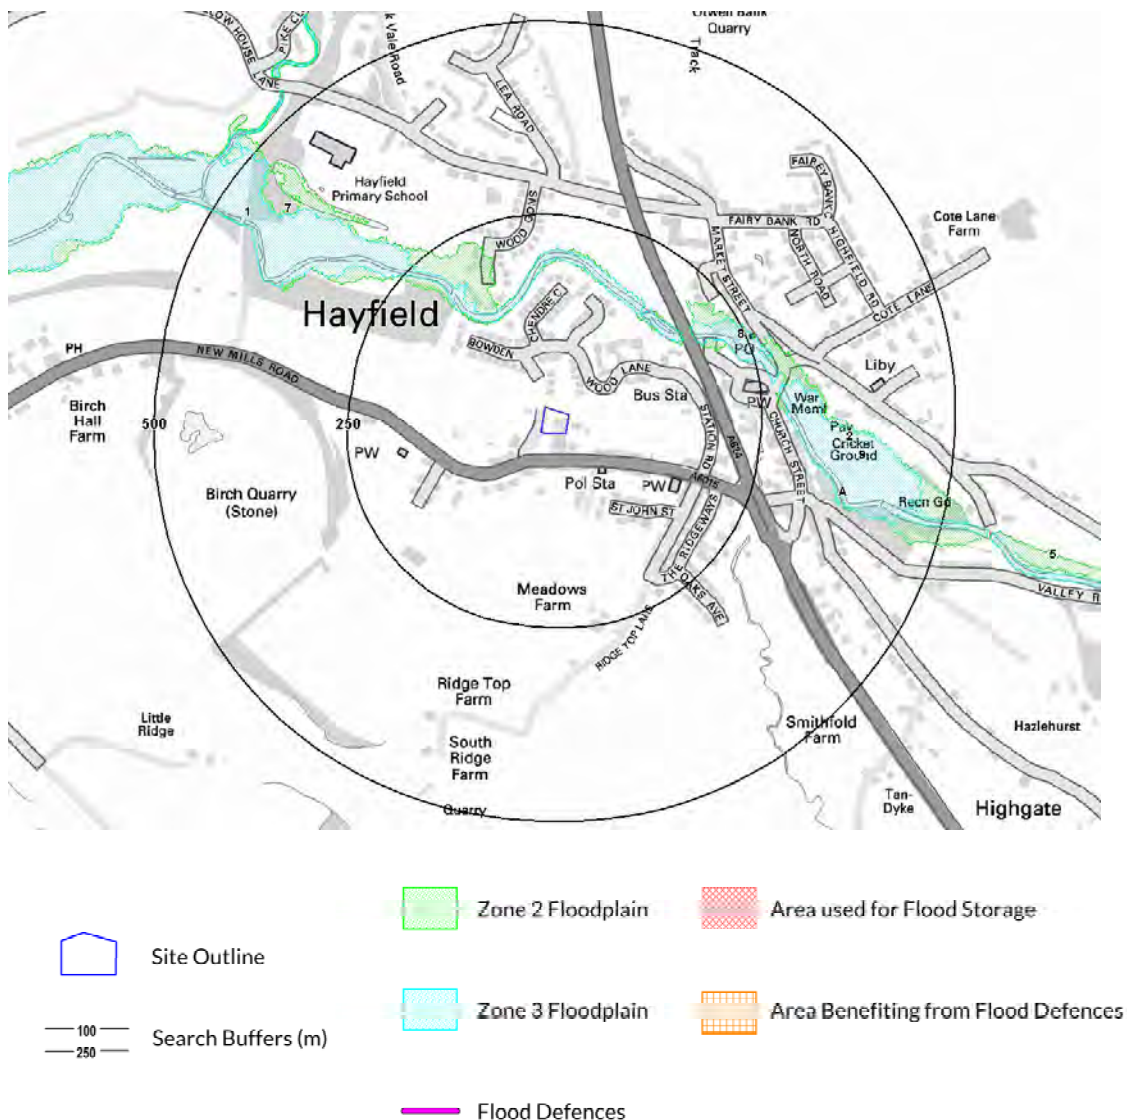
8.4.1 Environment Agency Flood Protection Zones

The Environment Agency Flood map (from rivers and the sea) shows that the site is not located within a Zone 2 and Zone 3 flood risk zone for fluvial (rivers) model. However such a zone is located within 250m of the site to the north. RoFRaS data for the study site indicates the property has a 1 in a 1000 chance of flooding from rivers in any given year.
