DAYTIME BAT SURVEY AT THE FORMER WHITE LION PUBLIC HOUSE, BUXTON, DERBYSHIRE

OCTOBER 2017

RACHEL HACKING ECOLOGY

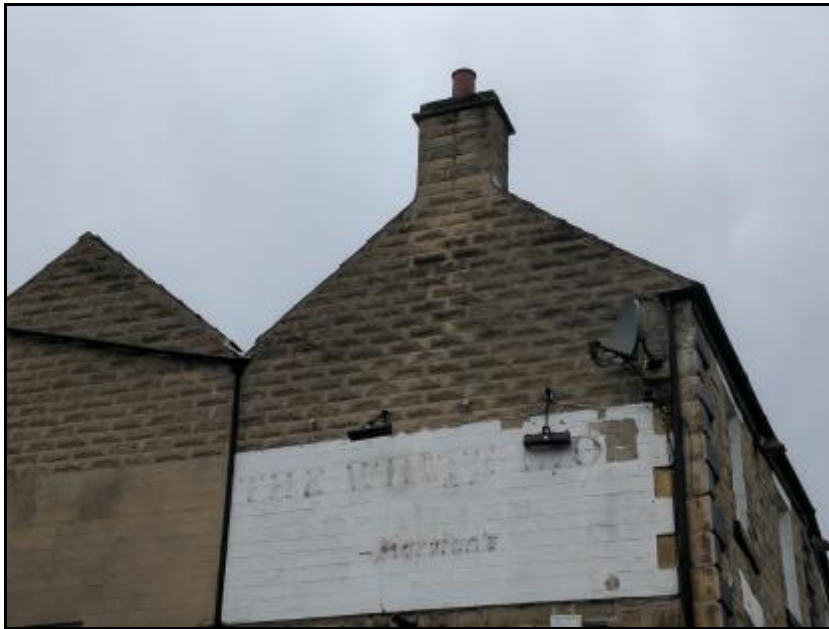
- 3.1 The former White Lion pub is constructed from stone, and has multiple pitched and tiled roofs. There is a large extension to the rear also with a pitched roof. All the buildings external stonework is complete, and showing no areas of major damage or missing mortar (see Photograph 1). The stone chimney stacks are complete and intact. The window and door frames are sealed to the stonework. The stone window lintels area complete and without cracks or gaps that bats could exploit. Parts of the exterior are rendered (see Photograph 2) which is complete and without cracks.

Photograph 1 showing the side elevation of the property

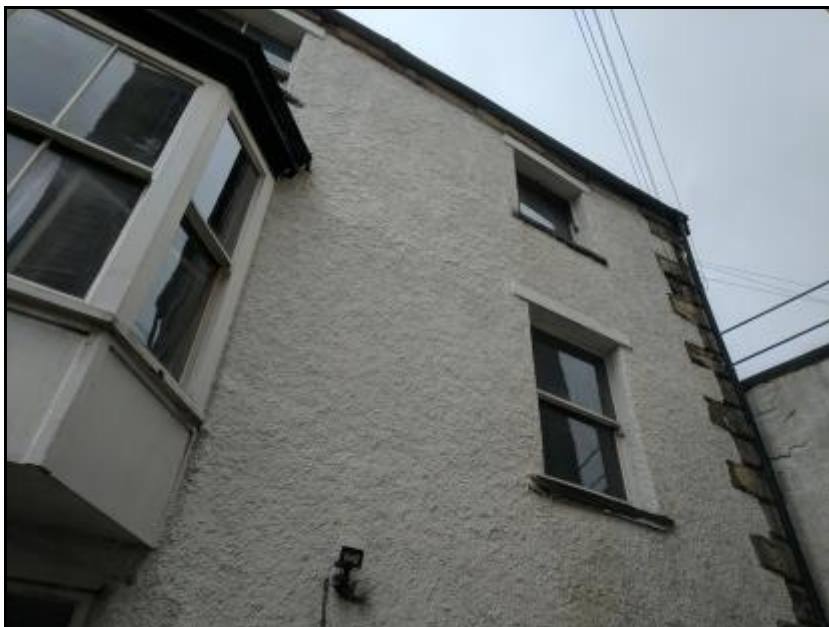
Photograph 2 showing the front elevation of the property

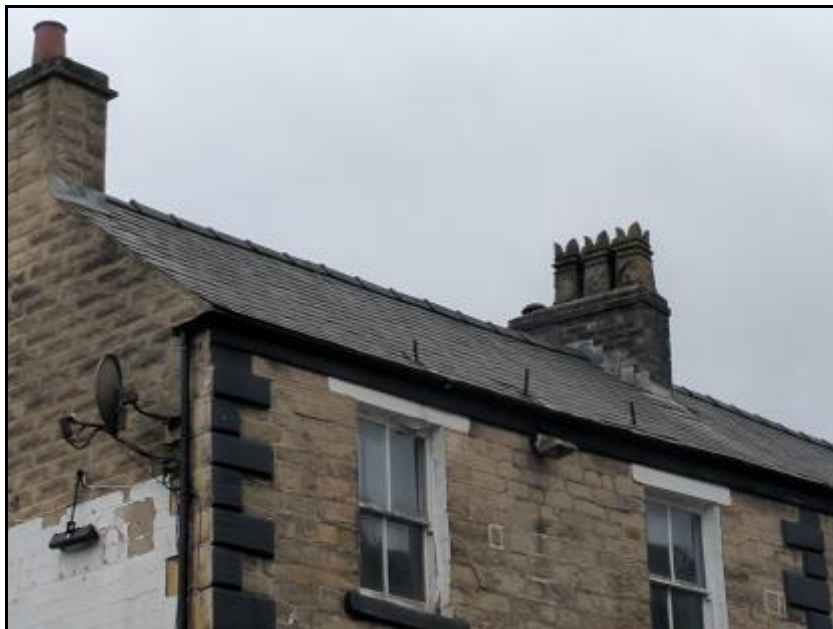
- 3.2 All the roof tiles are in position and flush to one another (see Photograph 3). The ridge riles are complete, with no major gaps under any of the tiles that bats are likely to exploit. The lead flashing at the base of the chimney stack and where the roof meets the external stonework is flattened and does not appear to provide a suitable bat roosting cavity. Wooden bargeboards exist around the edges of the roof. The bargeboards are entirely flush to the external stonework, and do not provide suitable bat roosting space nor entry into the property interior.

Photograph 3 showing the roof of the former public house

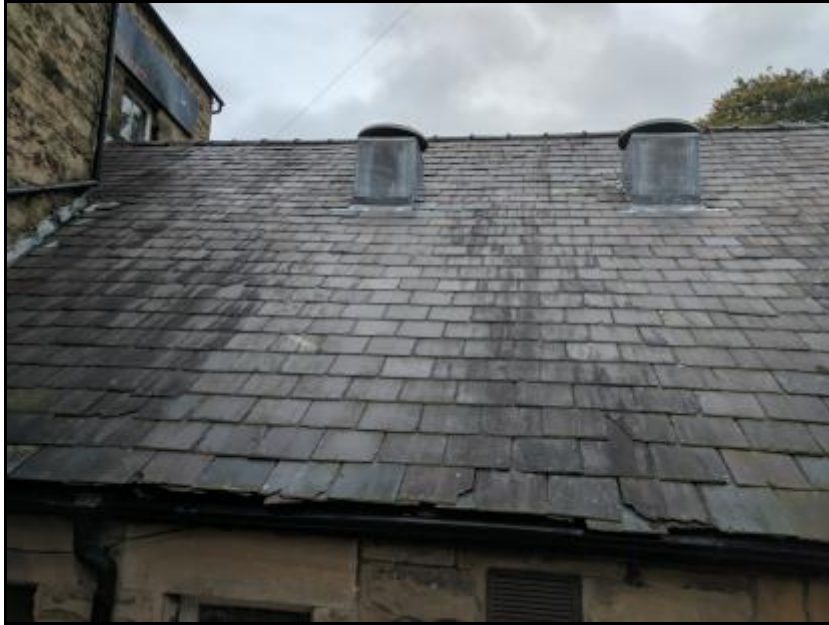
- 3.3 The rear extension is in a similar state of repair with all stonework and mortar intact. The roof is complete with only minor damage to some of the tiles (see Photograph 4). The extension appears well-sealed from the exterior. The gable ends are sealed. Negligible roosting opportunities exist in the extension exterior. Attached to the rear extension is a small storage building (see Photograph 5). The exterior stone and brickwork is complete. The small pitched roof is complete with all tiles present. The storage building appears well-sealed. Negligible roosting opportunities exist for bats to enter the building.

Photograph 4 showing the roof of the attached rear extension

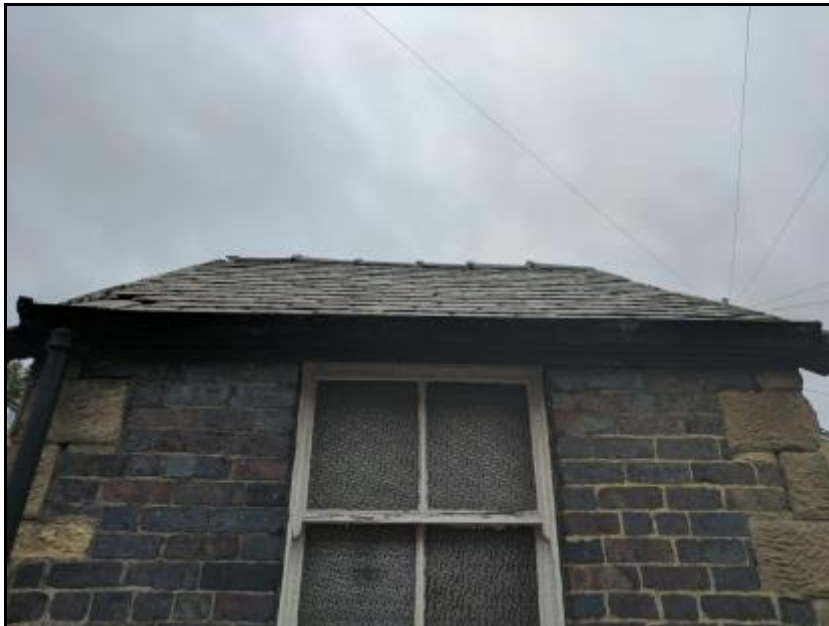
Photograph 5 showing the exterior of the small storage building attached to the rear extension

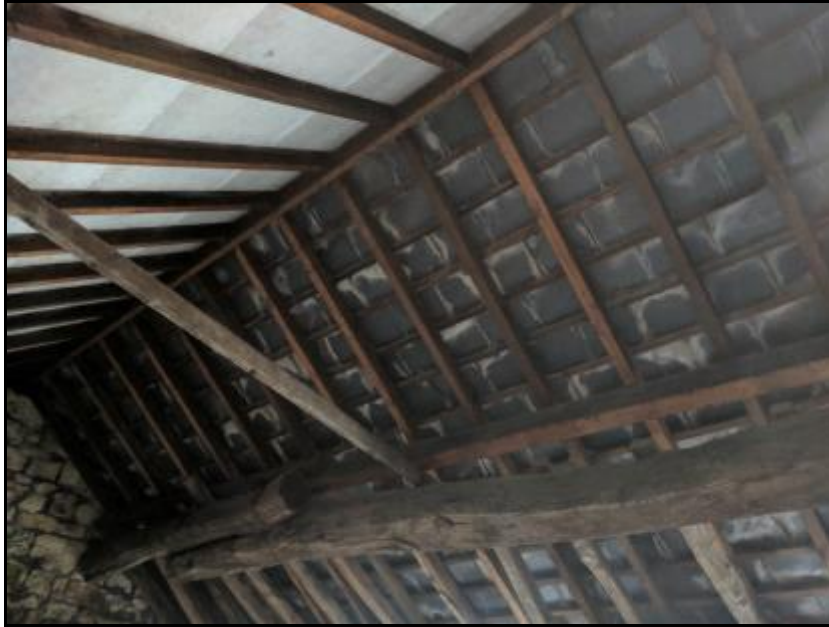
- 3.4 Internally, the main former public house building no longer has a roof void, with all the property ceilings now absent (see Photographs 6 and 7). Internal works have been carried out in recent years. All of the roofing was inspected internally and found to be complete and in good material condition. Most of the roof is unlined with all tiling mortar complete. All of the rooms are well-lit. The wooden roof support beams are without gaps or cracks that bats could exploit. All the internal stonework is complete and without suitable bat roosting cavities. Many of the windows and lintels are cobwebbed, suggesting no recent bat access. No evidence of bat activity, such as bat droppings, was found in the property interior.

Photograph 6 showing the timber beams in the roof void

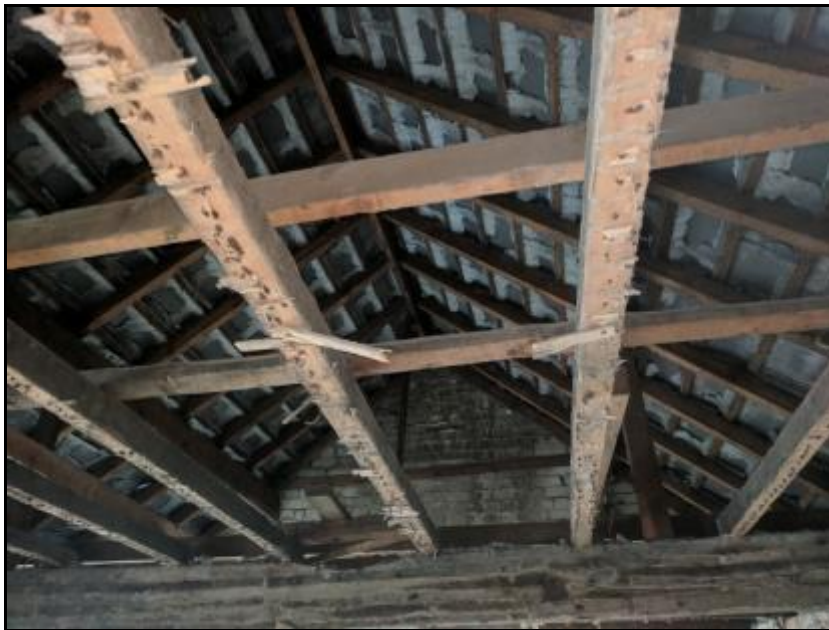
Photograph 7 showing the upper floors with removed ceilings

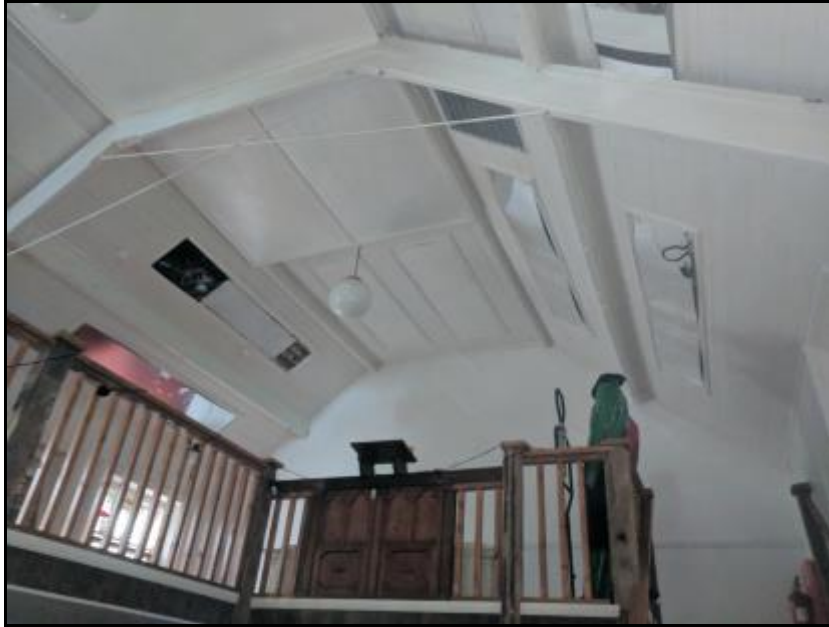
- 3.5 The rear extension does not have a roof void and is plaster boarded throughout (see Photograph 8). The interior room is well-lit, and offers no suitable bat roosting habitat. No evidence of bat activity was found in rear extension.

Photograph 8 showing the interior of the rear extension

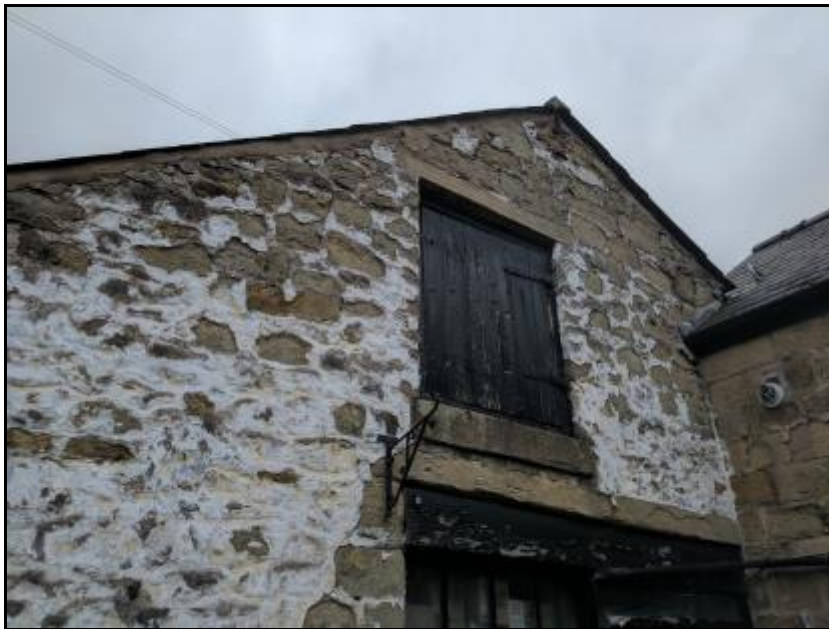
- 3.9 Attached to the main former public house building is a shippon with attached garages. The shippon external stonework is complete, with no missing stones or cavities in the mortar. The roof edging mortar is complete (see Photograph 9). The door frames are sealed to the stonework. The stone window lintels are complete and without cracks.

Photograph 9 showing the exterior of the shippon

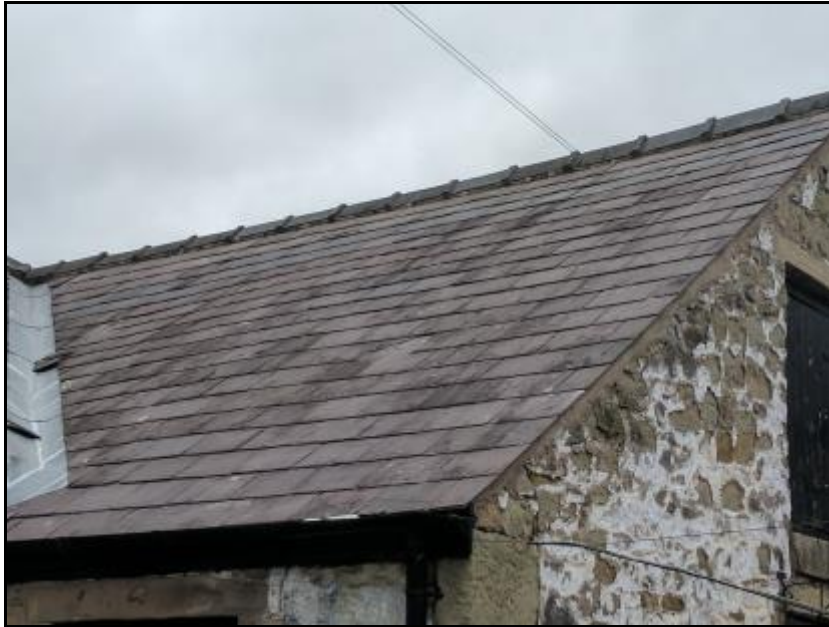
- 3.10 The shippon roof is in good material condition, with all roof and ridge tiles in position. The lead flashing is complete and flattened. The wooden bargeboards are flush to the external stonework. No potential

points of entry could be located, and negligible bat roosting opportunities exist in the shippon exterior.

Photograph 10 showing the roof of the shippon

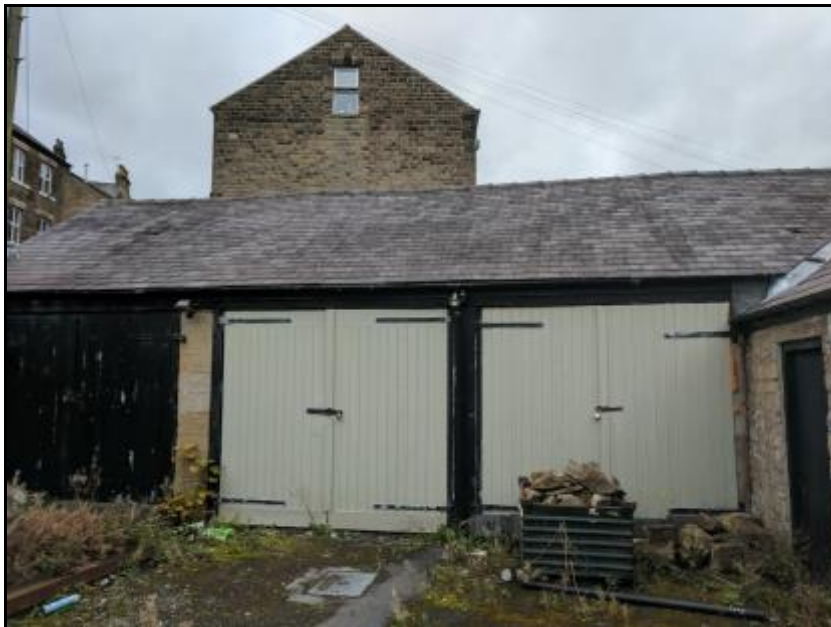
- 3.11 The attached garages are in a similar state of repair (see Photograph 11). The roof is complete, with only one small slipped tile, but the gap is shallow and does not appear to lead into the garage interior. The garage doors are complete, and the frames are sealed to the stonework. Negligible bat roosting opportunities exist in the garage exterior.

Photograph 11 showing the exterior of the garages

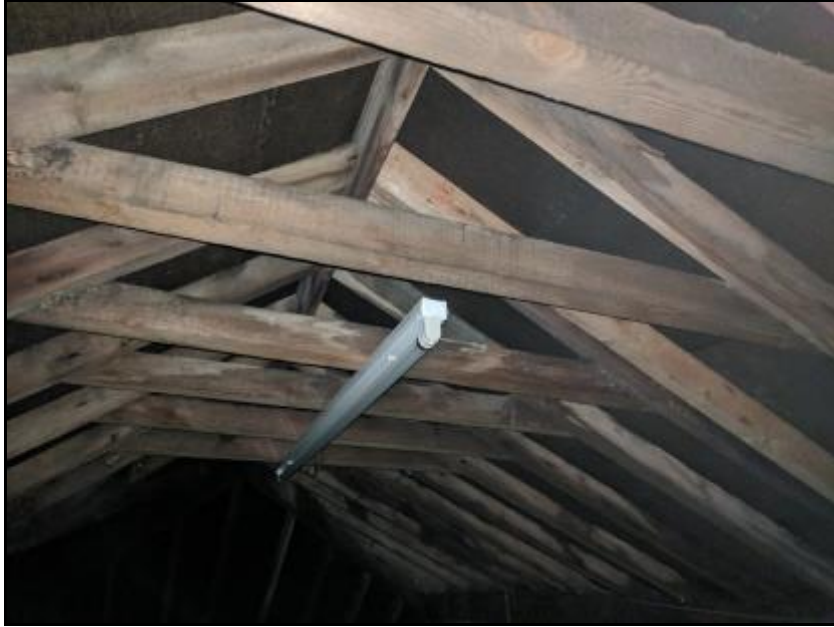
- 3.12 The shippon has one large roof void. The wooden roof beams are complete and without gaps or cracks. The roof is lined throughout with no tears in the lining (see Photograph 12). The roof void is not insulated. No daylight was visible at the roof edges suggesting the roof void is well-sealed. No evidence of bat activity, such as bat droppings was found in the shippon roof void.

Photograph 12 showing the roof void of the shippon

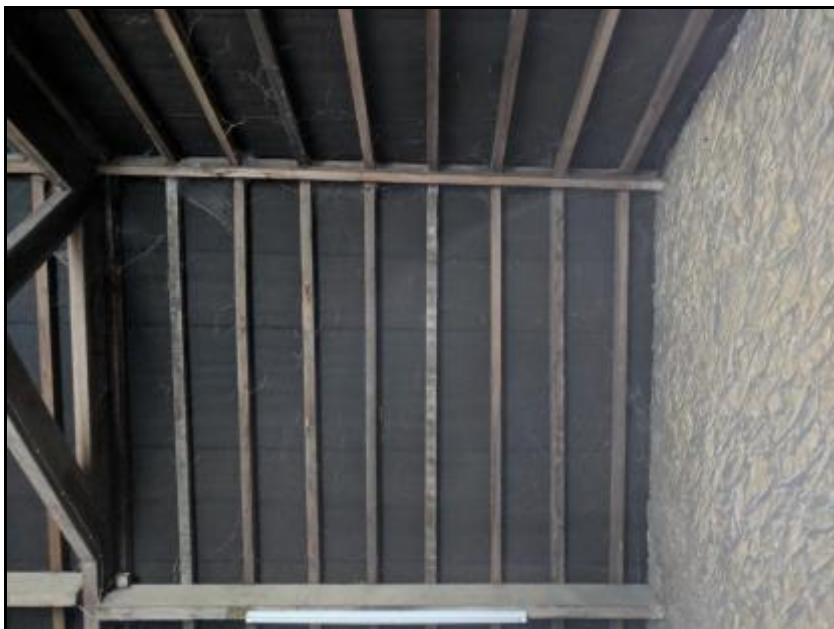
- 3.13 The garages do not have a roof void (see Photograph 13). The roof is lined throughout, with no tears in the lining. The roof beams are complete, and cobwebbed throughout. The gable walls are without areas of damage or missing mortar. No evidence of bat activity was found in the garages.

Photograph 13 showing the interior of the garages
