Our Ref: P7893/Let Rep 1
Date: 24th March 2017

Re: Site Investigation – Land off Simmondley Lane, Glossop

This summary letter report details the findings of the recent ground investigation and provides recommendations with regard to potential remediation requirements based on the available data. GRM's Standard Limitations of Reporting are provided in Appendix A of this summary report.

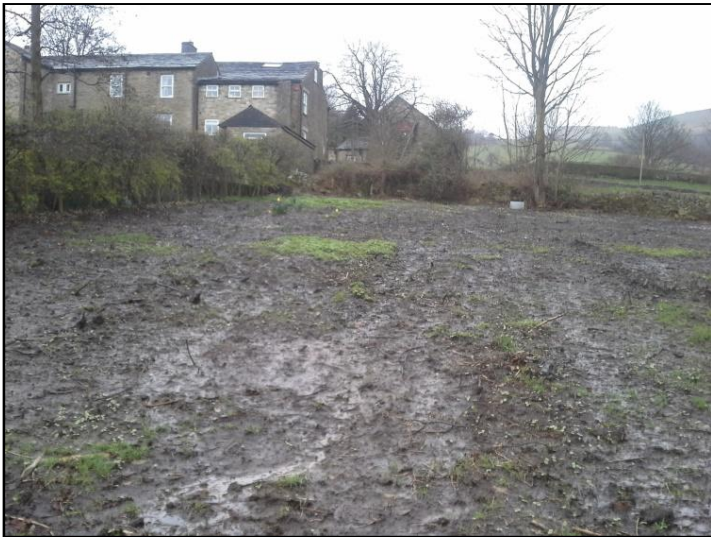
Photograph 1 – Site view towards southeast

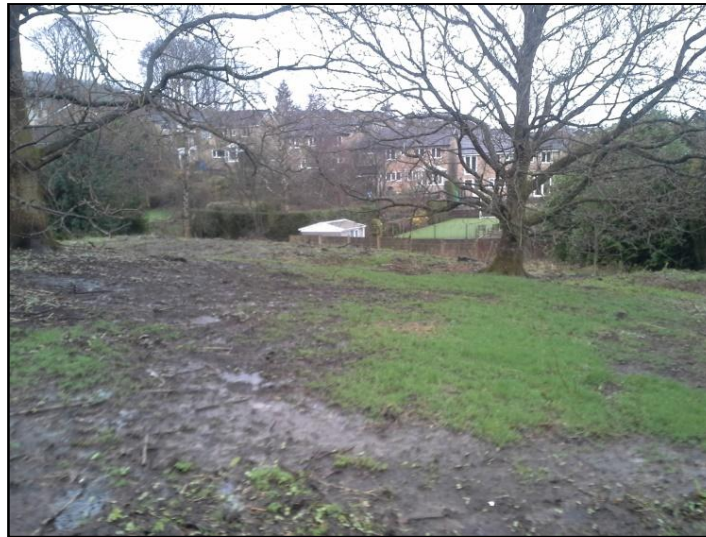
Photograph 2 – Site view looking west

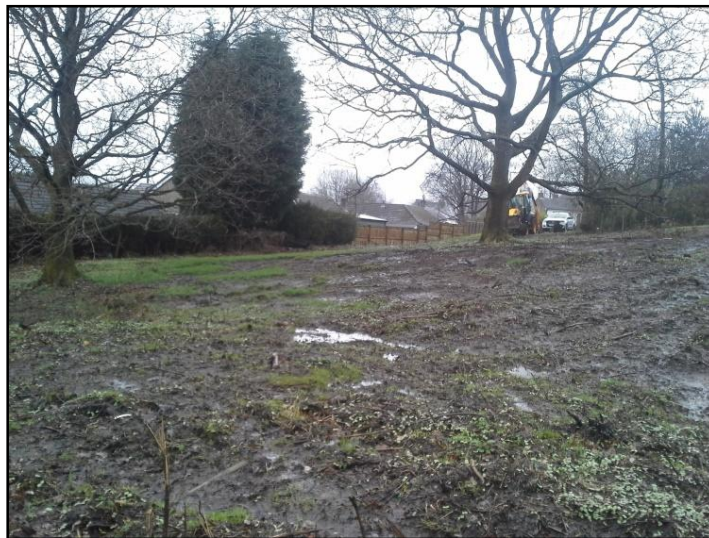
Photograph 3 – Site view looking northeast

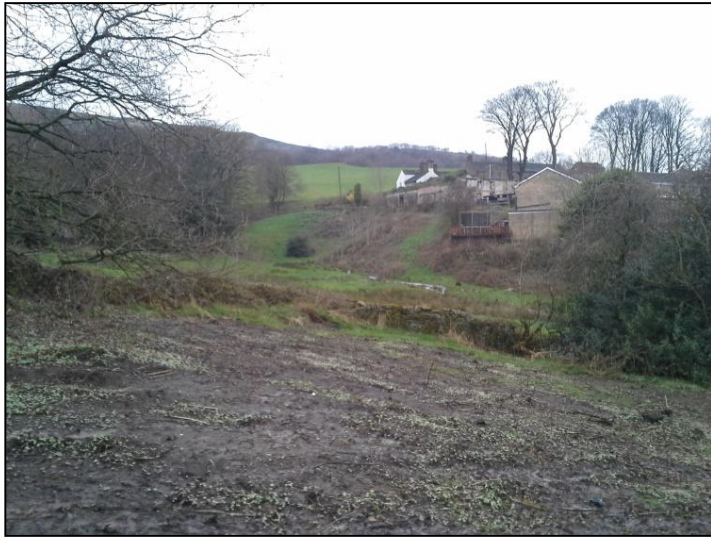
A stream is noted beyond the western boundary of the site, flowing in a northerly direction.

Photograph 4 – Valley and stream southwest

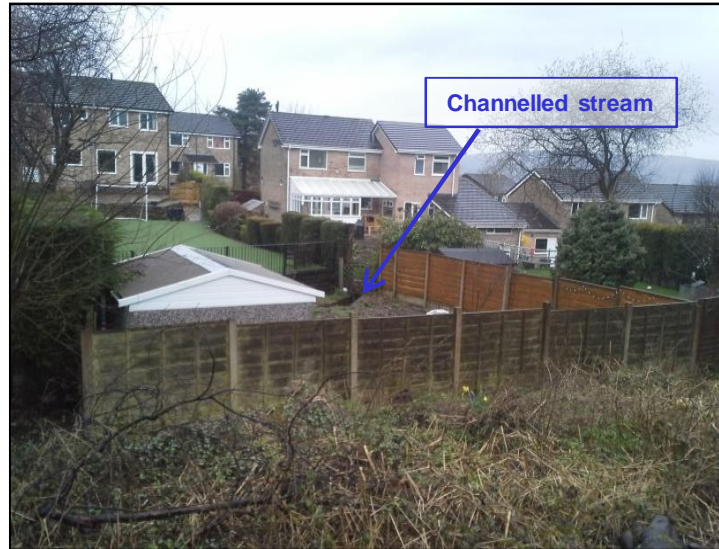
Based upon the existing information and site visit we believe that the Mill pond was formed by an embankment engineered across the valley to create a dam and the flow was controlled by sluices on the downstream side. As the pond was no longer noted by the early 1960s it is assumed that the embankment dam and sluices were broken out and removed, which allowed the stream to return to the natural channel along the valley. By the early 1990s the stream has been channelled, partially covered and landscaped into the rear gardens of the houses beyond the western boundary.

Photograph 5 – Stream channelled through rear gardens beyond western site boundary
