Derby House, Buxton Bat Survey

February 2018

Dunelm Ecology
consultant ecologists

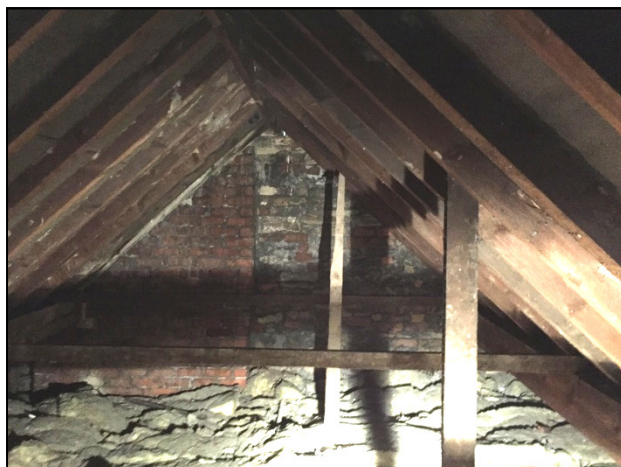
Description	Roosting Opportunities & Signs of Bat Use	Roost Potential
Mid 19 th century grade II listed building. Constructed from coursed millstone grit rubble with ashlar dressings. The walls are set under a series of pitched roofs clad with slate tiles. Only one roof void was accessible and this was lined with bitumastic felt and had a floor to apex height of 2.5 m. Several dormers protrude from the north, south and west elevations. Timber panelled eaves and spars are present on all sides of the building.	No evidence of bats was recorded. The building was re-roofed in the 1990s and is in good condition with very few potential access points observed. For example only a small number of gaps exist under ridge tiles. There are however numerous gaps under the eaves on all sides of the building, but particularly around gable sections on the west and south elevations. Additionally, there are several areas where mortar pointing has fallen away around quoins on the corners of the building but these appear to be superficial crevices.	High

Plate 1 Roof space

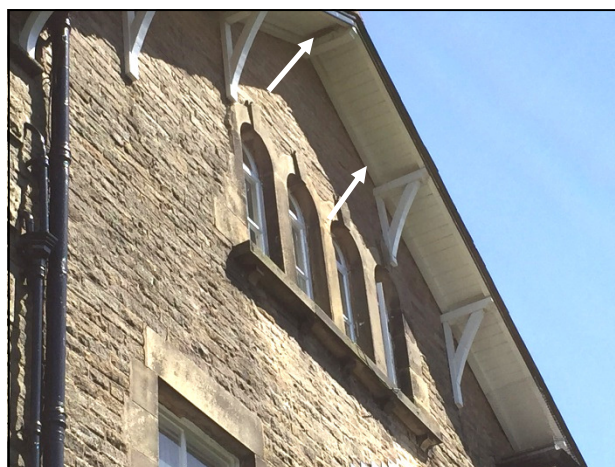
- 3.1.1 The results of the bat survey are shown in Table 3 below. In summary no evidence of bats was recorded although Derby House is assessed as having high bat roost potential due to it supporting numerous potential roost features and its location. The building is located immediately adjacent to Buxton Pavilion Gardens which provides optimal bat foraging habitat. As such bat roosts are likely to be common in the vicinity especially considering that the area is characterised by large dwelling houses that are likely to support roost sites. House martins are nesting in two separate locations on the west and south elevations near the apex of gable sections.

Plate 2 South elevation showing gaps under eaves and sand martin nests

- 4.1.2 In light of the above, and given the minor nature of the planning proposals, it is considered that the works would have no adverse impacts on the local bat population or individual bats. However, if any external roof timbers around the eaves require replacing, these should be replaced with like for like and gaps retained. Additionally, timber battens are inserted within crevices over 100 mm deep and pointed around. The battens can then be removed before the mortar fully dries; ensuring that potential access points are retained and bats are not entombed.

- 4.1.3 It is recommended that works within 5 m of the identified house martin nests as well as any works affecting vegetation, take place outside the bird nesting season (which generally runs from March to August inclusive). If works cannot be avoided during the nesting season then it is recommended that inspections should be undertaken, no more than 48 hours prior to works commencing, to ensure that there are no active nests present. If nesting birds were confirmed to be present then works would need to be postponed until young have fledged or alternatively a no works buffer zone installed preventing access to within 5 m of the nest. Alternatively, if works start prior to the breeding bird season, house martins may be deterred from nesting, especially if bird proof netting is used as an extra precaution. This approach is recommended to avoid potential infringement of the legislation that protects all breeding birds in the Wildlife & Countryside Act 1981.

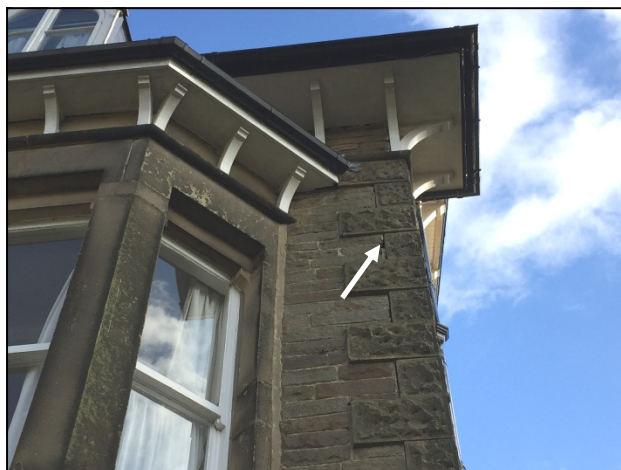
Plate 3 Gap where mortar has fallen away around quoins
