# The Network Rail (Buxton Sidings Extension) Order

## Contaminated Land *Formal Submission* Planning Condition 8 further information

**REMEDiation IMPLEMENTATION PLAN**

**Report No. PF1/F15005/5.2/MIC  
June 2018**

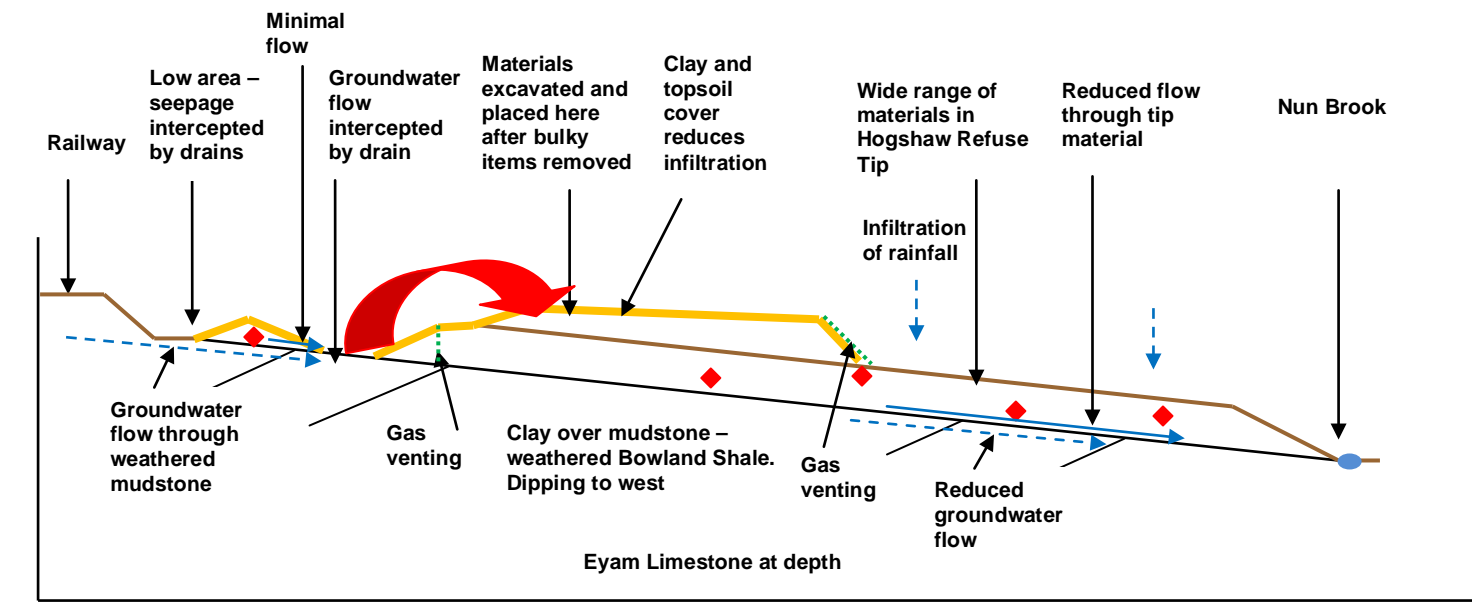
**Buxton Sidings Extension Scheme**  
Figure 5: Conceptual Site Model of Pollutant Pathways

**BEFORE**
